SAFETY ALERT

Crush Injuries during Crane Lift

Document No: **IW-HSQE-SA-19**

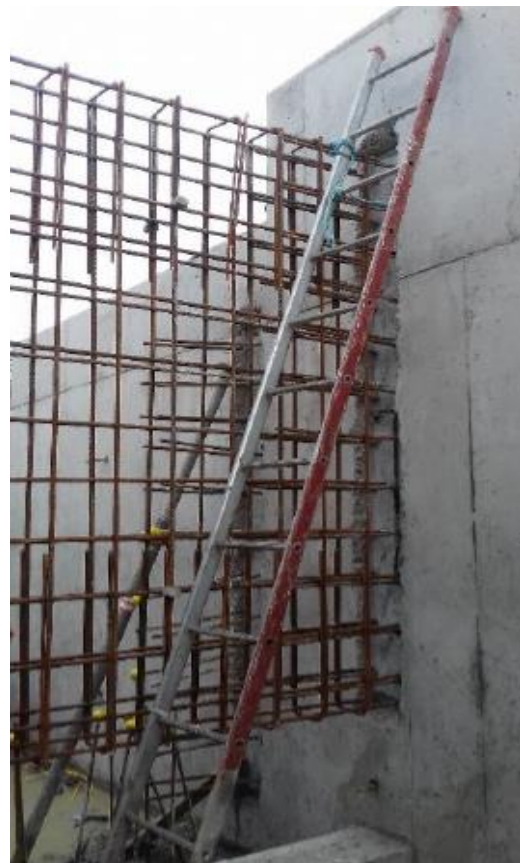
A banksman who had recently started works on the site suffered multiple fractures to his pelvis during a crane lift of a shuttering pan.

The shuttering pan which weighed approximately 500kg (3m High x 3.3m Wide) was being lifted into a process tank when the IP climbed a tied ladder (pre-installed for other works) to gather the tag line attached. While on the ladder, a gust of wind moved the shuttering pan and it made contact with the IP. The IP was momentarily pushed against pre-installed reinforcing steel. This impact resulted in multiple fractures to the IP's hip. The IP managed to descend the ladder but was in significant pain.

- The crane being used for the lift did not have an anemometer to monitor wind speed (it was documented in the lift plan that this was a requirement). Wind conditions were perceived to be calm; however, an unexpected gust of wind did catch the shutter on the day of the incident.
- IP did not adhere to safe working practices (banksman should have a supervisory role only for all lifts). The IP opportunistically used a ladder to collect the tag line to assist in the installation of the shutter while also performing the role of banksman.
- The Emergency Response Plan (ERP) was not sufficient. There was no adequate means of removing the IP from the tank and the giving of directions to the site location was proven difficult to the emergency services (no Eircode in the ERP).

- Ensure responsibilities are clearly communicated at site management level when there are personnel changes.
- Ensure all personnel are inducted to site and briefed on the Method Statement and Risk Assessment for the works.
- Ensure Banksman responsibilities are clearly defined prior to commencement of works.
- Remove equipment/ladders when they are no longer required to prevent opportunistic usage.
- Ensure the weather conditions are closely monitored at all times and an anemometer should be available to measure wind speed.
- Ensure the emergency response plan is adequate to deal with all emergency situations and regular drills carried out to ensure its effectiveness.
