Gas Utility inside Containment Damage

Document No: IW-HSQE-SA-27

SAFETY ALERT

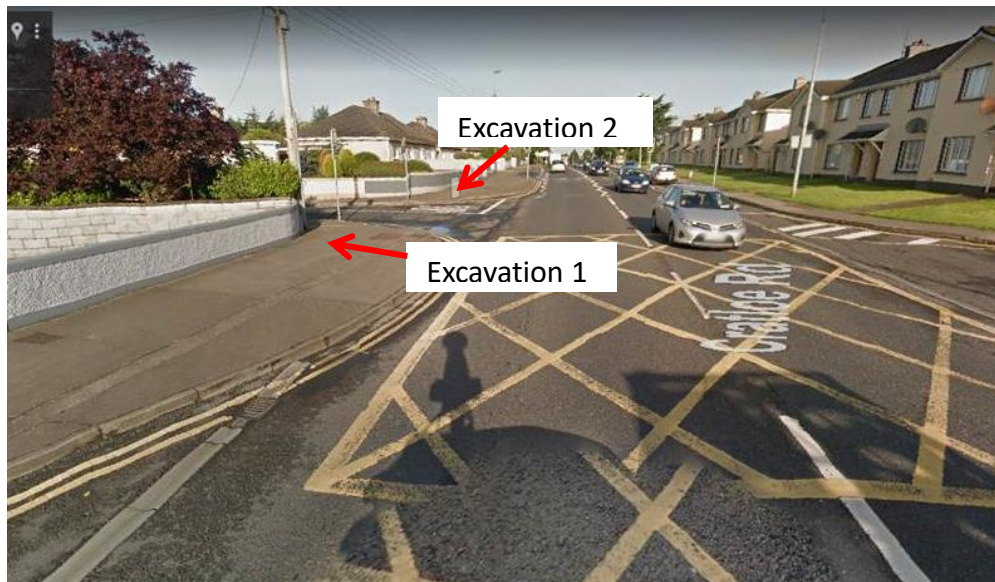
Fig 1 Location of the Excavations

- A second trench was opened, exposing two cast mains, 30m from trench opened previous day which was on the footpath on the opposite side of a road junction (Fig 1). The foreman instructed his GO to cut through the cast iron main at the boundary wall side, believing it to be the water main as this was the lay out that had been identified on the previous excavation.

- Do not assume that utilities identified in one trench will be in the same position elsewhere.
- Where services of a similar nature have been identified, further investigation works should be carried out to confirm the identity of the service such as contacting the service provider, identifying service connections etc.
- Where it has been identified that gas mains have been inserted in cast pipe and cast iron water mains are in the vicinity of these services, do not cut pipework until the contents have

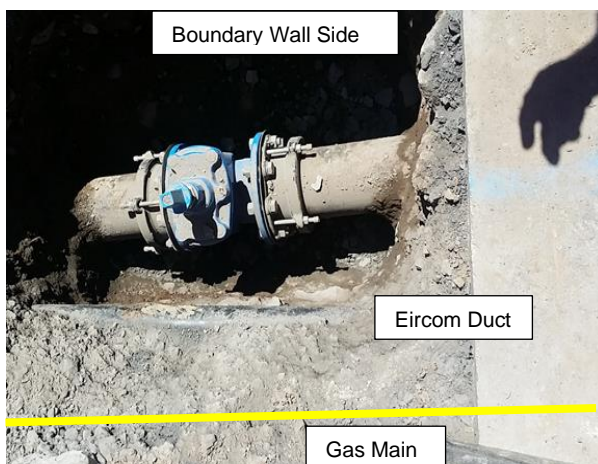
Fig 2 Excavation 1 Services Layout

- The Utility drawings indicated that there was a Ø125mm LP Gas main inserted in a cast iron pipe in the vicinity of the works.
- On the previous day the cast iron water main was exposed and a sluice valve was inserted. In this excavation the cast water main was to the far left (nearest the boundary wall) with an eircom duct and gas mains to the right of the water main (Fig2).

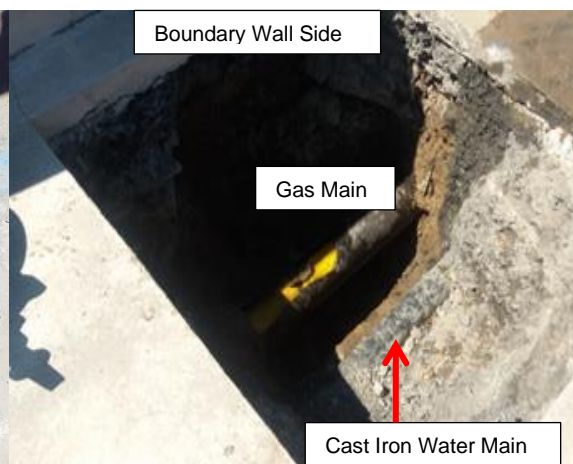
Fig 3 Excavation 2 Services Layout

- The GO used a consaw to cut into the cast iron main believing it to be the cast water main. The cut cast iron pipe contained the inserted $\text{Ø}125\text{mm}$ LP gas main which the GO also cut.
- There was an uncontrolled release of natural gas, on smelling gas, the GO stopped works and exited the trench to notify his supervisor.
- No injuries occurred during this incident.

- Mechanical equipment should not be used for cutting cast iron water mains where cast gas mains are known to be in the vicinity, use a pipe cutter.
