Site Deliveries

Document No: **IW-HSQE-SA-55**Approved By: Maura Kilcommons

SAFETY ALERT

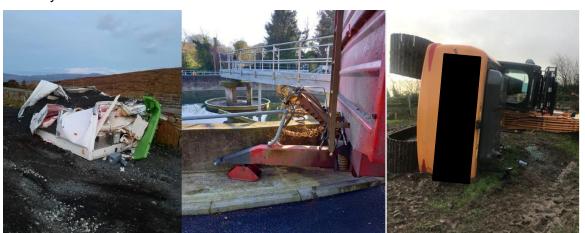
- 4. An articulated truck load of stone was being delivered to a laydown area outside of working hours. (The crew were finished and had left site). The truck driver was tipping the load adjacent to a mobile welfare unit and during the tipping of the load, the truck overturned and crushed the welfare unit.

- 7. A sludge trailer collided with a clarifier tank during a trailer change over. The trailer rolled from a parked position into a clarifier damaging a section of handrail, gear box and bridge scrapper.

Fig. 1: articulated truck overturned Fig. 2: Sludge trailer collided on welfare unit

with clarifier

Fig. 3: Excavator overturned during Loading

Irish Water have requested the Local Authorities & Delivery Partners involved to review all vehicle operations and controls and ensure the required checks/inspections are completed on all vehicles and plant.

- Ensure loading/unloading activities to sites are planned and supervised.
- Review accessibility and offload capacity of delivery location (may require restricting the size of vehicle allow to site).
- Ensure a suitable working space for all vehicles/ machinery on site/asset. Provide exclusion zones for machinery/vehicles and pedestrians. Where physical exclusion zone cannot be provided, ensure a system is implemented to manage interaction between plant and pedestrians.
- Develop and enforce a delivery procedure for asset/site.
- Assess/procure a competent transporter/contractor to undertake works.
- Ensure competent personnel complete the required daily vehicle/equipment checks and inspections as per own site procedures
