Appendix A16.13 Marine Archaeological Dive Survey Undertaken as Part of the Environmental Impact Assessment

**Greater Dublin Drainage Scheme
Underwater assessment
off Velvet Strand, Burrow, Co. Dublin
16D0051, 16R0076**

Report

07 September 2016

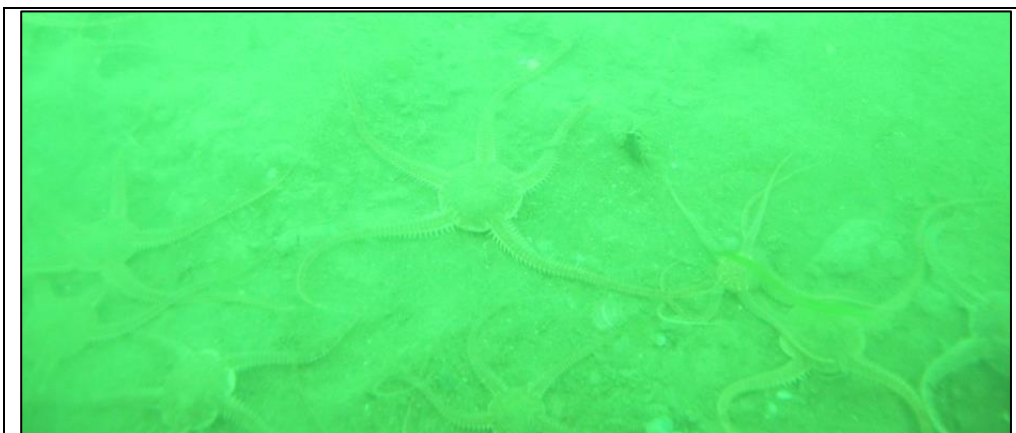
6.1 Dive Location 1, anomalies b1, mg7, ss4

Dive Log and interpretation					
Yellow buoy observed on site, suggesting the terminus of an existing outfall pipe is positioned in this location. There was no anomaly observed at the bottom of the down-line. Water depth was 8.2m, underwater visibility was 2m. A circular search commenced, extending to 40m from the down-line, and using a pendulum search pattern to ensure full coverage of the search area. The seabed surface comprises silt and sand, with a light rippled surface. The sediment is a medium density, permitting manual penetration to a depth of 3cm. The seabed is flat and featureless. There are no rises or hollows in contrast to the topographic anomaly b3 detected in the geophysical survey, which had suggested a slight linear variation. The natural slope seawards (to the East) was observed. The metal-detector did not detect any anomalies here. There is no feature in this location exposed on or above the seabed.

Underwater view of the seabed at Dive Location 1.

Recommendation					
No further work is required in this location prior to the construction phase. Archaeological monitoring of all seabed impacts is required during the construction phase.

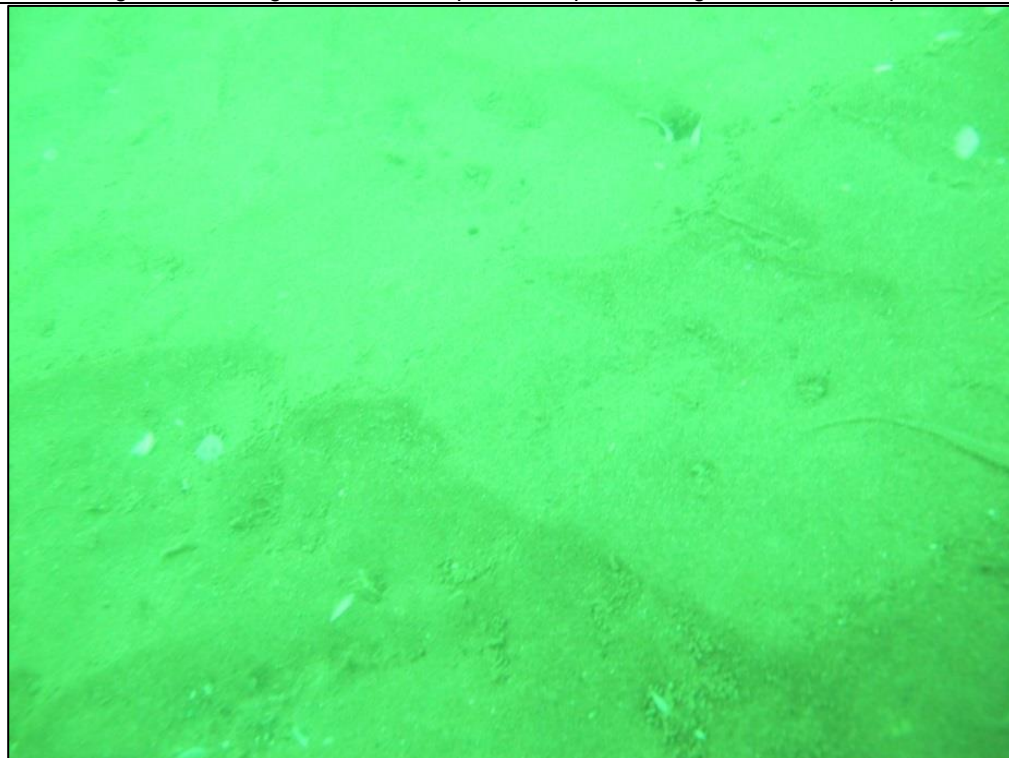
6.4 Dive Location 4, anomalies ss16

There was no anomaly observed at the bottom of the down-line. Water depth was 20m, underwater visibility was 1m.
Seabed composed of compact silty-sand with frequent crushed shell inclusions. The topography is flat and featureless. Hand penetration depth of 4cm. One full length of the swim-line completed, extending out to 20m from the base; no change in the seabed was observed. Strong current present. Underwater visibility 1m (max.).
The metal-detector did not detect any anomalies here.
There is no feature in this location exposed on or above the seabed.

Underwater view of the seabed at Dive Location 4.

No further work is required in this location prior to the construction phase.
Archaeological monitoring of all seabed impacts is required during the construction phase.

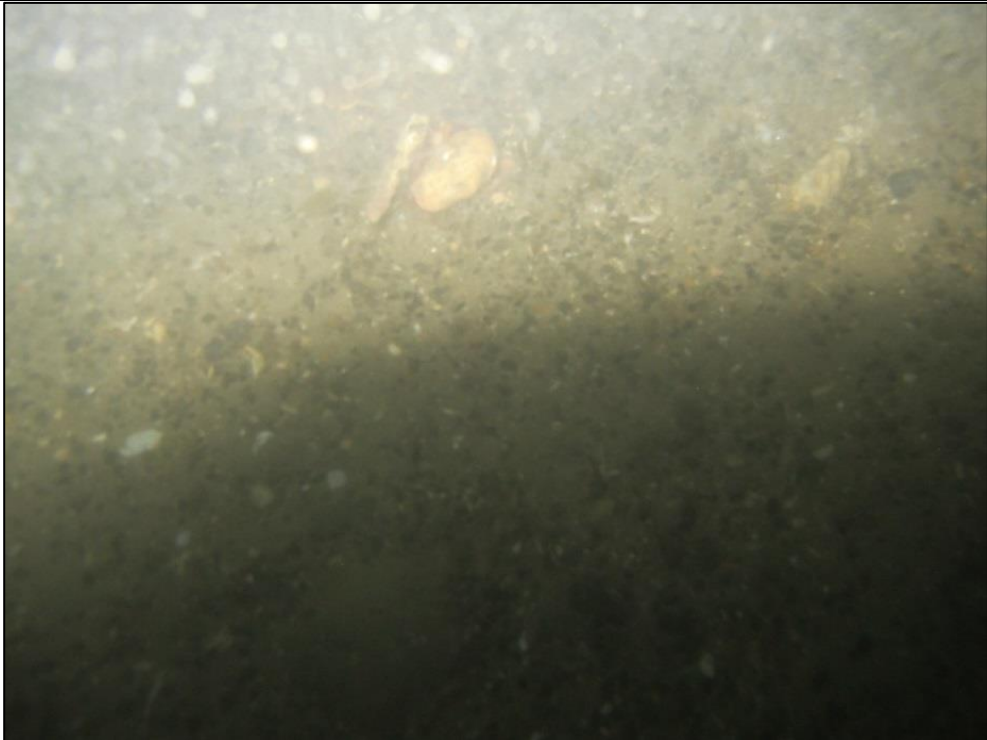
6.5 Dive Location 5, anomalies ss17, ss23, ss25

Dive Log and interpretation					
<p>There was no anomaly observed at the bottom of the down-line. Water depth was 18m, underwater visibility was 1m.</p> <p>Seabed composed of compact silty-sand with frequent crushed shell inclusions. The topography is flat and featureless. A localised area of cobble spread is present to the south of downline. A string of whelk pots was located a short distance south of this cobbling. Hand penetration depth was 4cm-6cm. The full length of the swim-line was reached and extended out to 40m from the downline. No change in seabed was observed. A strong current was present.</p> <p>The metal-detector did not detect any anomalies here.</p> <p>There is no feature in this location exposed on or above the seabed.</p>

Underwater view of the seabed at Dive Location 5.

Recommendation					
<p>No further work is required in this location prior to the construction phase.</p> <p>Archaeological monitoring of all seabed impacts is required during the construction phase.</p>
