Appendix A16.11 Intertidal Archaeological Survey Undertaken as Part of the Environmental Impact Assessment

**GREATER DUBLIN DRAINAGE SCHEME
INTERTIDAL INSPECTION
VELVET STRAND, BURROW, CO. DUBLIN
15D0019, 15R0025**

06 October 2015

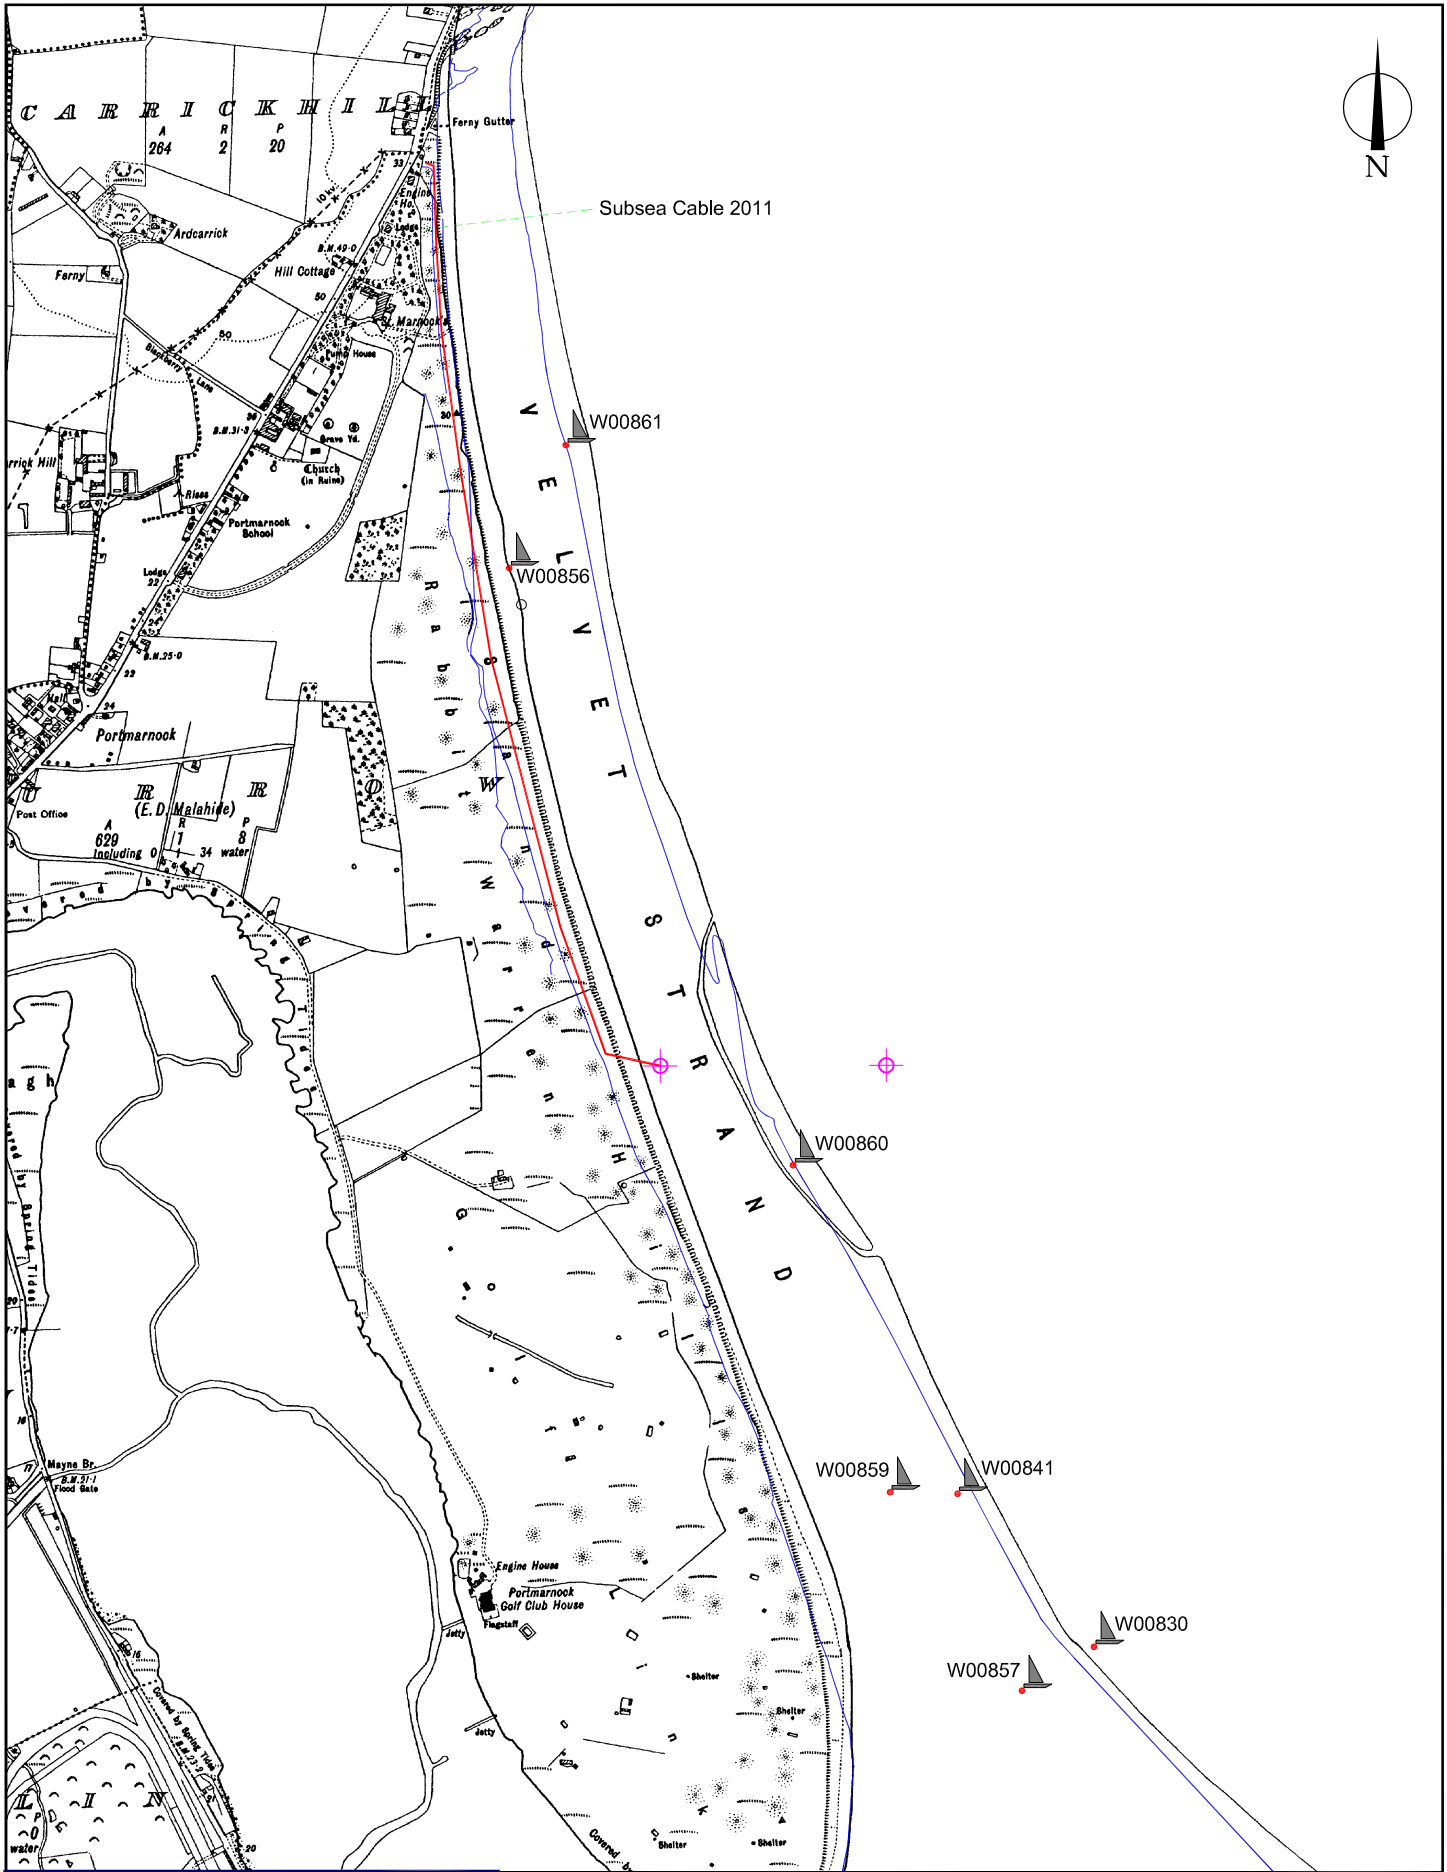
Drawing No.
 Figure 3

The sand dune system that overlooks the beach area is in retreat. Figure 3 shows the line of the shoreline as recorded on the Third Edition Ordnance Survey maps, c. 1912, as well as the present-day shoreline (highlighted as a blue line). The extent of coastal retreat can therefore be plotted. The dune system is low-lying, and some attempt at coastal protection is evident, where a line of limestone boulder is inserted at the foot of the dunes today (Plate 3).

Title
 Figure 3- Extract from OS (1912) 25" mapping with location of proposed development, limit of present day coastline, and known shipwreck sites superimposed.

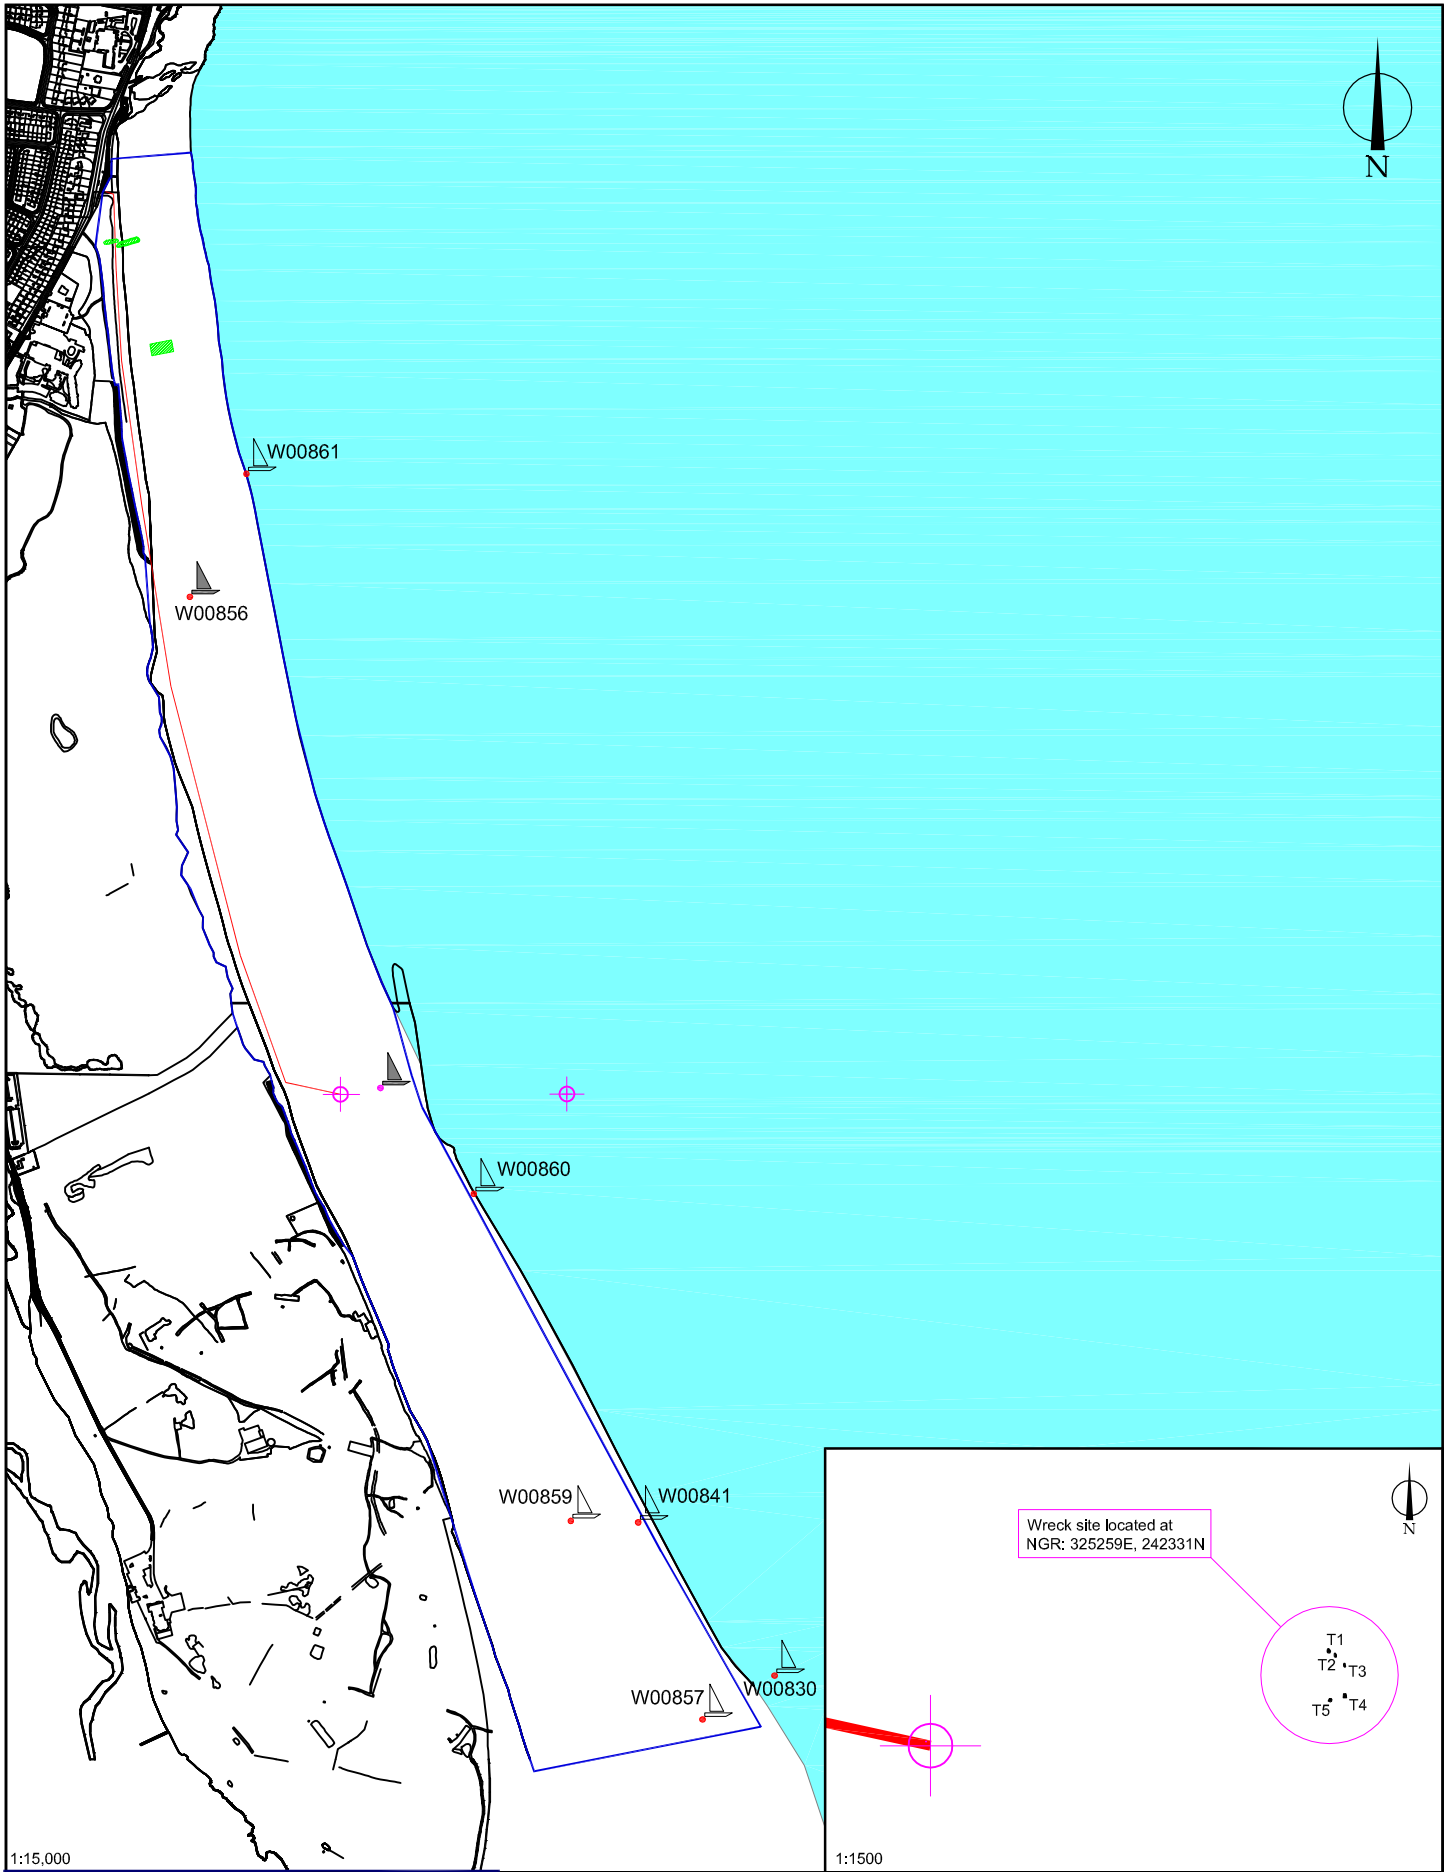
Drawing No.
 Figure 4

The new shipwreck is located at 325259E 242328N (ITM 725182E 742352N), placing it 7m north of a straight line between Boreholes 1 and 2, and 80m east of Borehole 1 (Figure 4, Plates 11-13). It is represented by a series of six framing timbers, whose eroded tips are exposed just above the covering sands. Five of the timbers form a bow-shaped plan that suggests the length of one side of the vessel and its orientation. The sixth timber is the only member suggesting the other long side of the vessel. The wreck is orientated North-South and the line of timbers represent the starboard side. The exposed timbers extend over an area that is 10m long, while the sixth timber is 3.2m away, and indicates the possible width of the vessel. It does not appear to be a large vessel, but it should be noted that the full extent of the vessel is buried. The exposure of the timbers along the starboard side may indicate that the vessel lies on its side, tilted towards land. There is no metal associated with the

The location of the new wreck lies directly between Boreholes 1 and 2, and would be considered to be within the direct impact area of the outfall pipe should the borehole locations reflect the proposed centerline.

Title
 Figure 4- Project Drawing showings location and extent of ADCO Survey Area and survey observations.
 [Thumbnail: location and position of five framing timbers from a shipwreck buried within the beach deposits on Velvet Strand].

AVOIDANCE. It is recommended that the site of the new wreck is avoided during site investigations and construction.

EXCAVATION. If avoidance is not possible, it will be necessary to excavate fully the new wrecksite prior to the construction of the outfall, to preserve the site by record. Excavation would be carried out as an intertidal exercise and would be done by a specialist team of maritime archaeologists.

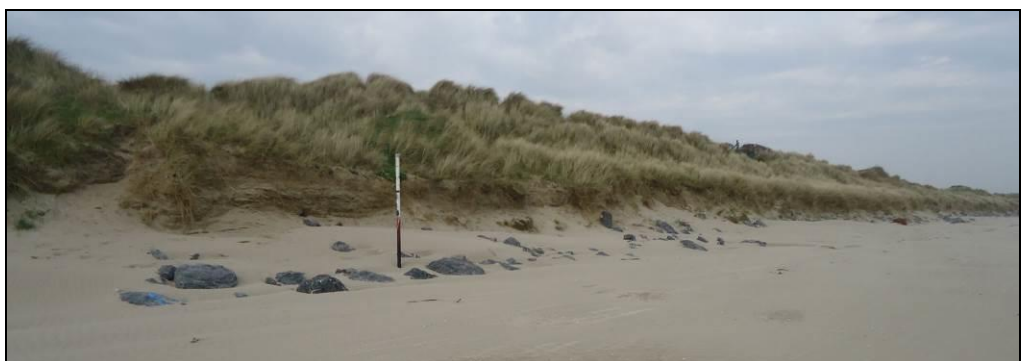
Plate 3: View looking North at foot of sand dunes, at a point where the access route will turn eastwards across the beach. The dark grey boulders reflect the line of rock-armour protection inserted to prevent coastal retreat.

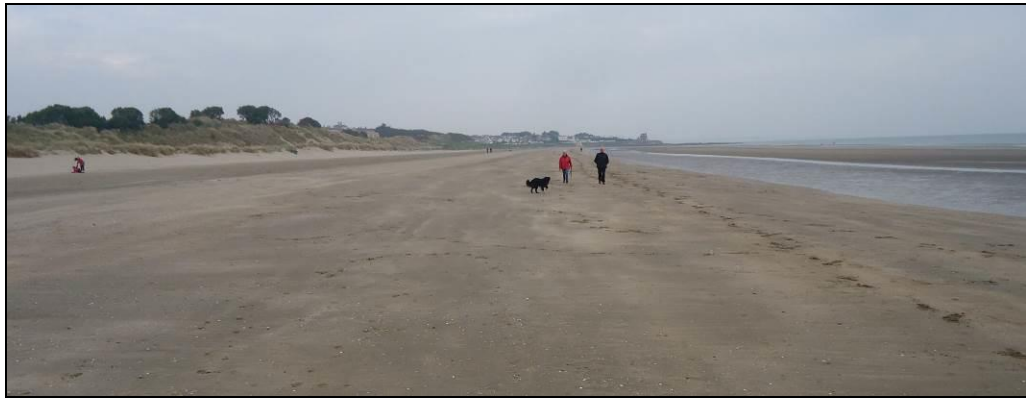
There is little variation in the sand topography across the beach or along its length. A gentle variation in sand height across its width gives rise to some element pooling at Low Water (Plate 4). These features no doubt reflect the dynamic nature of the sand movement along the beach that results from longshore drift.

Plate 4: View looking North across intertidal foreshore, showing the gentle modulation of the sands, and presence of some intertidal stream channel on the seaward side.

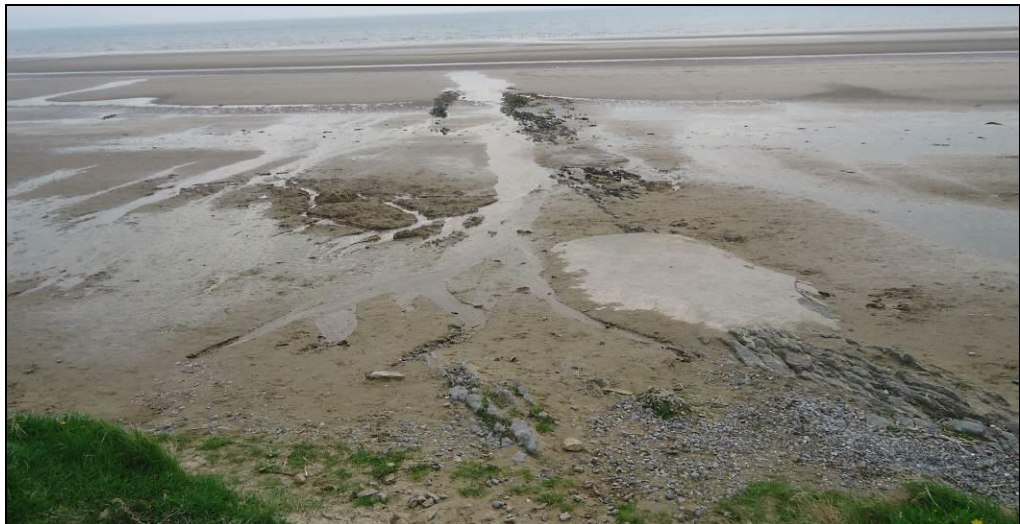
Three areas of bedrock were observed on the beach. A linear exposure extends eastwards from the High Water Mark, close to the north end of the survey area (324724E 24409N) (Plate 5). A pad of concrete is evident on the landward end of the exposure. The location coincides with the alignment of a subsea cable inserted in 2011, and it is suggested that the outcrop may have been cut into to secure the cable landfall. The access route will be directed across this location.

Plate 5: View looking East across a rock outcrop that appears to be cut into, perhaps for a subsea cable laid in 2011. The bright patch in the centre-bottom of the image is a concrete spread.

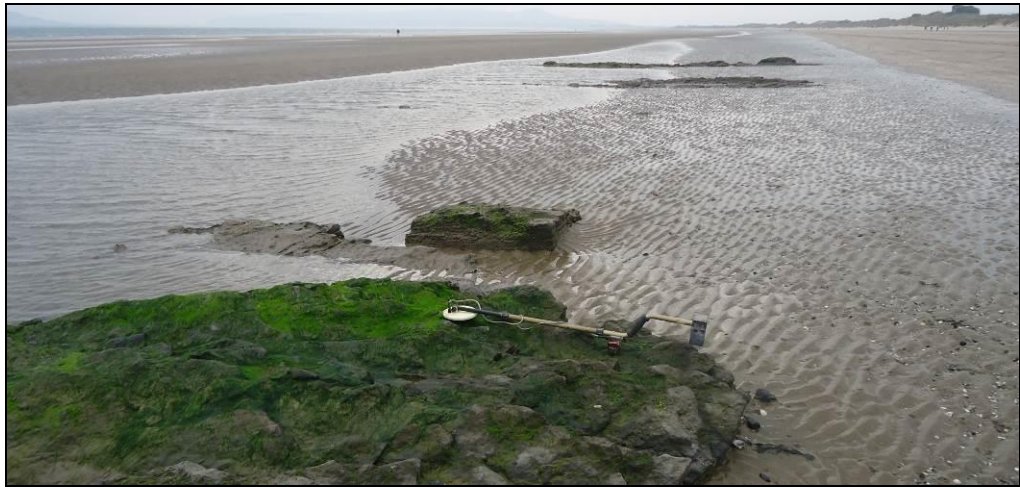
A second exposure of bedrock lies to the south (325259E 242328N) (Plate 6). It comprises localized three exposures of rock that are aligned broadly ENE-WSW, and dip to the south. The alignments continue those evident on the headland that creates the north end of Velvet Strand. The exposures lie 80m east of the proposed access route and will not be impacted by any works.

Plate 6: View looking South across three exposures of rock outcrop.

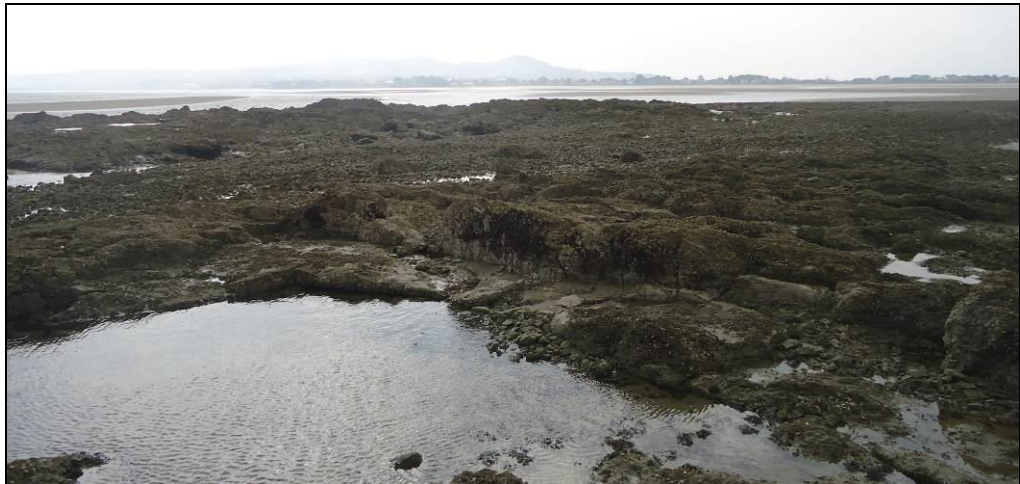
The third exposure of rock lies to the south, where the beach widens noticeably. Rock itself is not entirely evident as there is a thick cover of concreted shell (325898E 241079N) (Plate 7). This location is 1.4km south of the proposed works and will not be impacted by the works.

Plate 7: View looking Southeast across low bedrock exposure, some 1.4km south of the development area.

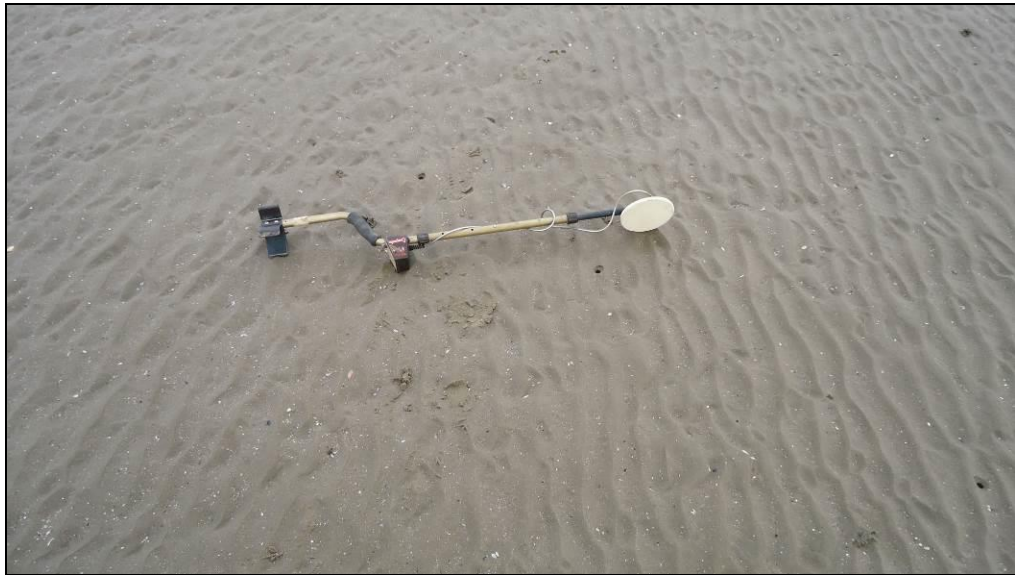
In the case of site W00856, which lies approximately 63m east of the proposed access route, observations made in 2002-3 recorded 20 timber frames and some hull planking, and details that included the presence of treenails, dowel holes and copper bolts. There is nothing visible today (Plates 8-10). The lack of visibility of these features today is compounded by the absence of any detection of buried metal at the location. This might suggest that the charted coordinates are inaccurate; however, careful search of the wider area around the location also failed to identify any feature. The absence of visible remains at any of the other known wrecksite locations that were inspected, suggests instead that they are buried beneath the covering sands. This in turn suggests a very dynamic state of the sands that form the beach area; a point that is supported by the progress of coastal retreat which is evident when comparing the historic coastline with the present-day coastline.

Plate 8: View of current sand surface at the location of known wrecksite W00856, showing no indication of the wreck today.

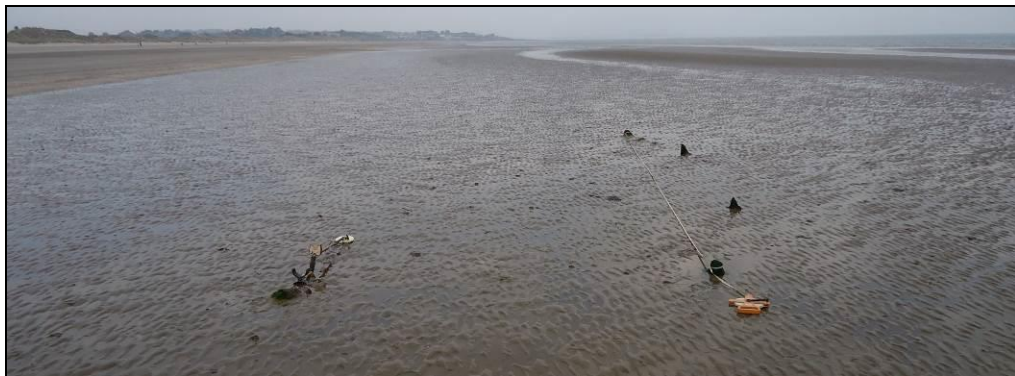
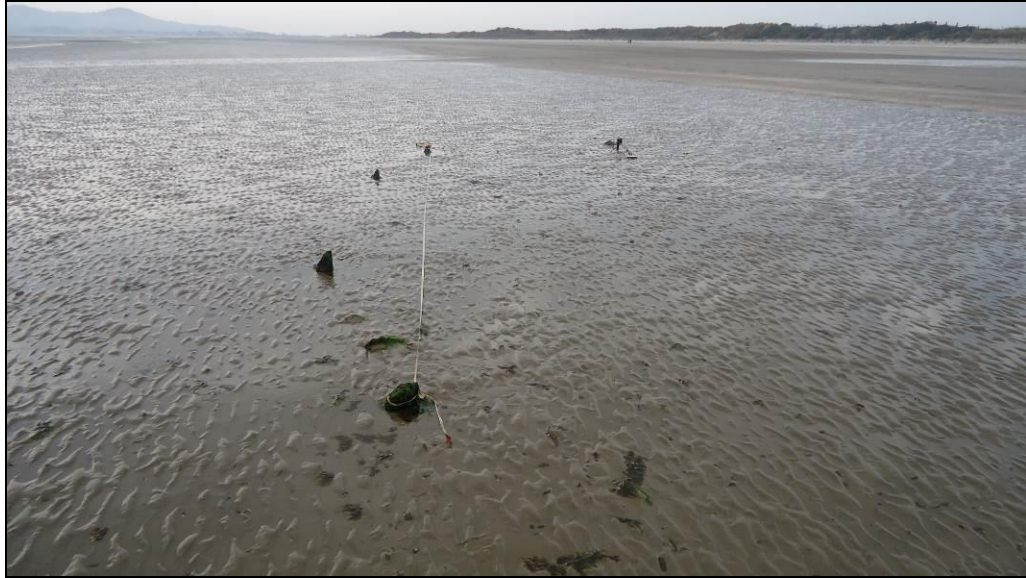
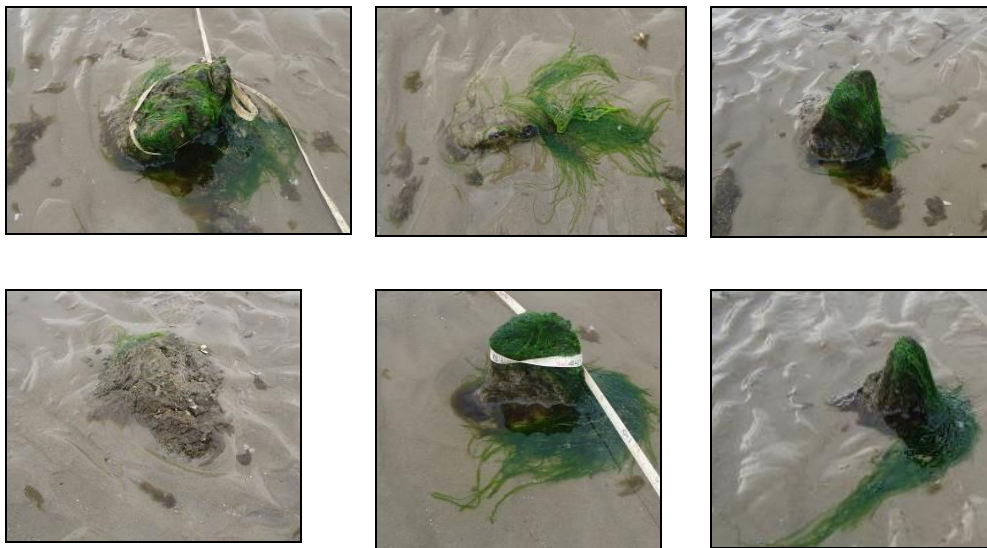
timber and no indication of fastenings in the little that is exposed. Metal detection did not highlight the presence of ferrous metal in the underlying sands.

The fragmentary details of the new wrecksite do not compare closely with details of the known wrecksites on Velvet Strand, suggesting that it is indeed an entirely new and previously unrecorded wreck.

Plate 11: View looking North across the exposed tips of the framing timbers representing the location of a new wrecksite, 80m east of Borehole 1.

Plate 12: View looking South across the exposed tips of the framing timbers representing the location of a new wrecksite, 80m east of Borehole 1.

Plate 13: Close-up view of the six framing timbers that identify the new wrecksite, 80m east of Borehole 1. Clockwise from top follows the timbers from N to S, with the SW timber on the lower left.

Should the wrecksite be impacted on directly or indirectly, it will be necessary to excavate the remains in advance of such works commencing, and remove it from the development area.

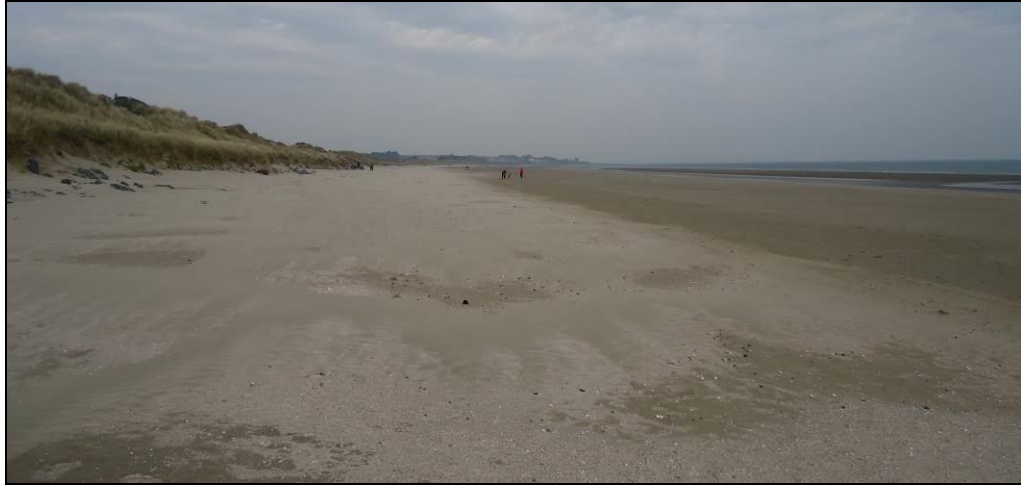
The route of the proposed access route was inspected and no features of archaeological interest were observed (Plate 14).

Plate 14: View looking North along the shoreline at the foot of the dunes, where it is proposed to run the access route.
