Grid Flooring

Document No: IW-HSQE-SA-22

1. What Happened?

SAFETY ALERT

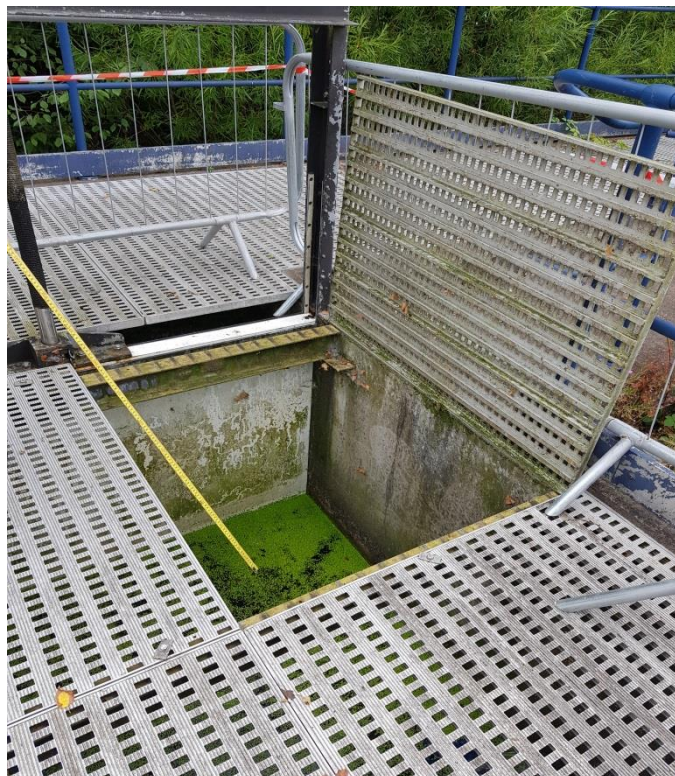
Two Mechanical & Electrical operatives were attending Monaghan WWTP on the 14th August 2018 to supply and install a new grit trap blower at the inlet works. The two operatives proceeded to the works location. As the second operative walked up the concrete steps and proceeded to cross the grid flooring, it appears the grid flooring moved resulting in the operative falling into the sump (approx. 1.7m deep) sustaining a broken arm and a shoulder and a deep laceration to his leg.

Photo 1: Grid flooring over Inlet Works

The works area was sealed off with steel safety pedestrian barriers to prevent unauthorised entry. Checks were carried out on all remaining locations containing grid flooring on site to ensure grid flooring was secure.

- Ensure all grating/grid platforms and walkways are checked to ensure they are secure and stable. Where defects are noted the area should be suitably secured using barriers and repairs should be carried out.

- Ensure that regular checks are continued to be carried out on all gratings/grid floorings installed in raised platforms or over fall hazards and report any deficiencies immediately.
