Strimmer Blade Injury

Document No: IW-HSQE-SA-24

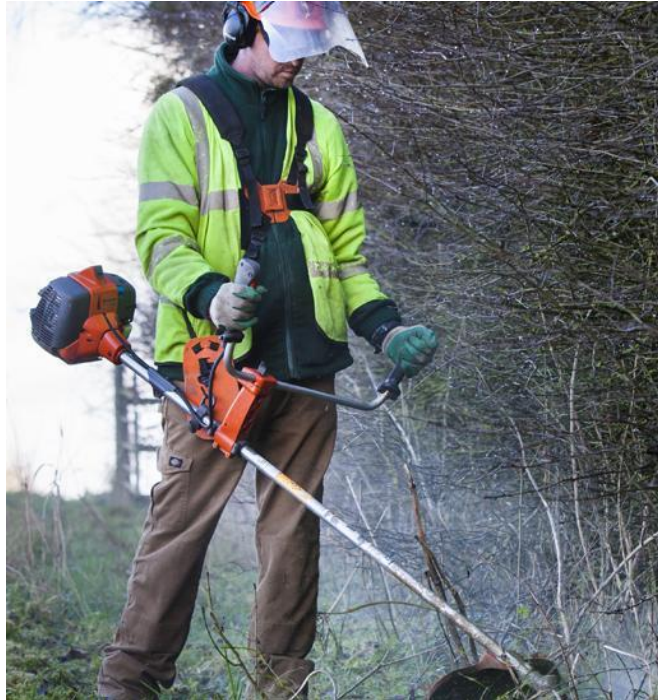
The operative decided to change the cutter head by removing the cord attachment and securing a brush cutter blade to the strimmer. The operative resumed the cutting back

of the vegetation but after approximately 10 minutes the brush cutter blade loosened and detached from the strimmer whilst in use. The blade made contact with the operative's leg where it cut through his safety wellington boots. This resulted in a deep laceration to the front of his right ankle. The operative was brought to hospital where the injury was assessed. The operative was found to have suffered lacerated tendons which required surgery.

- ✓ An accident investigation was undertaken and it was found that while the operative had previously received training in the use of brush cutters, the operative did not securely attach the blade to the strimmer head.

- ✓ Prohibited the use of strimmer cutting blades from all their sites.
- ✓ Communicated the incident details to all their employees.
- ✓ Completed a review of activity risk assessments, training and re-inducted all personnel before work recommenced on site.

- ✓ Ensure the equipment being used is suitable for the task – risk assessments should be carried out for all tasks being undertaken.
- ✓ Ensure equipment has the appropriate safety guards in place and the guards are in good condition.
- ✓ Where an item of equipment has a possibility of multiple attachments, ensure the attachments are suitable as per manufacturers guidelines, fit for purpose and appropriate for the task being undertaken.
- ✓ Training should be provided to operatives for any equipment they are required to operate.
- ✓ If changing the cutter heads of strimmer's, ensure the attachments are securely fastened using the appropriate tools.
