SAFETY ALERT

IR3 Dangerous Occurrence Generator Battery Disintegration

Document No: PS-HSQE-SA-77

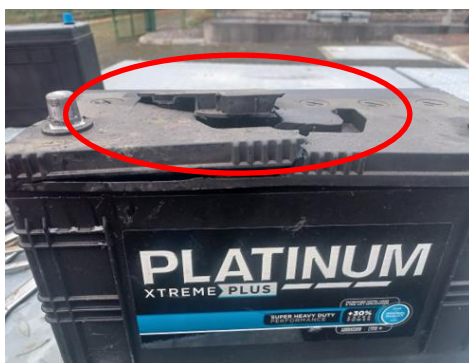
Incident 1. image

While conducting the routine weekly test of the backup generator, a sudden loud bang emanated from the generator when the changeover switch was activated within the control room. Upon inspection, the operative discovered that the battery had shattered and disintegrated. The operative promptly ensured safety of the site, confirming there was no risk of fire, and immediately notified their manager.

The battery type in both incidents is an older type of battery that is constantly fed by a trickle charger. This can lead to the battery drying out of the cell, generating heat and resulting in battery failure causing the battery to shatter and disintegrate. With newer generators the batteries are fitted with an automatic cut-off which eliminates battery dry-out and battery failure.

- Uisce Éireann requested an incident report and service inspection be completed on the generator by the Water Service area approved generator service contractor.
- The generator battery has been replaced.
- Generator service technician to investigate if trickle charger is causing damage to generator battery.

- Ensure routine visual inspections are undertaken, in line with the manufacturer's specifications, to check for signs of damage, corrosion, or leakage.
- Ensure a regular inspection and maintenance schedule is implemented in accordance with the recommendations provided by the manufacturer and/or supplier, including changing out the battery where it is at the end of its recommended lifespan.
- Ensure correct charging procedures are followed to prevent issues arising from either overcharging or undercharging the batteries.
- Ensure that operators understand the safe use and maintenance of the generator and its components, including the batteries.

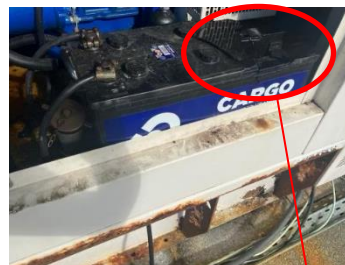
Incident 2. images

It is noteworthy to mention that a similar occurrence previously took place at another UÉ site while undertaking similar checks.

Point of failure can be seen on top of the battery.
