**Underwater Archaeological Assessment,  
River Lee Estuary, Monkstown, Co Cork**

**Inter-tidal Foreshore Survey,  
Owenduff River, Carrigaline, Co. Cork**

**Cork Harbour Lower Drainage Scheme**

**20<sup>th</sup> October 2007**

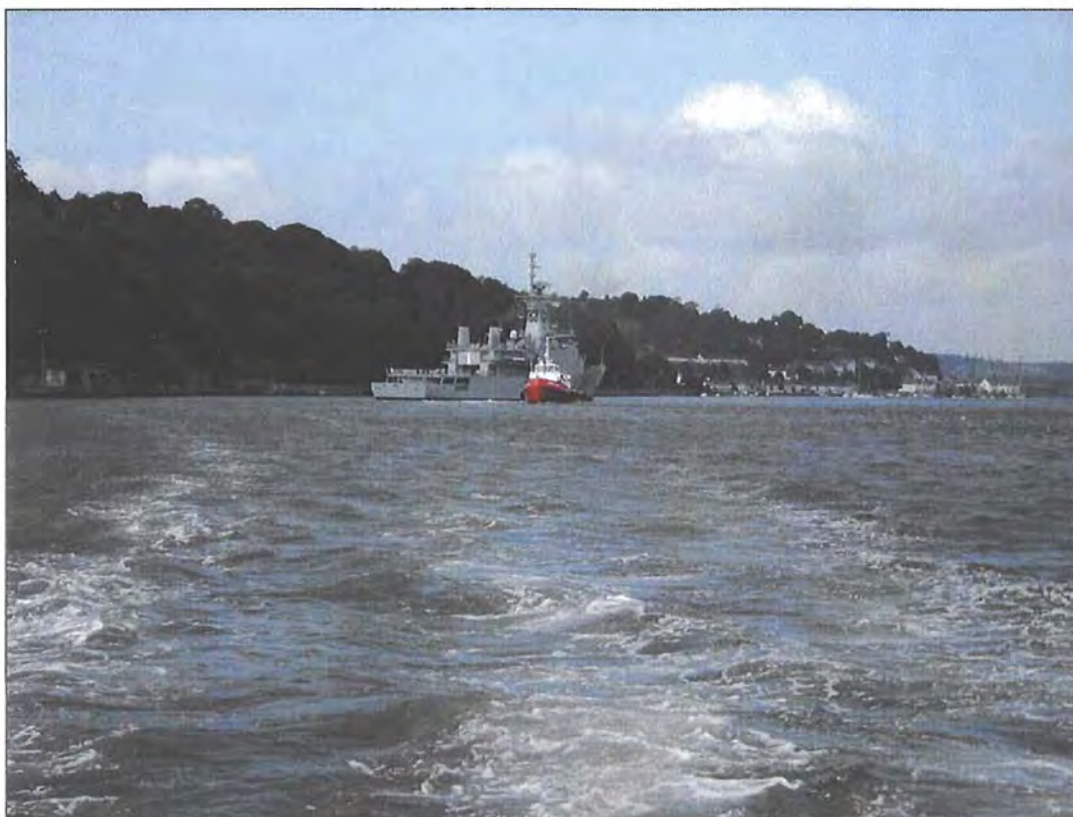
**Plate 1:** North-facing view of the estuary mouth, River Lee survey area in distance.

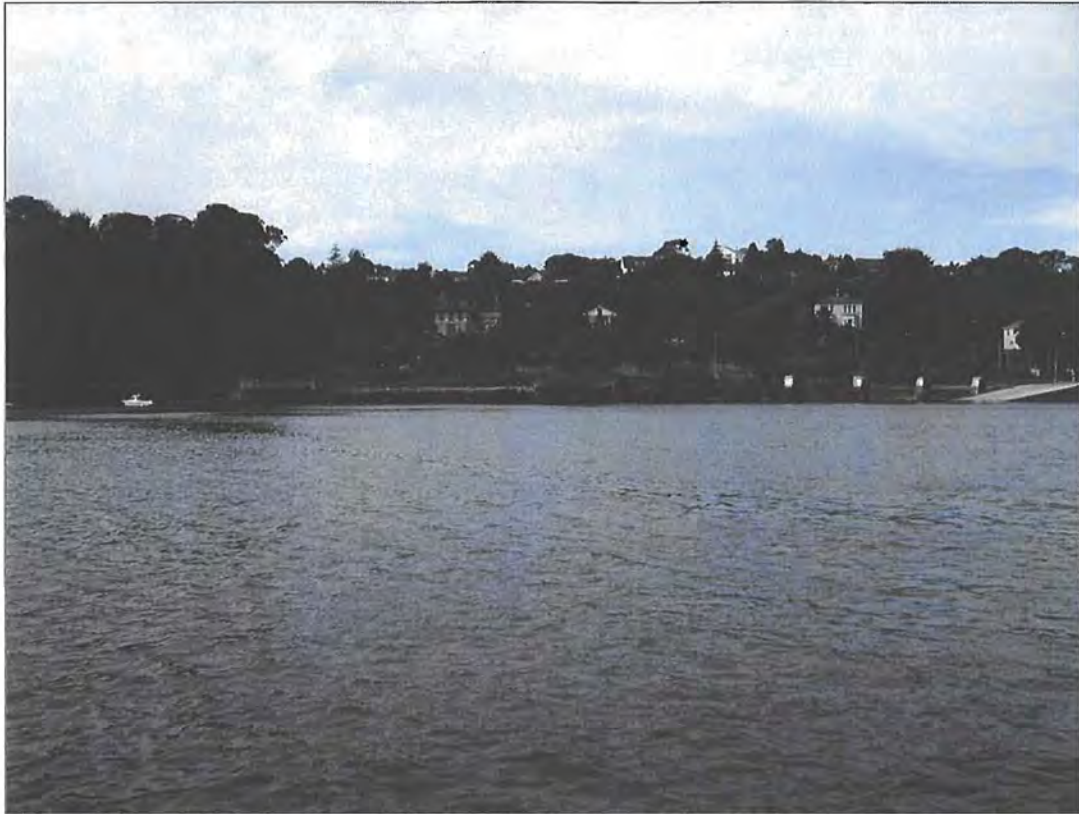
**Plate 3:** West-facing view across Marine Pipeline Survey Area, River Lee Estuary.

The R610 roadway runs along the western side of the river, behind which, a series detached houses are located. A steep, wooded hill is located behind these residences (Plate 3). The remains of the Royal Victoria Baths are located upon the waterfront, to the east of the roadway. The site is impacted by the pipeline corridor along its northern (upstream) side. The baths consisted of two wings, with an interlinking corridor, and provided separate bathing areas for both male and female patrons. A plunge pool and 150ft swimming area was located on the eastern side of this interlinking corridor, at the river's edge. The southern wing was one storey, while the northern wing was three stories high. The baths were extended in 1858 to include an entertainment area and Turkish bath. The northern wing was destroyed by a fire in 1859 and the baths were extensively refurbished. The baths underwent a decline in popularity during the latter part of the nineteenth-century and by 1929 they were left in a derelict state. Shortly after the upstanding elements of the structure were demolished, the rubble being used to in-fill the swimming area. The foundations of both the north and south wings are still visible today and rise c.2.5m from the waters edge at Low Water (Plates 4-5).

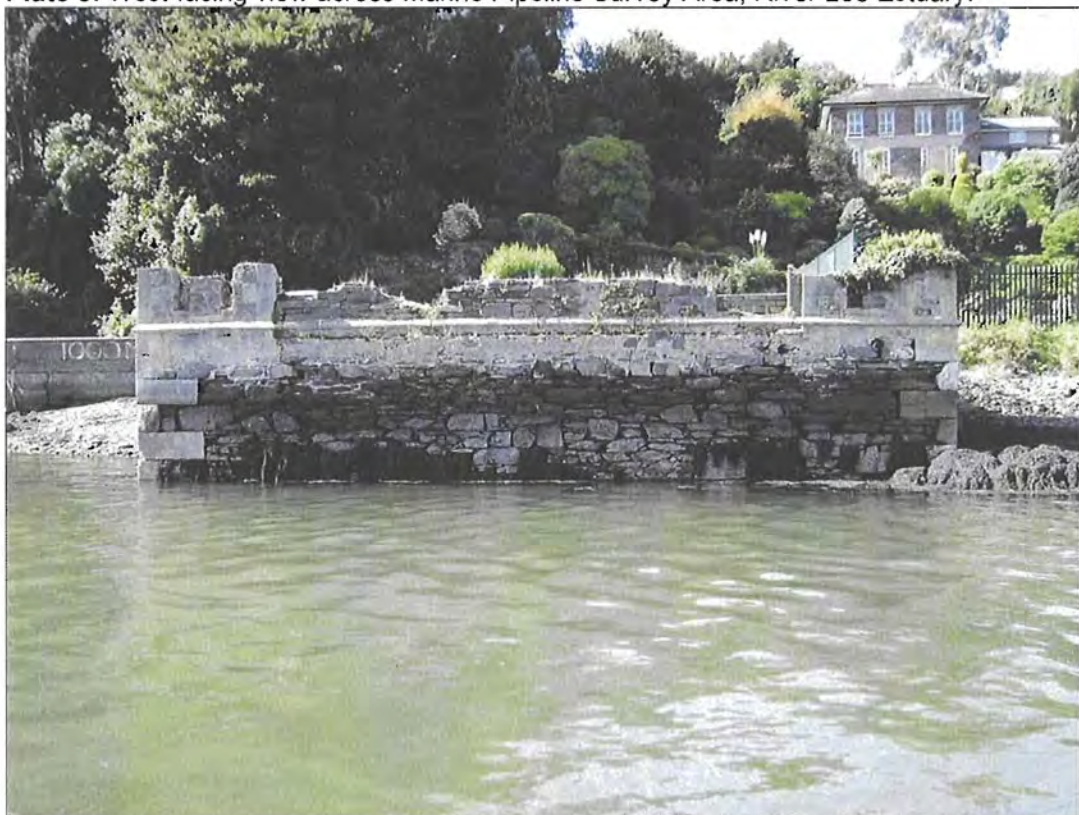
**Plate 4:** West-facing view of downstream (southern wing) masonry façade from the remains of the Royal Victoria Baths located on the west side of the River Lee.

archaeologically significant material uncovered at this time. In addition, it is recommended that direct impacts to the site of the Royal Victoria Baths be avoided, preserving the *in-situ* masonry foundations.

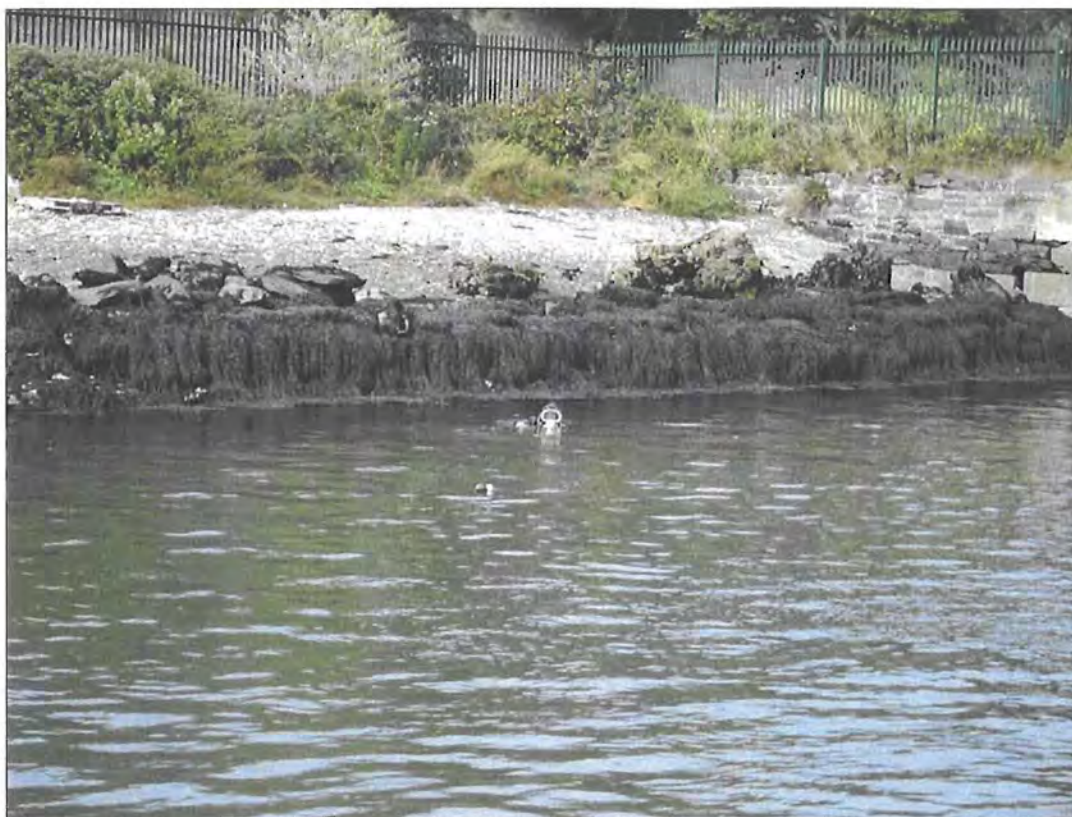
**Plate 5:** Northwest-facing view of western side of survey area, adjacent to the remains of the Swimming area of Royal Victoria Baths; diver in middle distance.

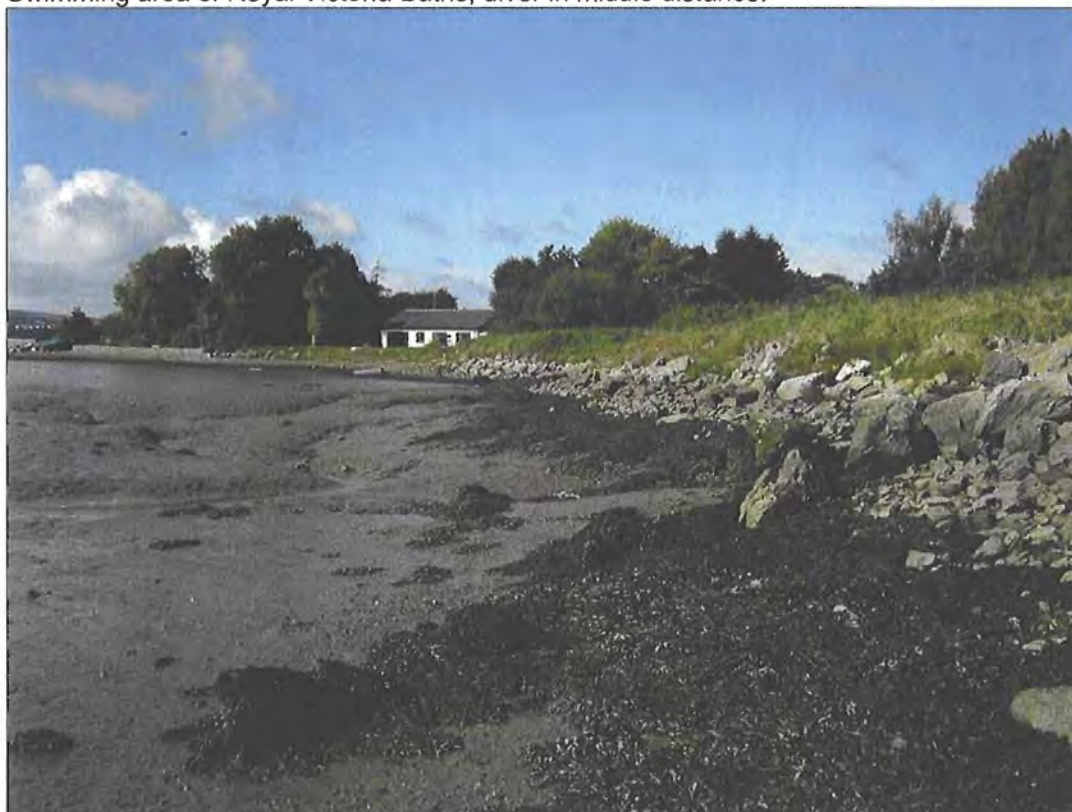
**Plate 6:** West-facing view of start of pipeline route along upper foreshore; shot taken from survey start-point (see Figure 6 for location).

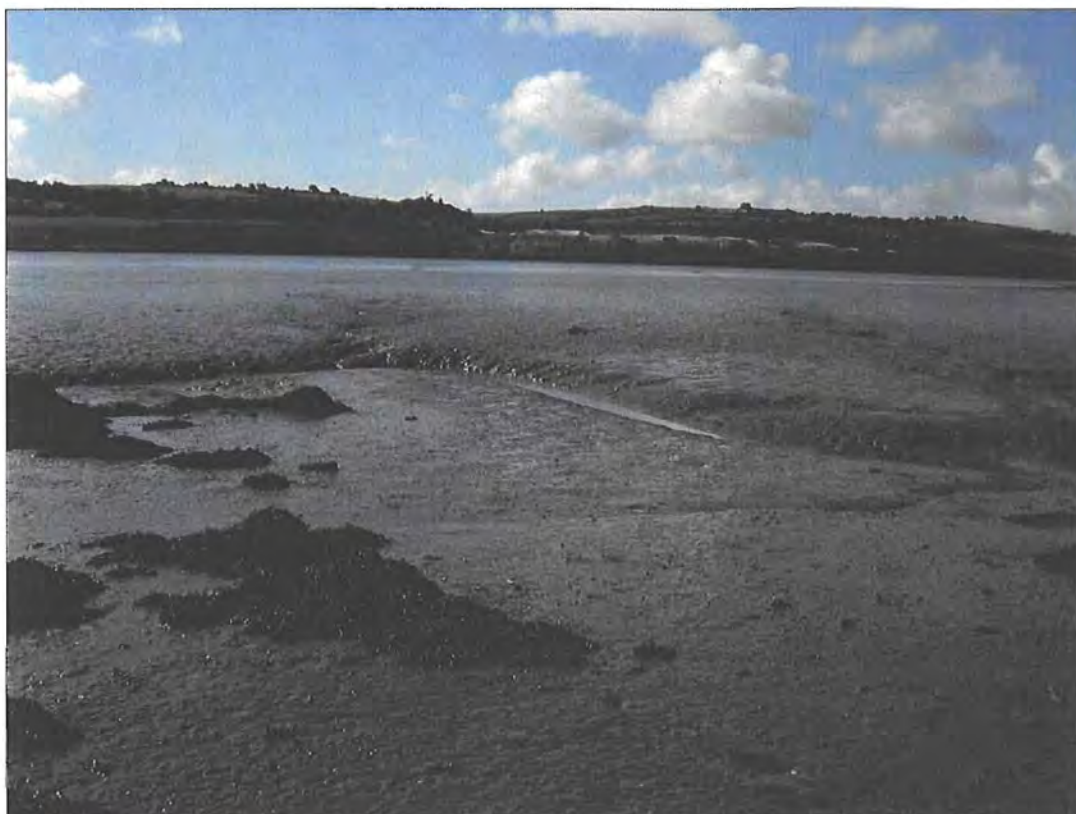
**Plate 7:** South-Facing view of inter-tidal mud flats along the northern side of the Owenduff River, shot taken from survey start point (see Figure 6 for location).

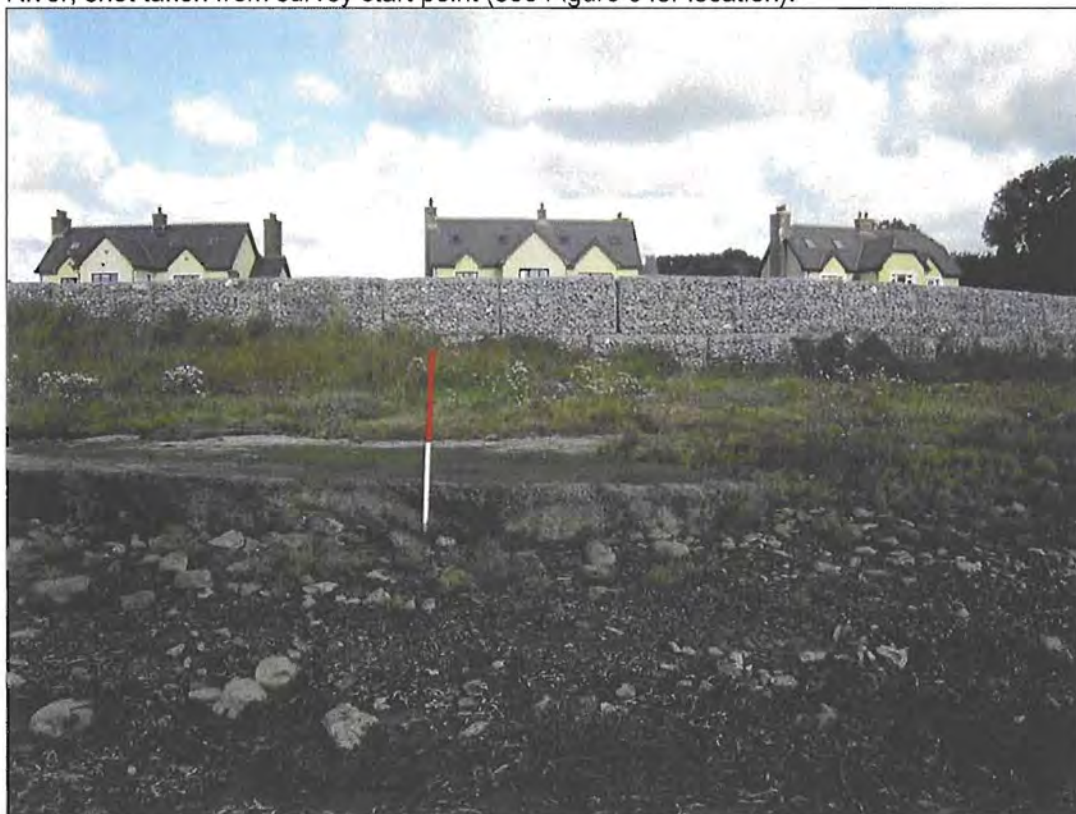
**Plate 8:** North-facing view of upper foreshore c.350m along pipeline route (see Figure 6 for location); 1m scale.

Approximately 400m along the survey area the upper foreshore changes topography and a 0.20m high lip delineates the High Water Mark. Rough grasses and low-lying vegetation are located behind the HWM and stretch northwards for a distance of c.10m before reaching a recently constructed gabion wall (Plate 8). This wall is associated with a recent housing development and has been placed to minimise the effects of winter flooding on adjacent houses. The foreshore gently slopes towards the inter-tidal zone, the upper reaches (c. 20m width) of which are composed of small angular stones and large gravels with sporadic patches of seaweed (Plates 9-10). The rest of the inter-tidal zone is composed a silty-clay (40%/60% mix) that stretches 30m southwards to the Low Water Mean (LWM). This foreshore topography remains consistent for the next 400m, although the inter-tidal zone increases in width (60m+), and a mixture of rock-armour and a steep sided (earthen) flood-embankments replace the gabion wall along the limits of the upper foreshore (Plates 11-13).

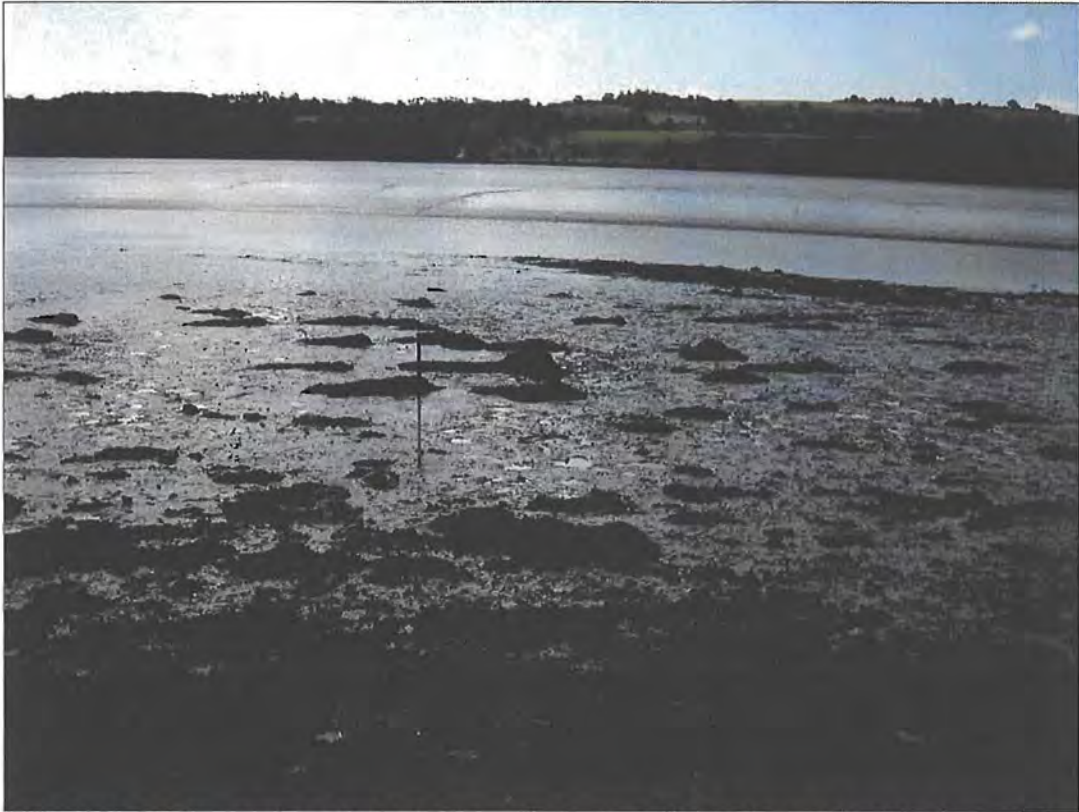
**Plate 9:** South-facing view of inter-tidal mud flats along the northern side of the Owenduff River, shot taken from c.400m from survey start-point (see Figure 6 for location).

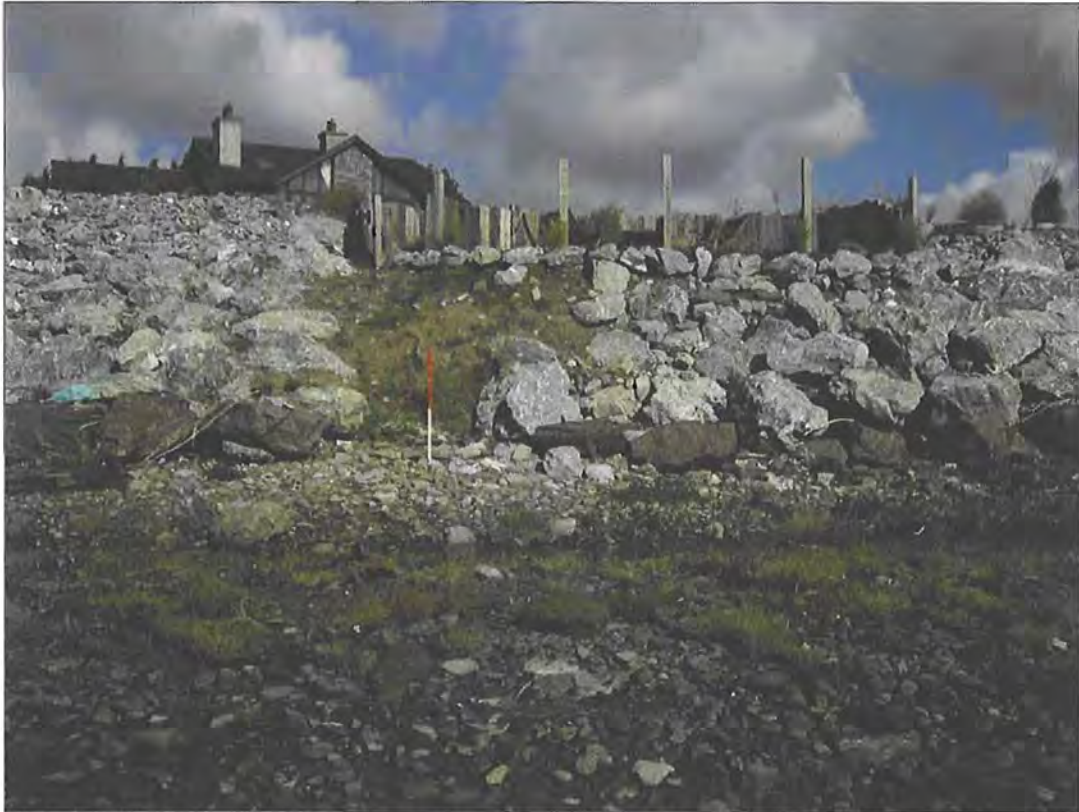
**Plate 11:** North-facing view of upper foreshore c.550m along pipeline route (see Figure 6 for location); 1m scale.

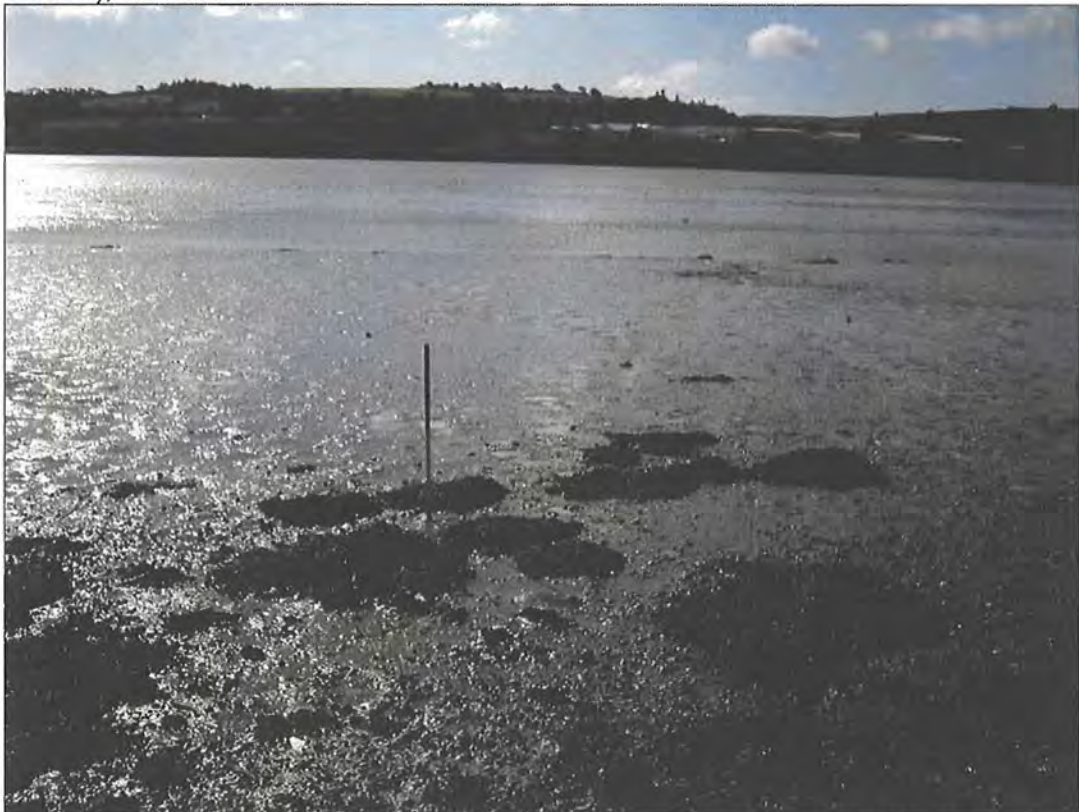
**Plate 12:** South-facing view of inter-tidal mud flats along the northern side of the Owenduff River, shot taken from c.600m from survey start-point (see Figure 6 for location); 1m scale.

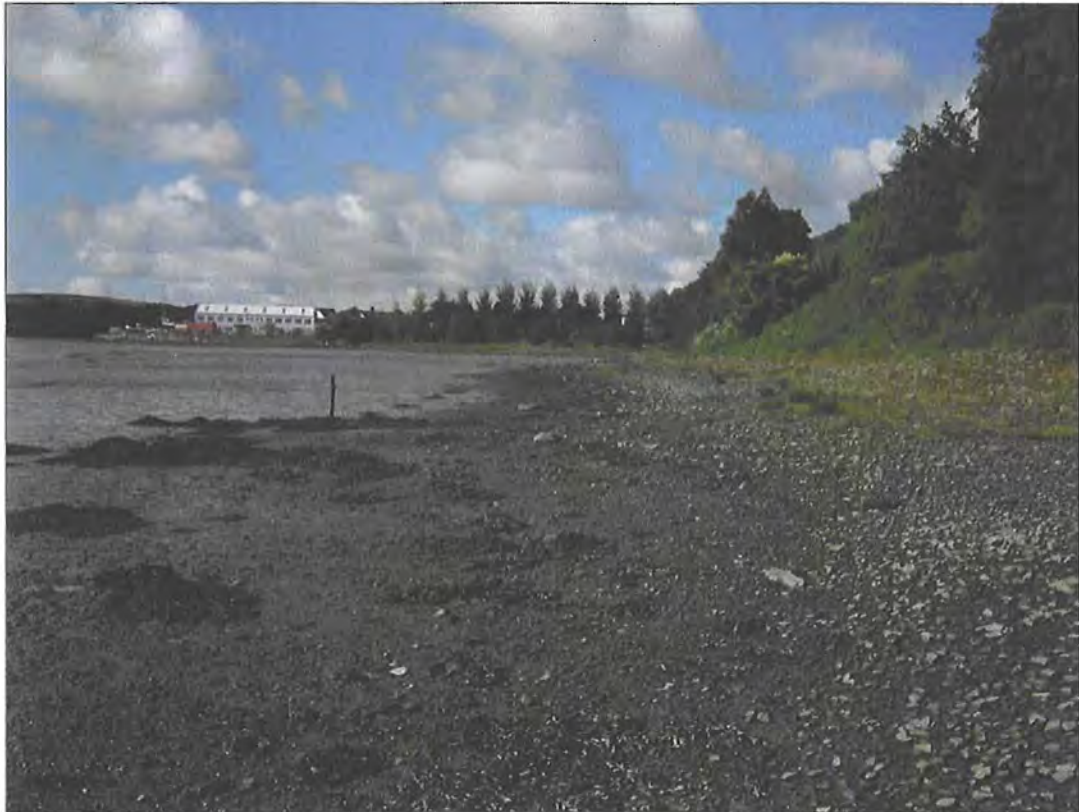
**Plate 13:** West-facing view of pipeline route along upper foreshore; shot taken c.550 along proposed pipeline route (see Figure 6 for location).

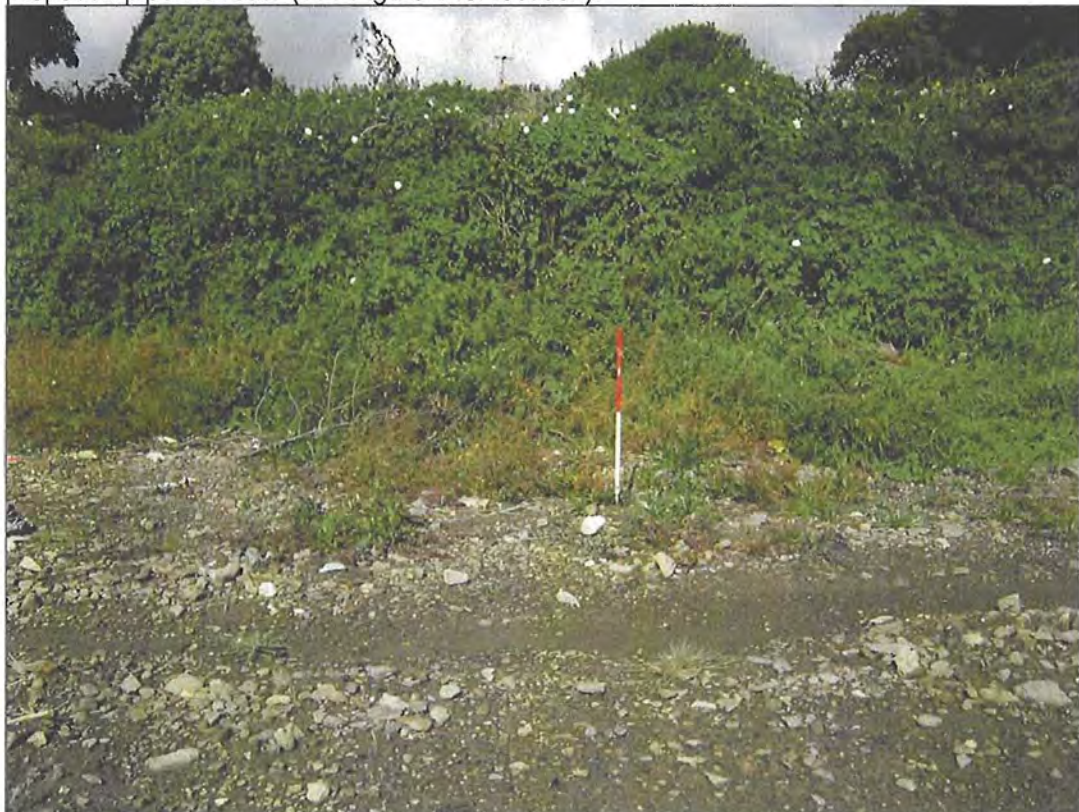
**Plate 14:** North-facing view of upper foreshore c.800m along pipeline route (see Figure 6 for location); 1m scale.

Approximately 800m along the survey area, the banding of small stones, river gravels, and patches of seaweed located along the upper reaches of the inter-tidal zone increase in width to c. 40m (Plates 14-16). A large amount of fibre glass and high density plastic fragments litter this zone, probably associated with an active boatyard located nearby. Three softwood vertical timbers (0.10m x 0.10m) protrude from the mudflats at NGR: 1774476E, 626237N and were most likely represent temporary mooring posts (Plate 15).

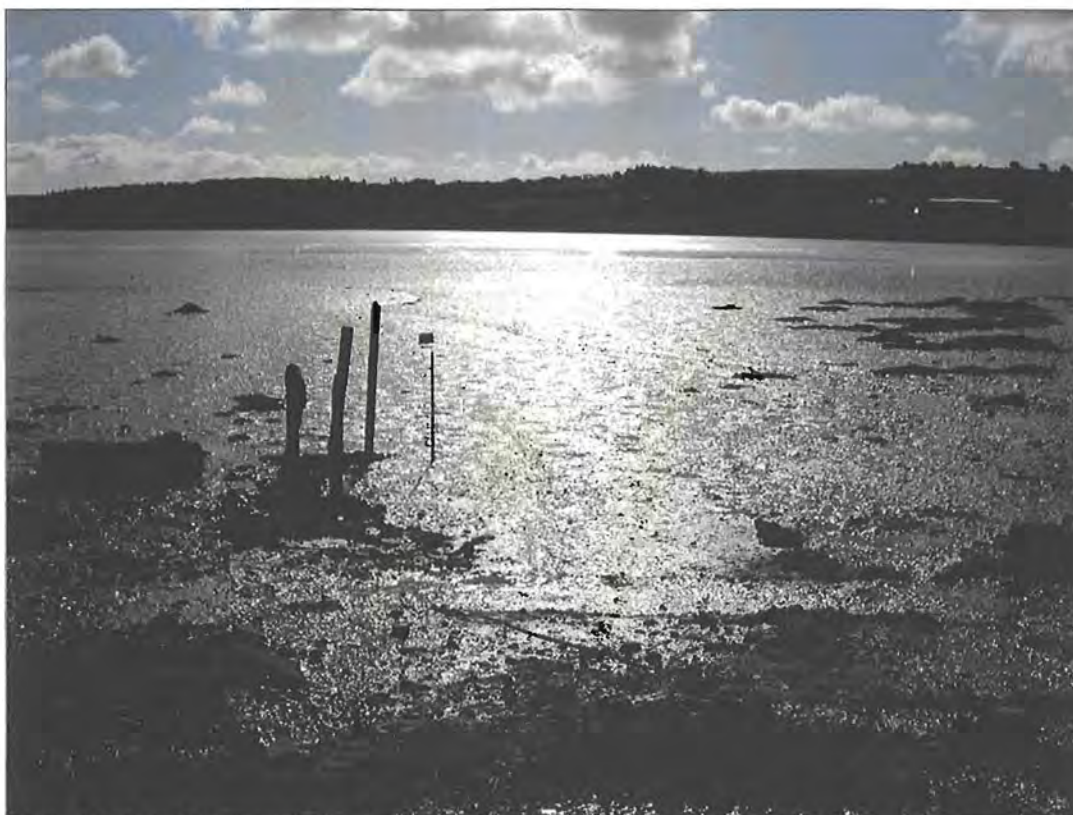
**Plate 15:** South-facing view of inter-tidal mud flats along the northern side of the Owenduff River, shot taken from c.850m from survey start-point (see Figure 6 for location); three modern mooring posts in foreground (1m scale).

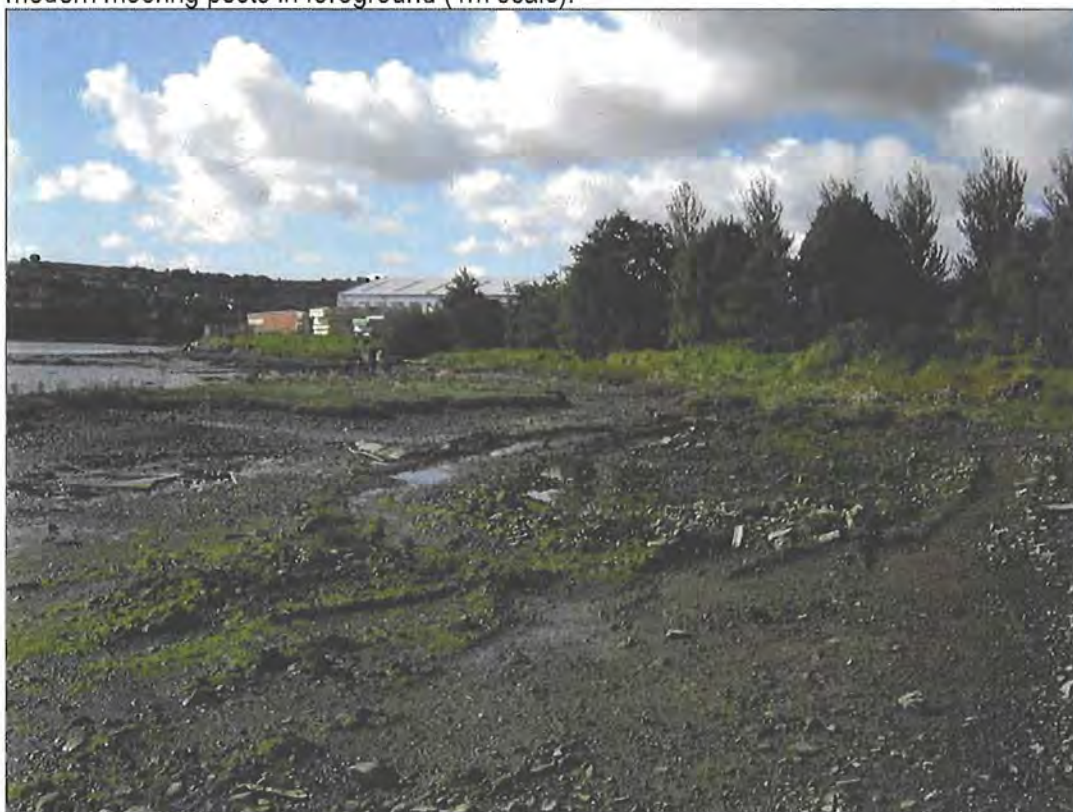
**Plate 16:** West-facing view of pipeline route along upper foreshore; shot taken c.800 along proposed pipeline route (see Figure 6 for location).

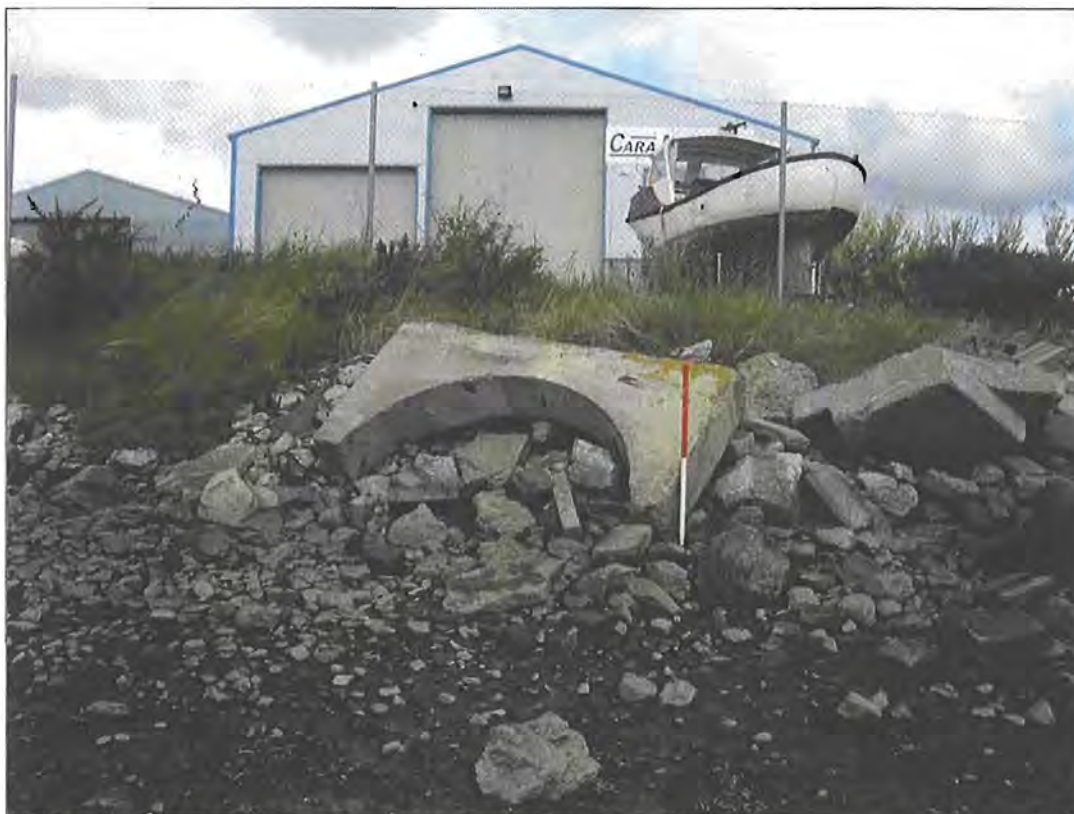
**Plate 17:** North-facing view of upper foreshore c.100m along pipeline route (see Figure 6 for location); 1m scale.

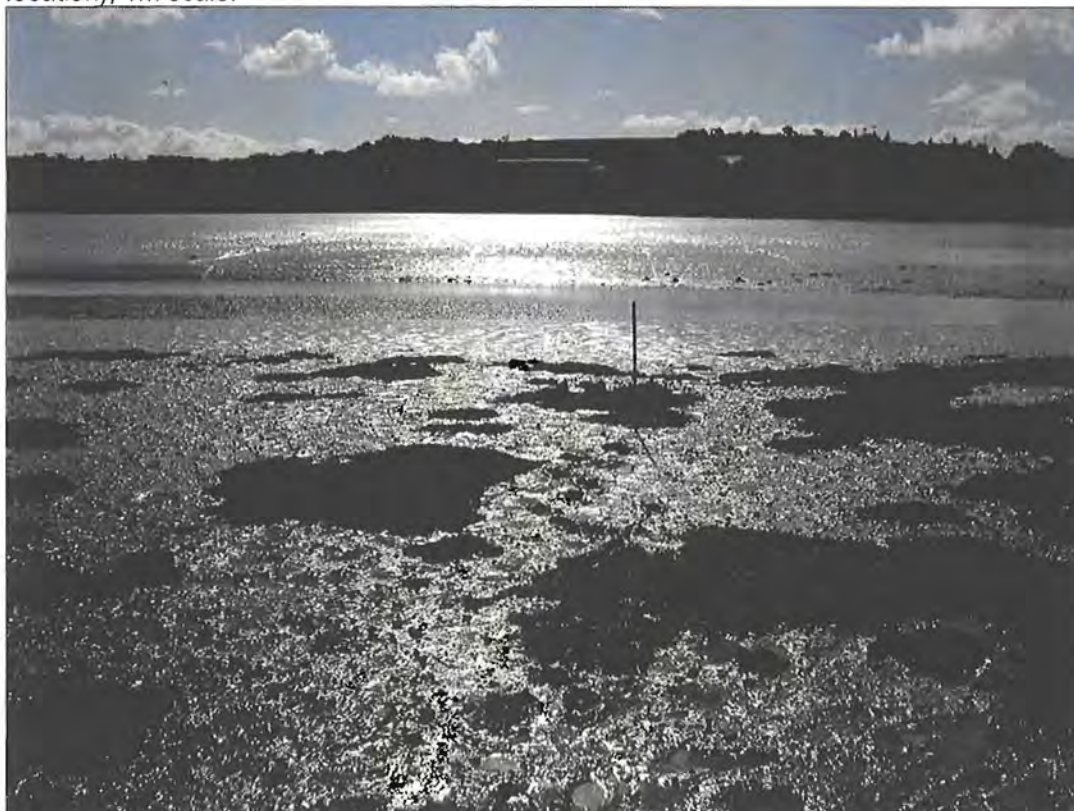
**Plate 18:** South-facing view of inter-tidal mud flats along the northern side of the Owenduff River, shot taken from c.1050m from survey start-point (see Figure 6 for location); 1m scale.

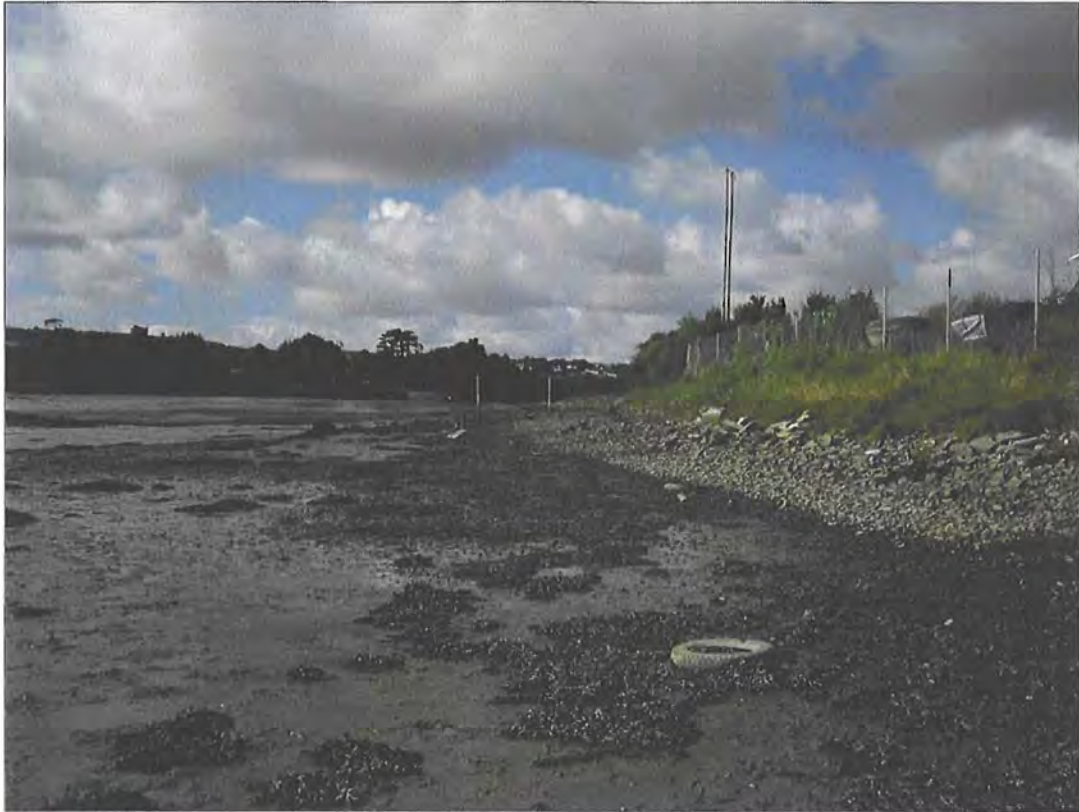
**Plate 19:** West-facing view of pipeline route along upper foreshore; shot taken c.1000m along proposed pipeline route (see Figure 6 for location).

The foreshore topography remains largely unchanged for the remainder of the survey area, although the inter-tidal zone between 1000m and 1600m decreases in width to c.20m as the estuary narrows and the central river-channel meanders to the north (Plates 19-27). At NGR: 174329E, 623438N (c.1120m along the survey area) a linear deposit of rocks stretches across the waterway, this appears to be rock-armour protection for a pipeline crossing the river (Plate 21). In addition, a series of concrete pipe-divisions are located along the HWM, running for a distance of approximately 800m, between NGR: 174304E, 623933N and NGR: 173706E, 623612N (Plate 22).

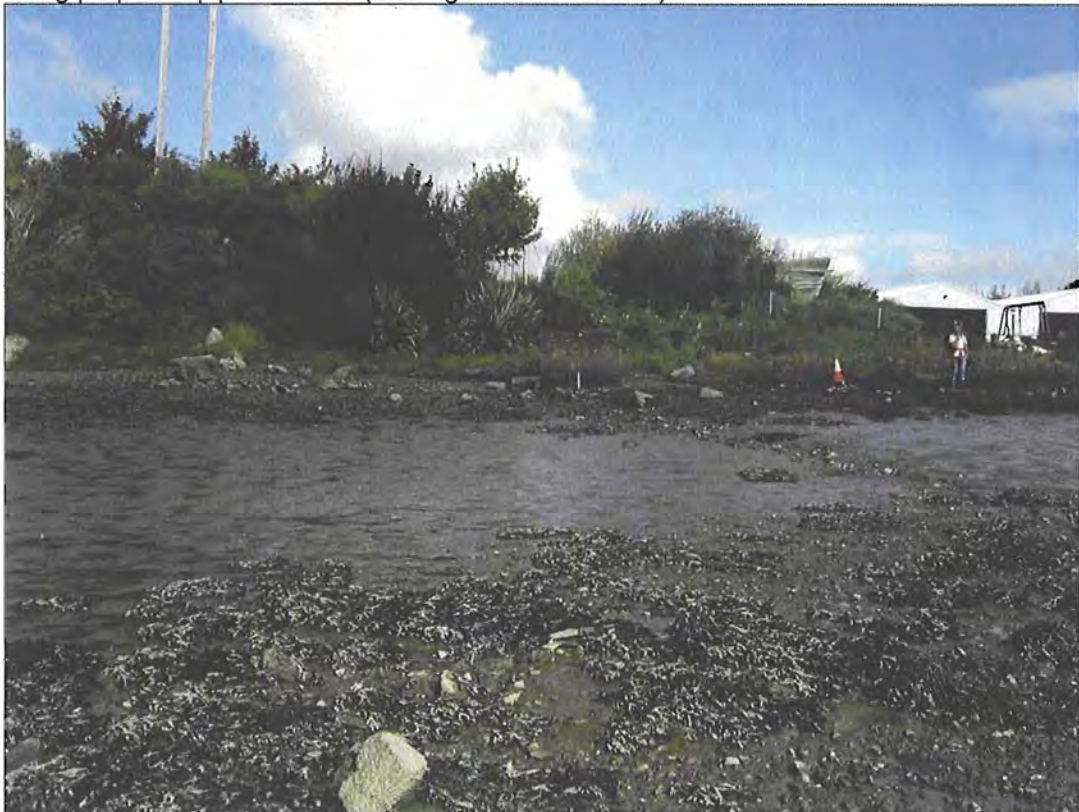
**Plate 20:** North-facing view of upper foreshore c.1120m along pipeline route (see Figure 7 for location).

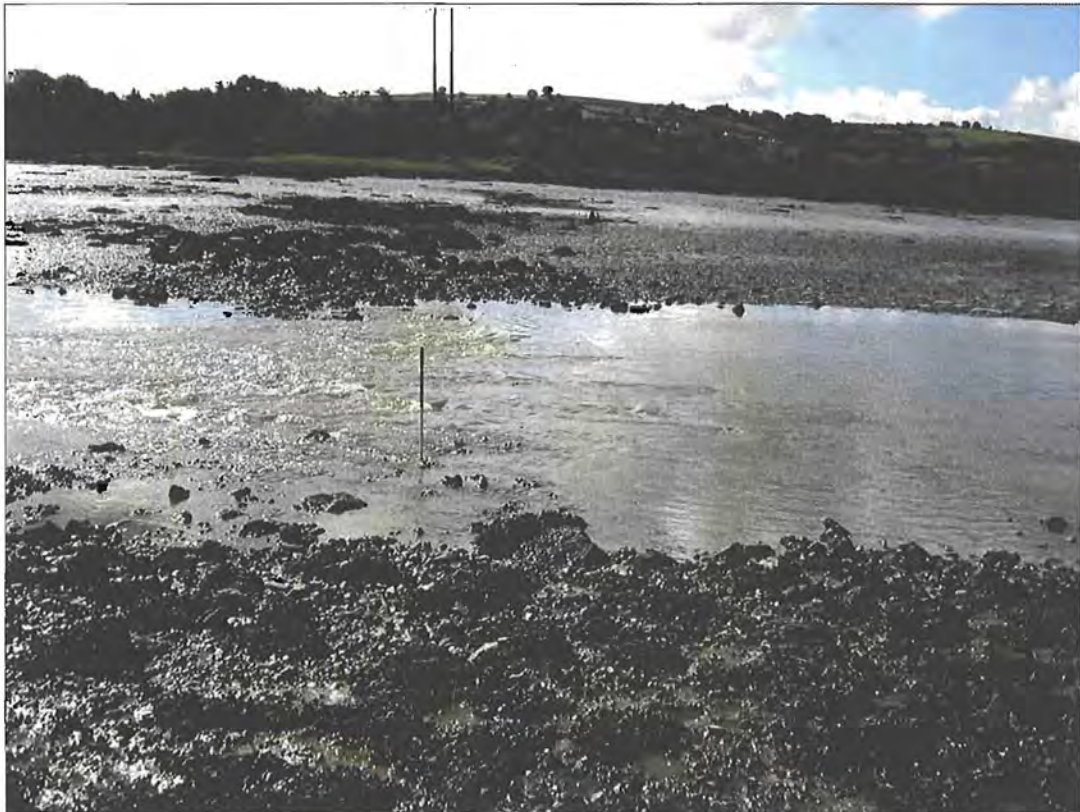
**Plate 21:** South-facing view of central channel of the Owenduff River at Low Water. Note: rapids caused by rock armour protection for a previous pipeline across the river; shot taken 1120m along proposed pipeline route (see Figure 7 for location); 1m scale.

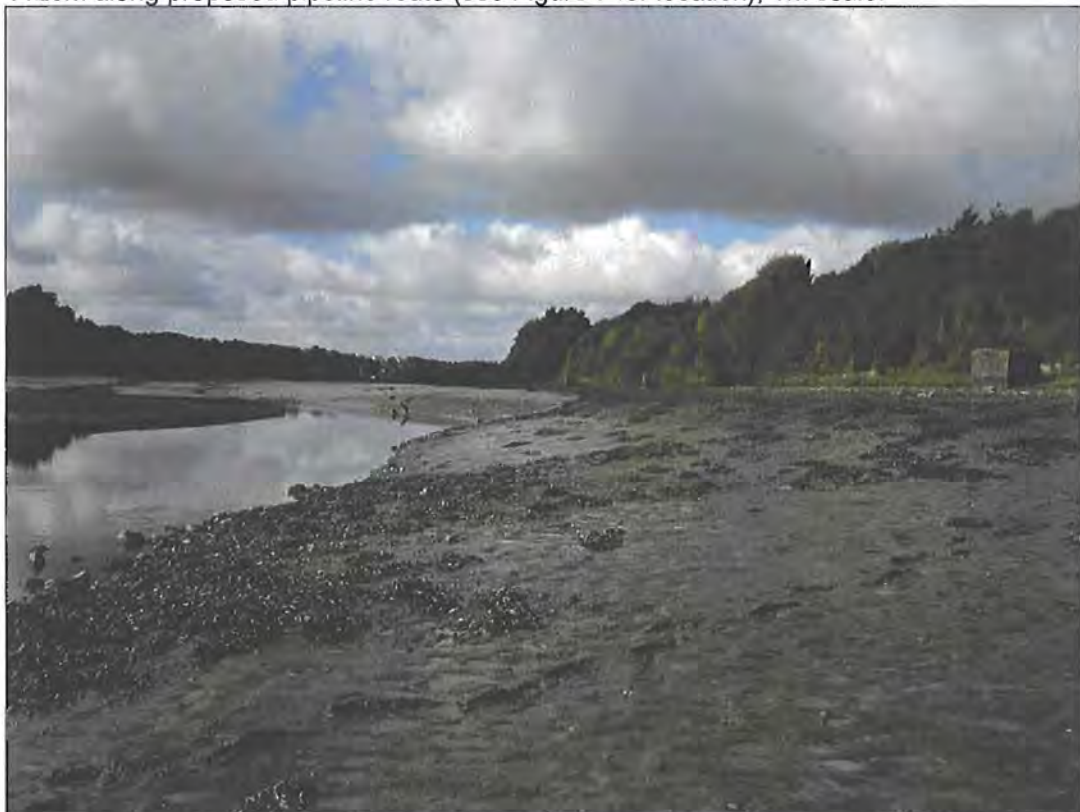
**Plate 22:** West-facing view of pipeline route along upper foreshore; shot taken c.1120m along proposed pipeline route (see Figure 7 for location).

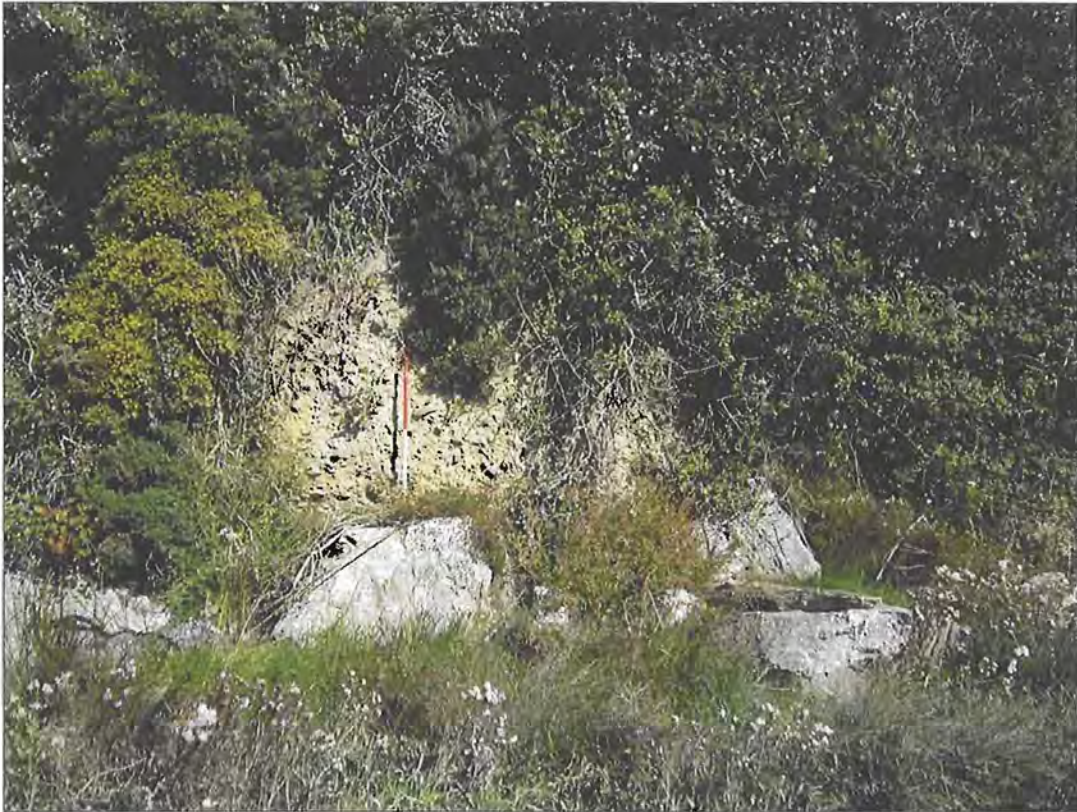
**Plate 23:** North-facing view of small sand and gravel cliff face delineating the northern limit of the upper foreshore c.1280m along proposed pipeline route (see Figure 7 for location).

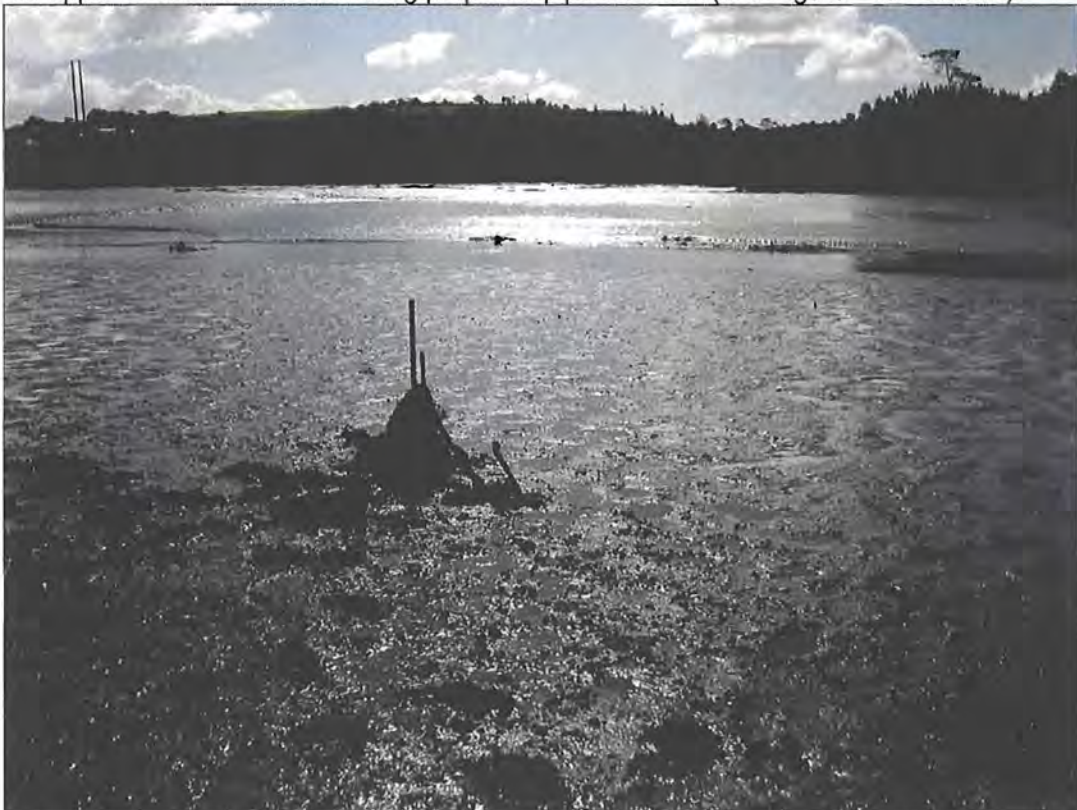
**Plate 24:** South-facing view of inter-tidal mudflats c.1280m along proposed pipeline route  
Note: modern anchor in foreground (see Figure 7 for location); 1m scale.

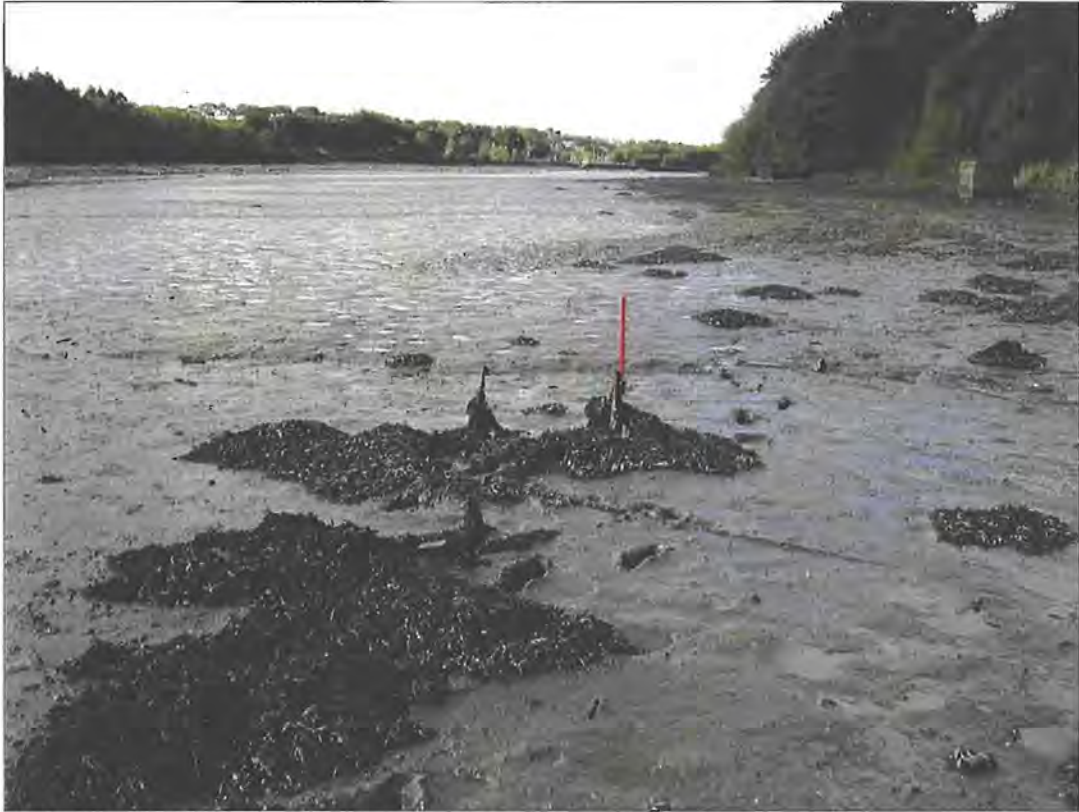
**Plate 25:** West-facing view of inter-tidal mudflats c. 1280m along proposed pipeline route  
Note: modern fragmentary remains of iron boat-trolley in foreground (see Figure 7 for location); 1m scale.

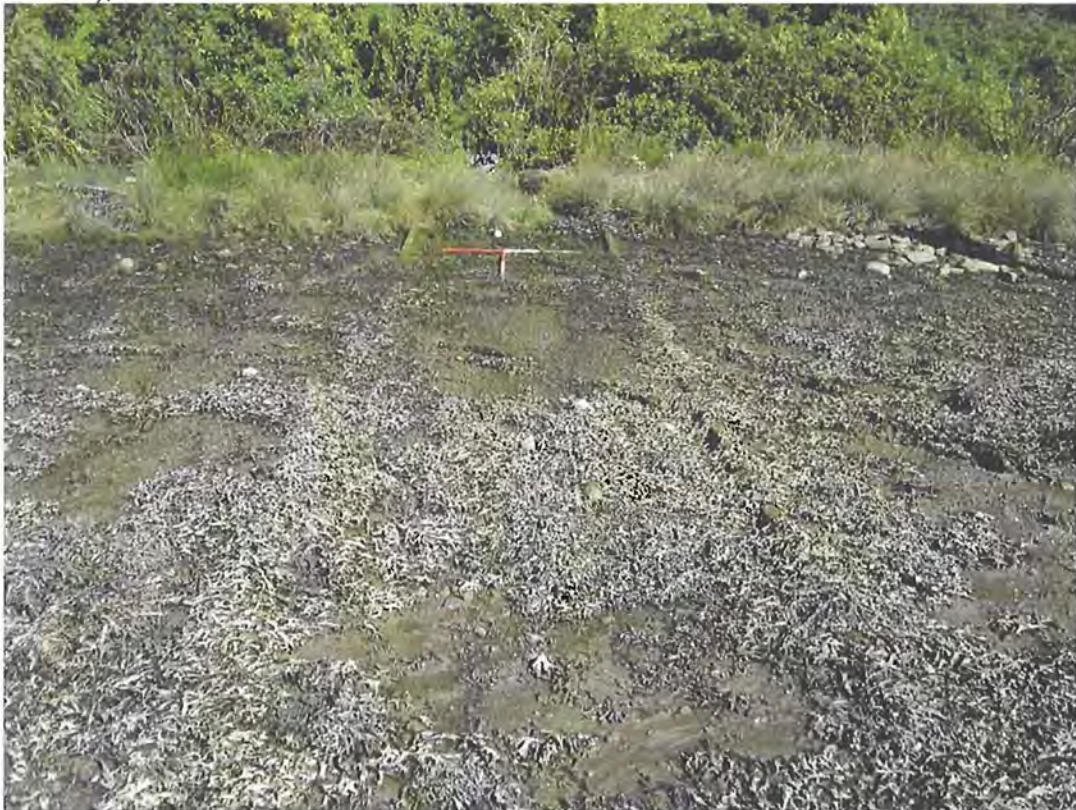
**Plate 26:** North-facing view of upper foreshore c. c. 1280m along proposed pipeline route  
Note: partially buried iron-trackway for boat-trolley/ launch (see Figure 7 for location).
