**Underwater Archaeological Assessment,  
River Lee Estuary, Monkstown, Co Cork**

**Inter-tidal Foreshore Survey,  
Owenduff River, Carrigaline, Co. Cork**

**Cork Harbour Lower Drainage Scheme**

**20<sup>th</sup> October 2007**

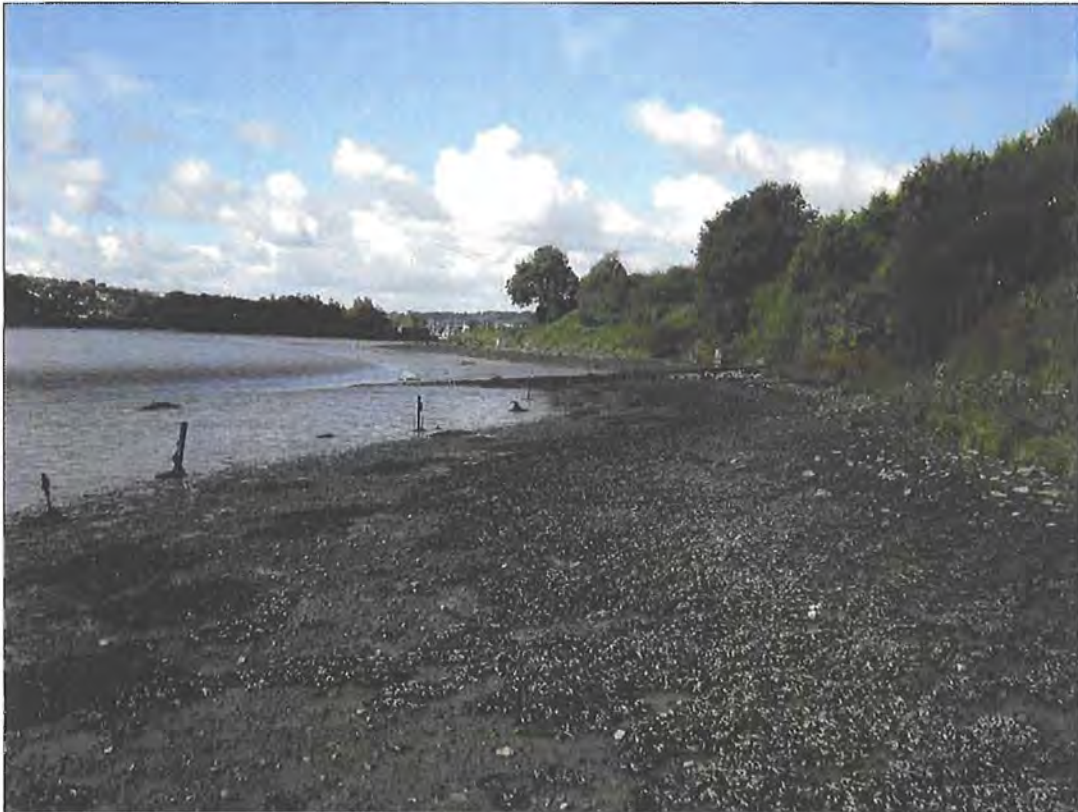
**Plate 27:** West-facing view of inter-tidal mudflats c.1450m along proposed pipeline route  
Note: Iron-trackway for boat-trolley/ launch in distance (see Figure 7 for location).

The foreshore topography remains largely unchanged for the remainder of the survey area, although the inter-tidal zone between 1000m and 1600m decreases in width to c.20m as the estuary narrows and the central river-channel meanders to the north (Plates 19-27). At NGR: 174329E, 623438N (c.1120m along the survey area) a linear deposit of rocks stretches across the waterway, this appears to be rock-armour protection for a pipeline crossing the river (Plate 21). In addition, a series of concrete pipe-divisions are located along the HWM, running for a distance of approximately 800m, between NGR: 174304E, 623933N and NGR: 173706E, 623612N (Plate 22).

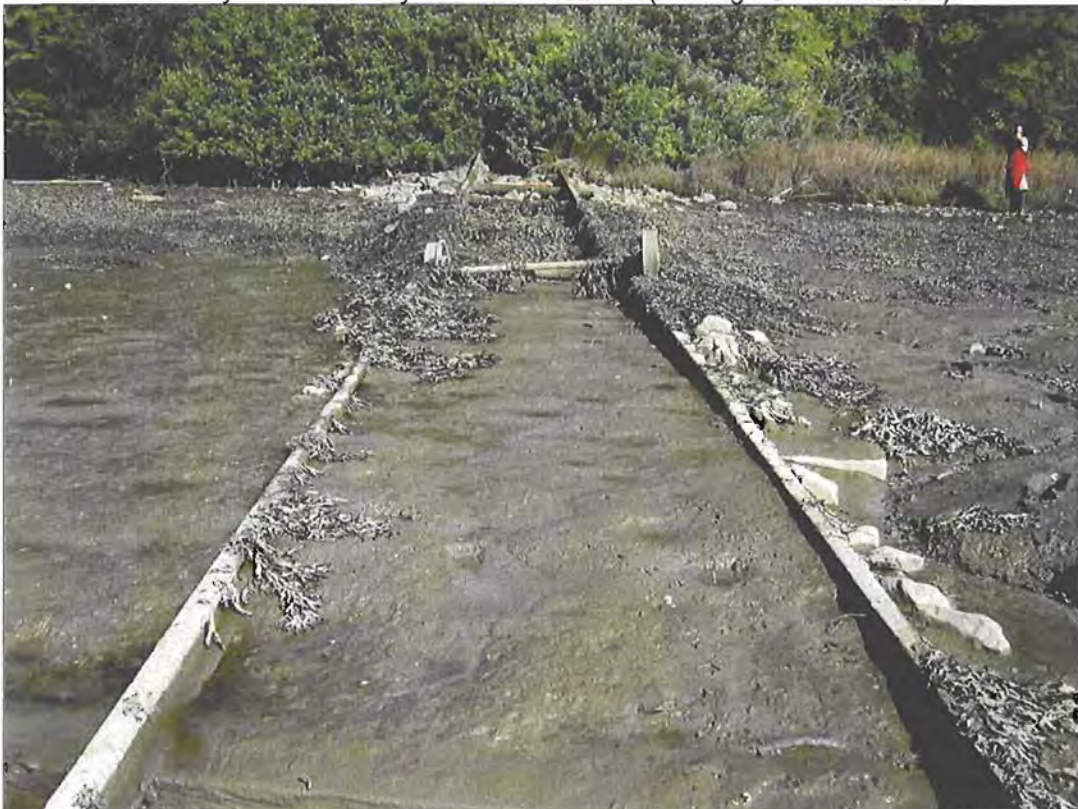
**Plate 28:** North-facing view of iron-trackway for boat-trolley/ launch located c. c.1520m along proposed pipeline route (see Figure 7 for location); 1m scale.

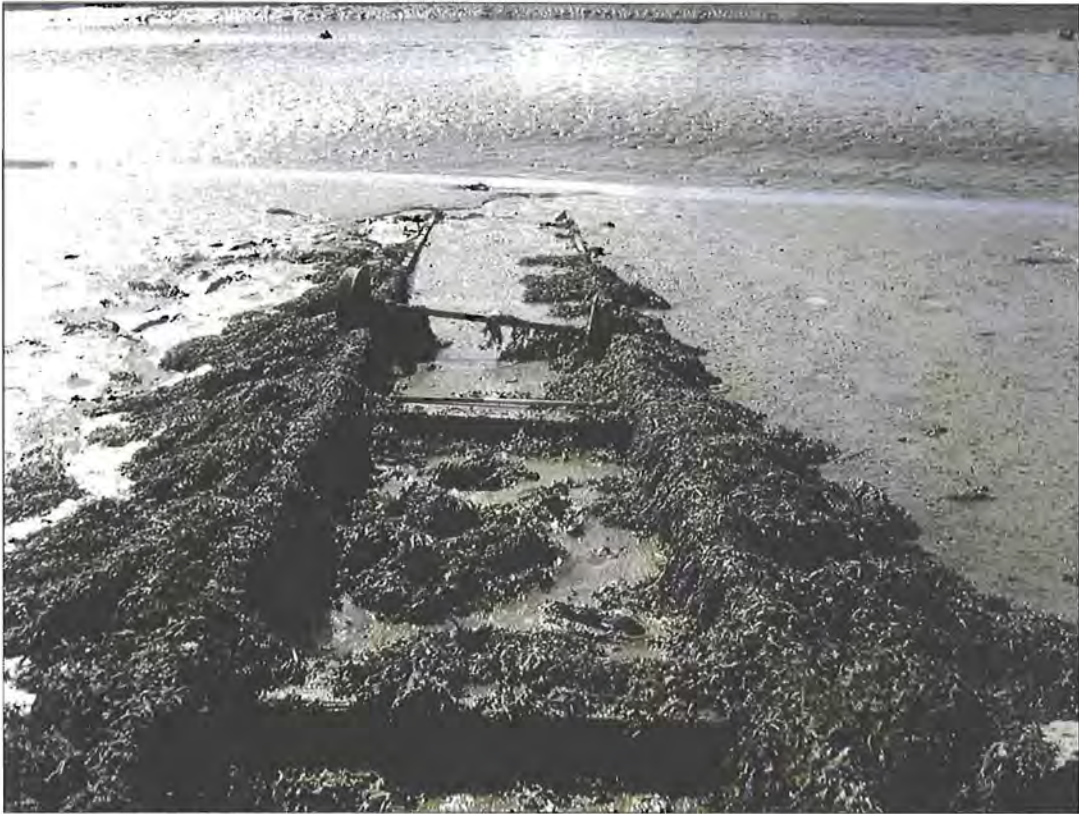
**Plate 29:** South-facing view of iron-trackway for boat-trolley/ launch located c. c.1520m along proposed pipeline route (see Figure 7 for location), 1m scale.

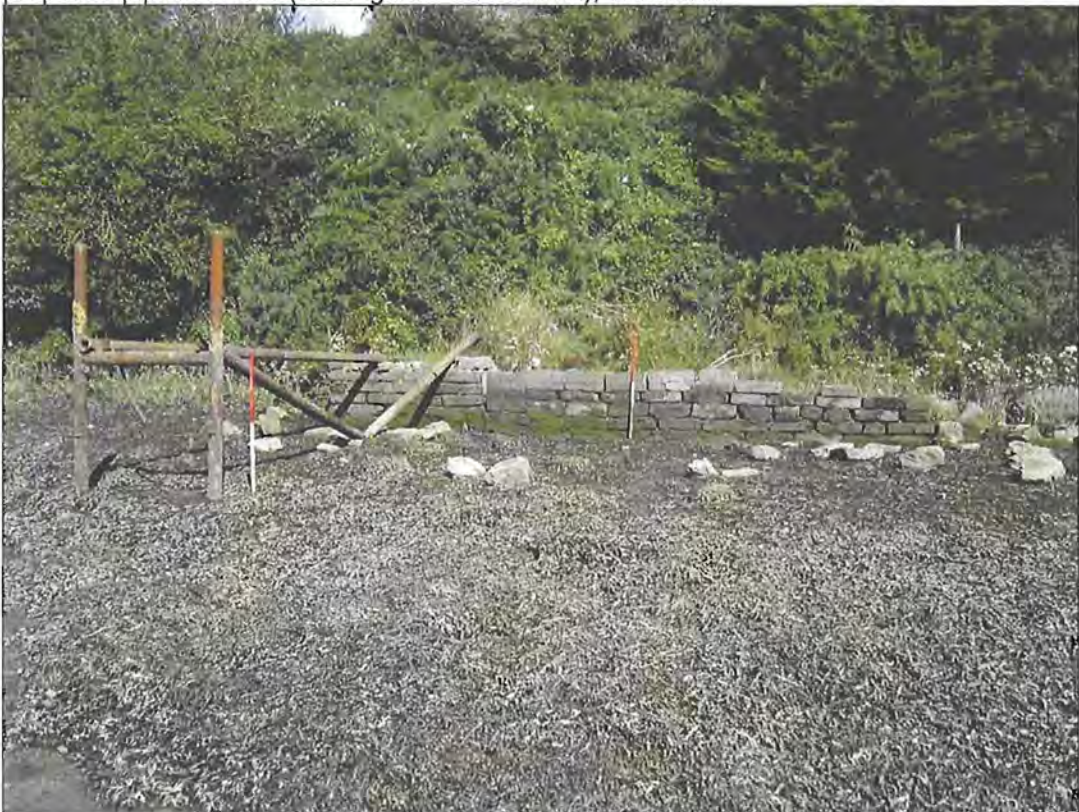
**Plate 30:** North-facing view of the remains of a modern boat Jetty c.1555m along proposed pipeline route (see Figure 7 for location); 1m scale.

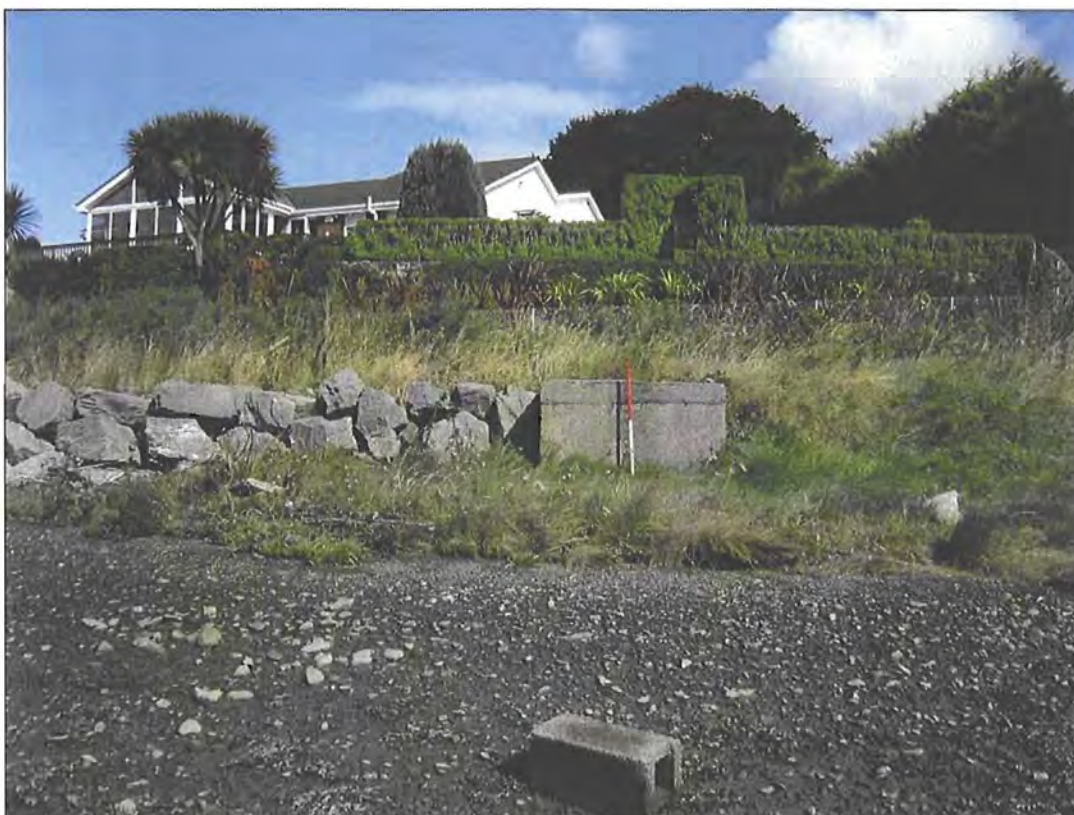
**Plate 31:** North-facing view of the upper foreshore c.1700m along proposed pipeline route (see Figure 7 for location); 1m scale.

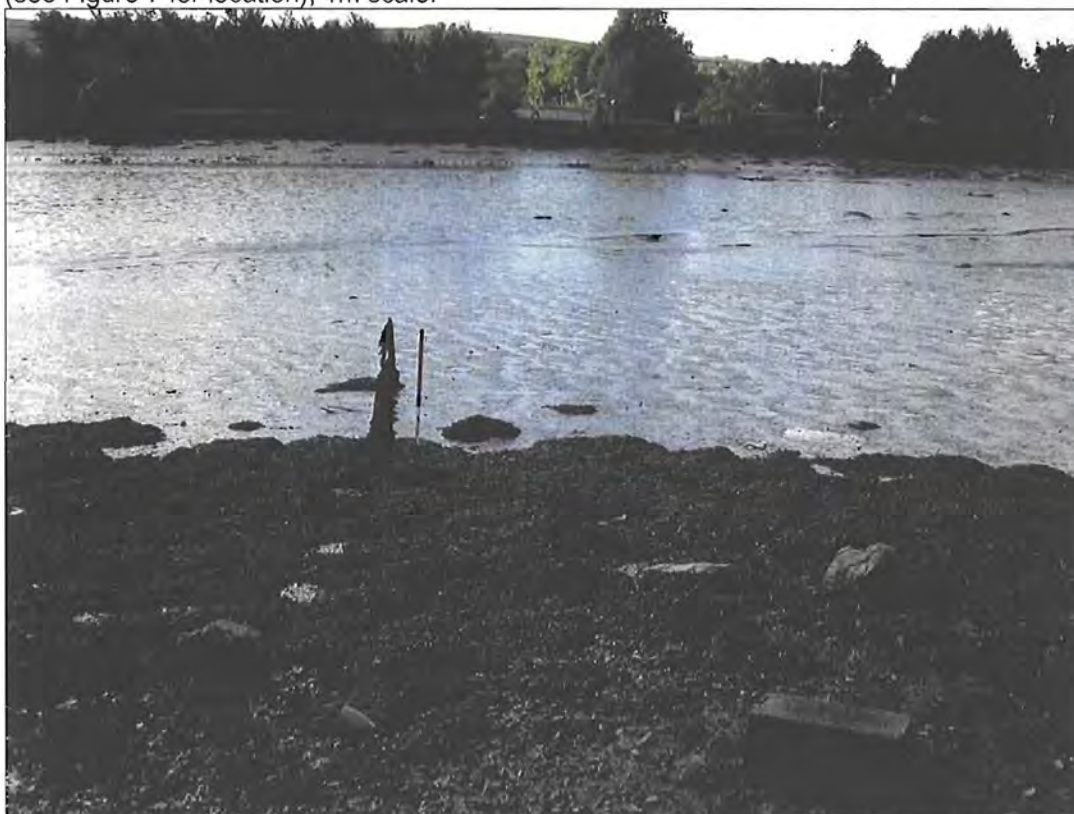
**Plate 32:** South-facing view of foreshore c.1700m along proposed pipeline route (see Figure 7 for location); mooring post middle distance (1m scale).

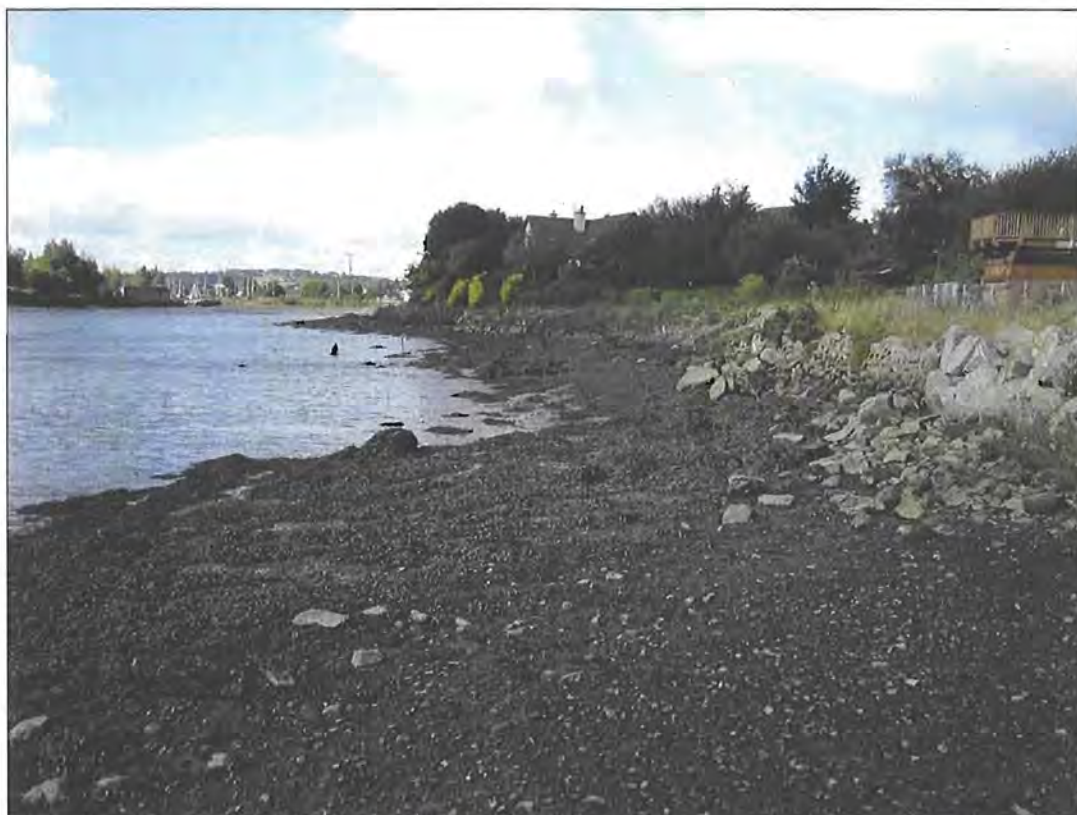
**Plate 33:** West-facing view of foreshore c.1700m along proposed pipeline route (see Figure 7 for location).

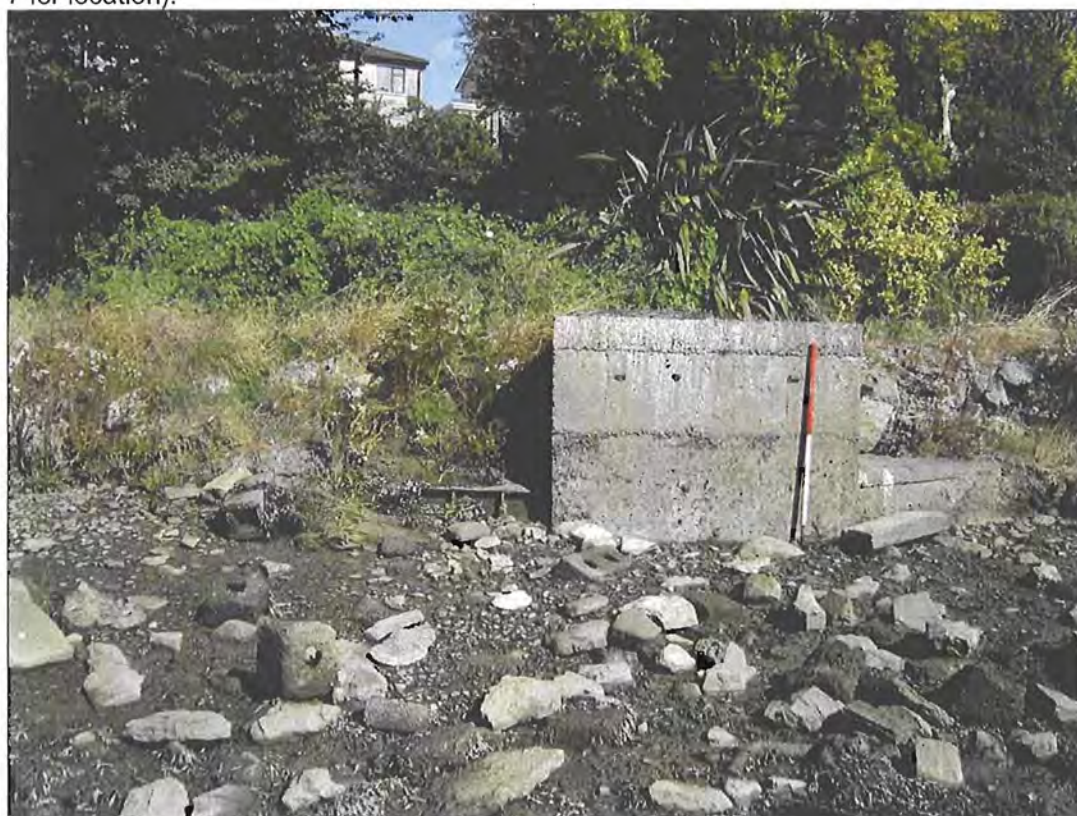
**Plate 34:** North-facing view of the upper foreshore c.1860m along proposed pipeline route (see Figure 7 for location); 1m scale.

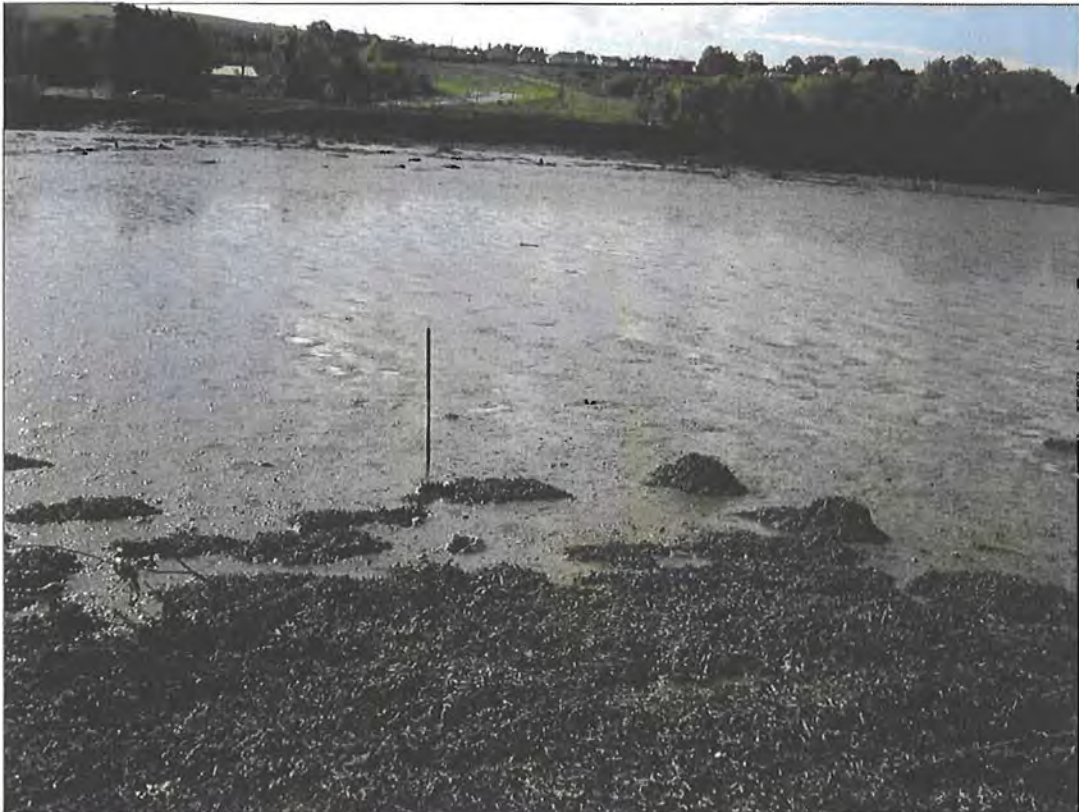
**Plate 35:** South-facing view of foreshore c.1860m along proposed pipeline route (see Figure 7 for location); 1m scale.

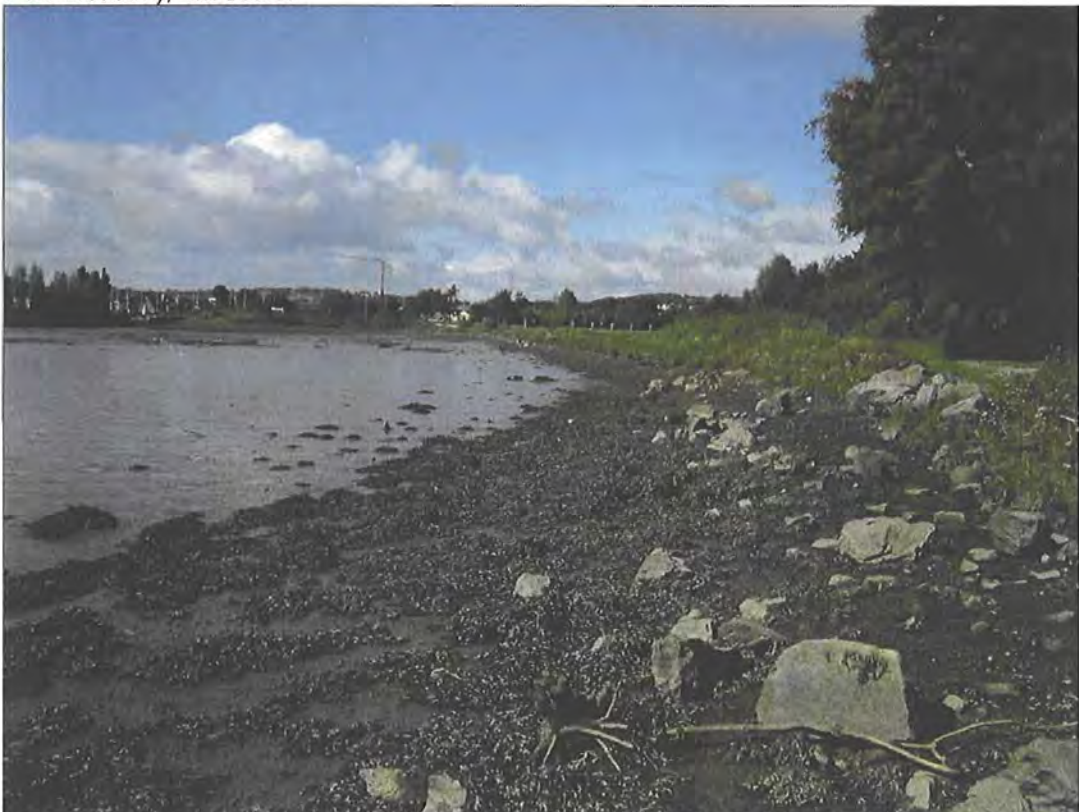
**Plate 36:** West-facing view of foreshore c.1860m along proposed pipeline route (see Figure 7 for location).

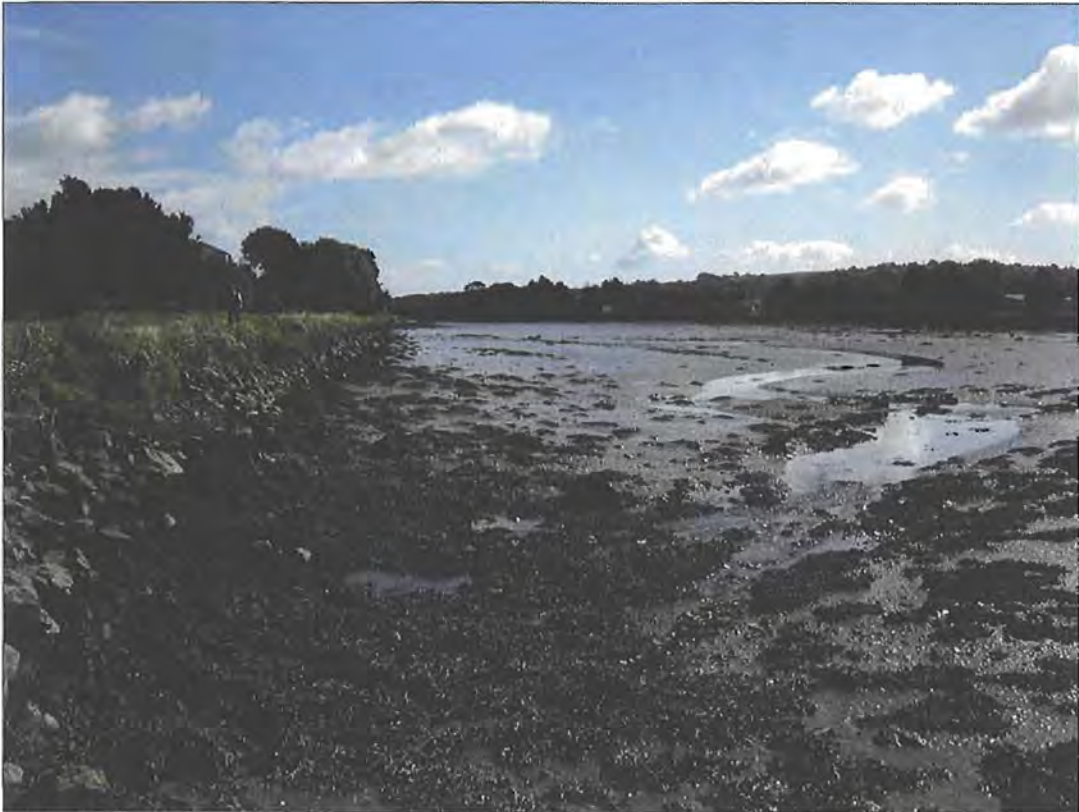
**Plate 37:** East-facing view from survey end-point, c.70m west from end of proposed pipeline route (see Figure 7 for location).

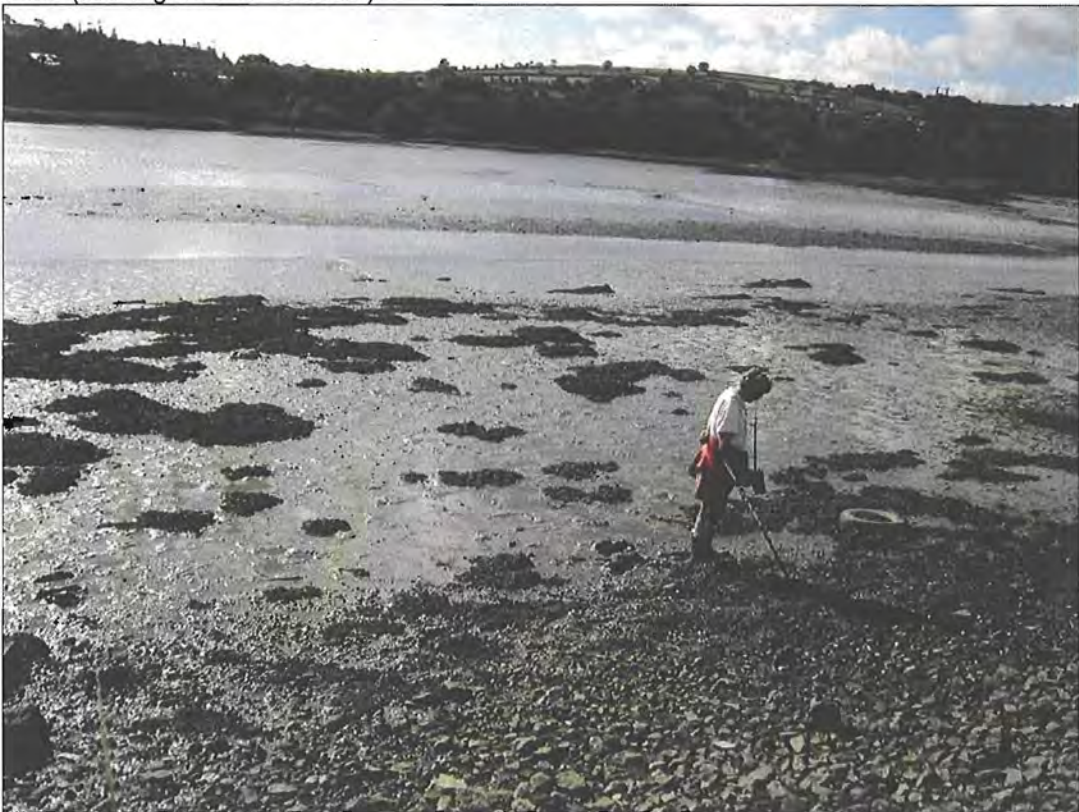
**Plate 38:** Working-shot of metal-detector use along survey area.

A metal-detection survey was undertaken along a 50m stretch of foreshore to provide a sample target-ratio that would be representative of the rest of the foreshore survey area (Plate 38). The survey was undertaken between NGR: 174410E, 624499N and NGR: 174374E, 624184N. A high target ratio of 1 hit every 1m<sup>2</sup> was encountered. The majority of these hits were sub-surface. Surface hits included drinks cans, iron nails, a fishing hook, an iron rowlock, and a metal bucket fragment.
