Greater Dublin Drainage Scheme

Fingal County Council

TW/12/PRJ-007

TechWorks Marine Limited

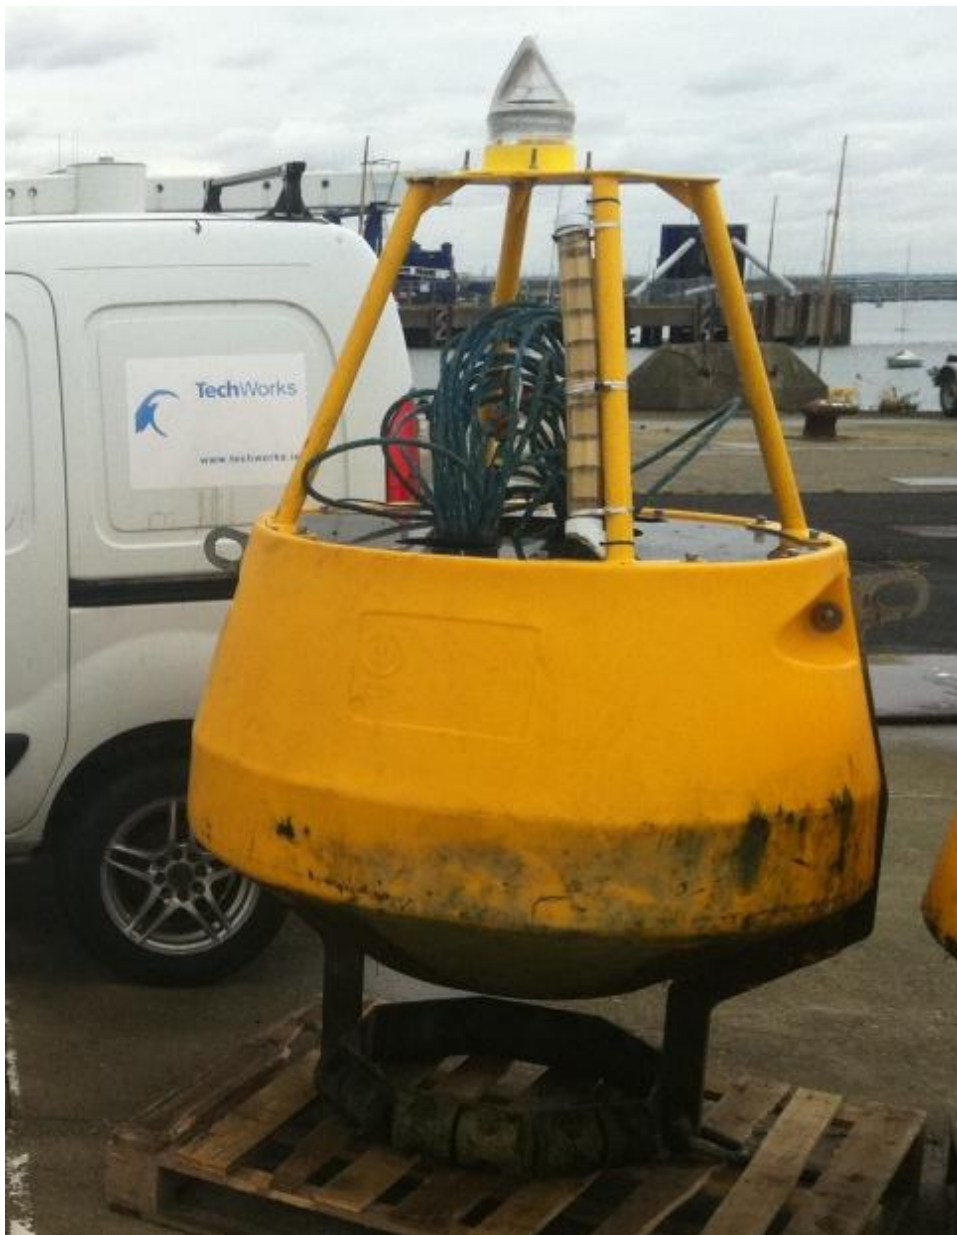
Figure 2. The Mobilis marker buoy has a radar reflector and navigation light programmed to flash 5 times every 20seconds. Combination cable cable has been chosen for the mooring as it offers extra strength and allows instruments to be clamped on without coming under any strain forces.

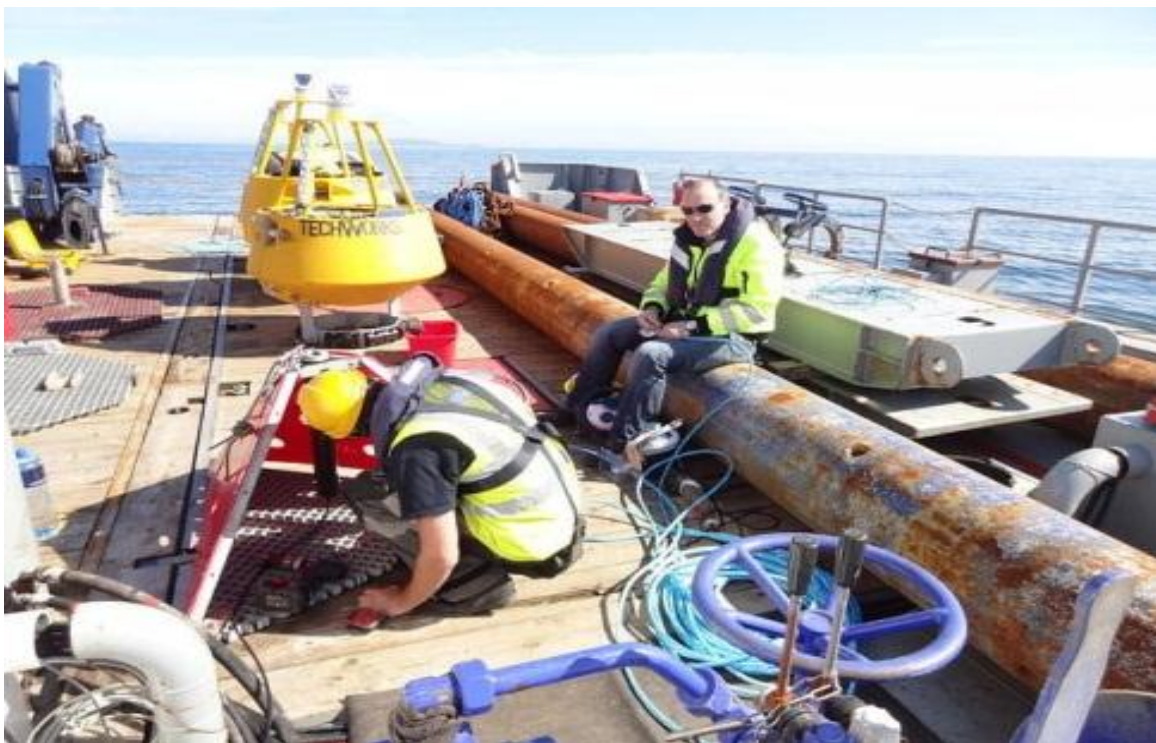
Figure 4. On board the SMS Meercat adding ballast to the Aquadopp frame

equipment is checked over and the lead is attached to the ADCP frames for ballast. The Jacketed mooring cable is cut to required length using an angle grinder and secured to buoy and sinker chain. All instruments are programmed and switched to sampling mode.

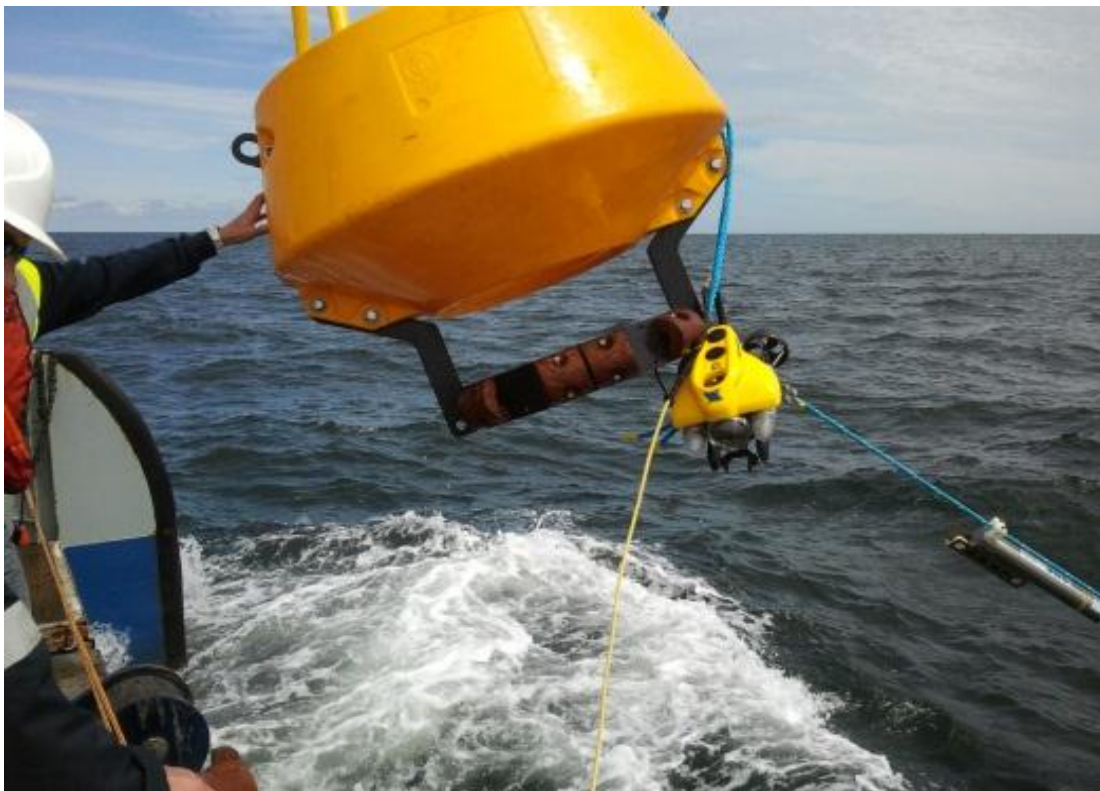
Figure

5. The VideoRay ROV entangled around the marker buoy which had to be lifted to undo the tether

13.55 – The team decide to bring in the ROV and make one more attempt to get a shot of the frame on the Sea floor. As the vessel makes another sweep at the buoy, the ROV is deployed but the tether gets wrapped around the mooring cable as the vessel drifts past. Recovery by piloting the ROV out of harm’s way becomes impossible and so the deck crane is used to lift the buoy from the water and detach the ROV. The tether has suffered some damage from the strain it came under and as a result, could not be further utilised.

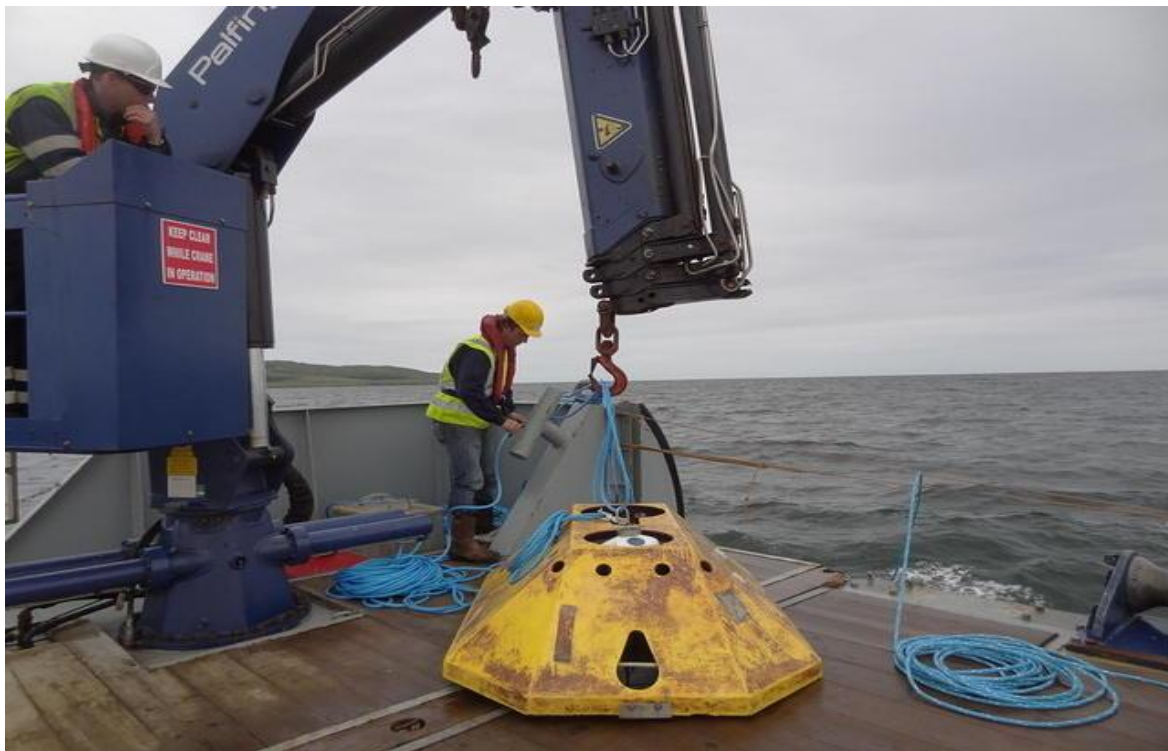
Figure 6. The deck crane being used to lift the AWAC trawl-resistant frame into the water

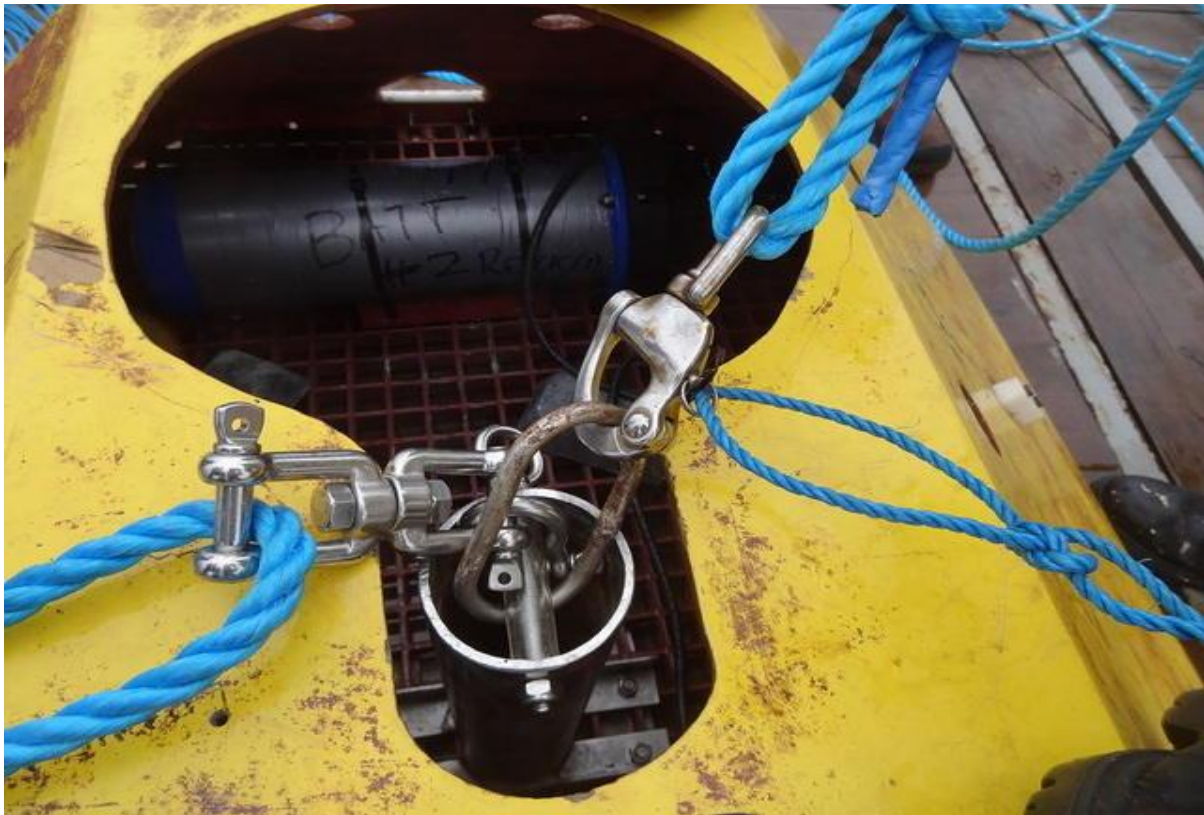
Figure 7. Quick release shackle attached to vertical steel pole.

17.44 – Team arrives at site C and prepare the final set of equipment for deployment. The deployment polyprop rope used in the previous deployment had to be left submerged with the second frame after complications meant that it could not be recovered. As a result a new plan is devised using a ‘quick release’ shackle to lower the frame into position and then use a thin rip cord to release the set-up once the frame reaches the seafloor. (See photo)

18:40 – Anchor Chain released to seafloor at position $53^{\circ}24'.5552$ N , $006^{\circ}02'.3954$ W. As the frame reaches the seafloor the rip cord is pulled but the team are unable to generate enough horizontal force to remove the pin from the shackle. As a result, the deployment rope remains attached to the frame. To ensure the rope doesn’t float above the instrument, one of the team attaches an anchor chain shackle to the end of the rope to sink it out of harm’s way.

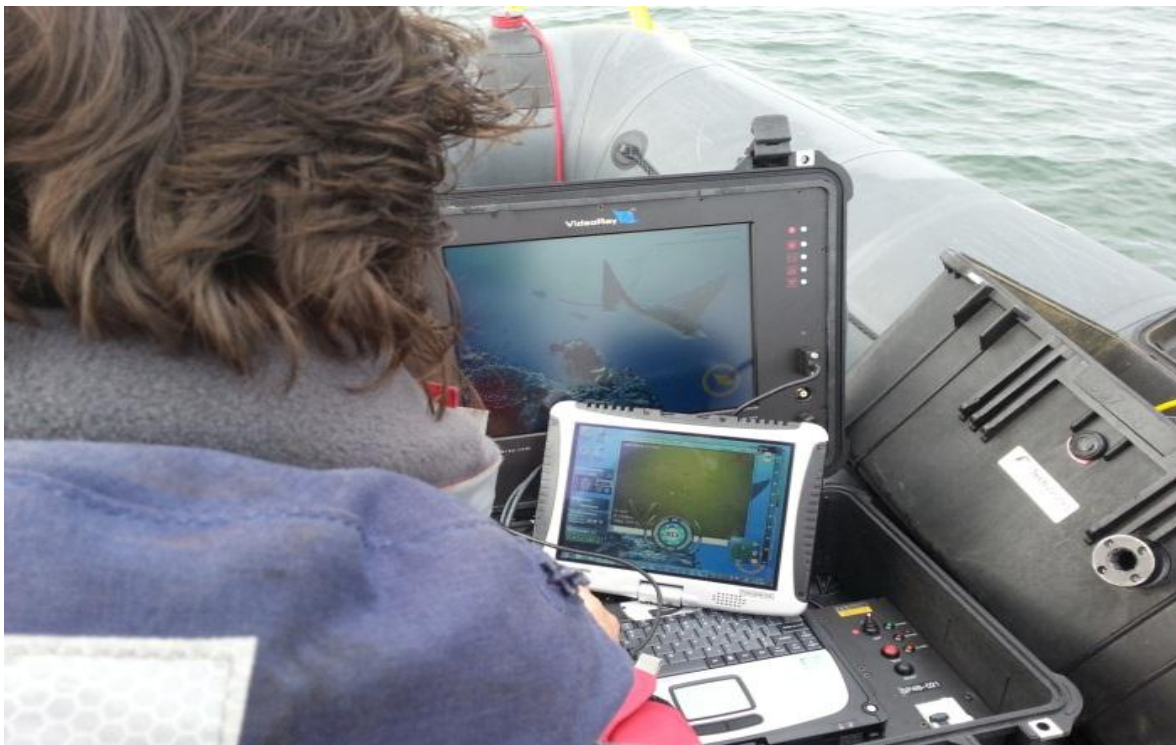
Figure 8. Deploying the ROV from the boat. The deck console is shown which along with the laptop used for recording the video stream to file.

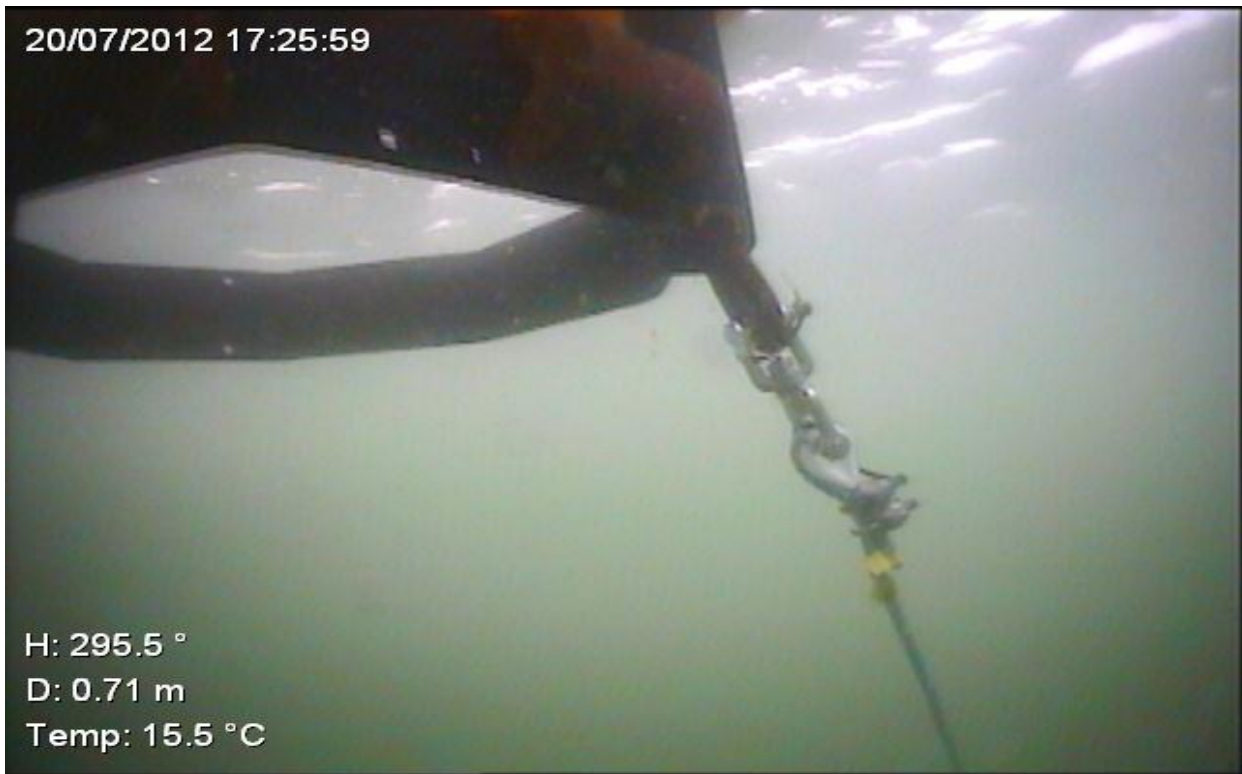
Figure 9. Underside of the marker buoy with swivel shackle connected to mooring cable

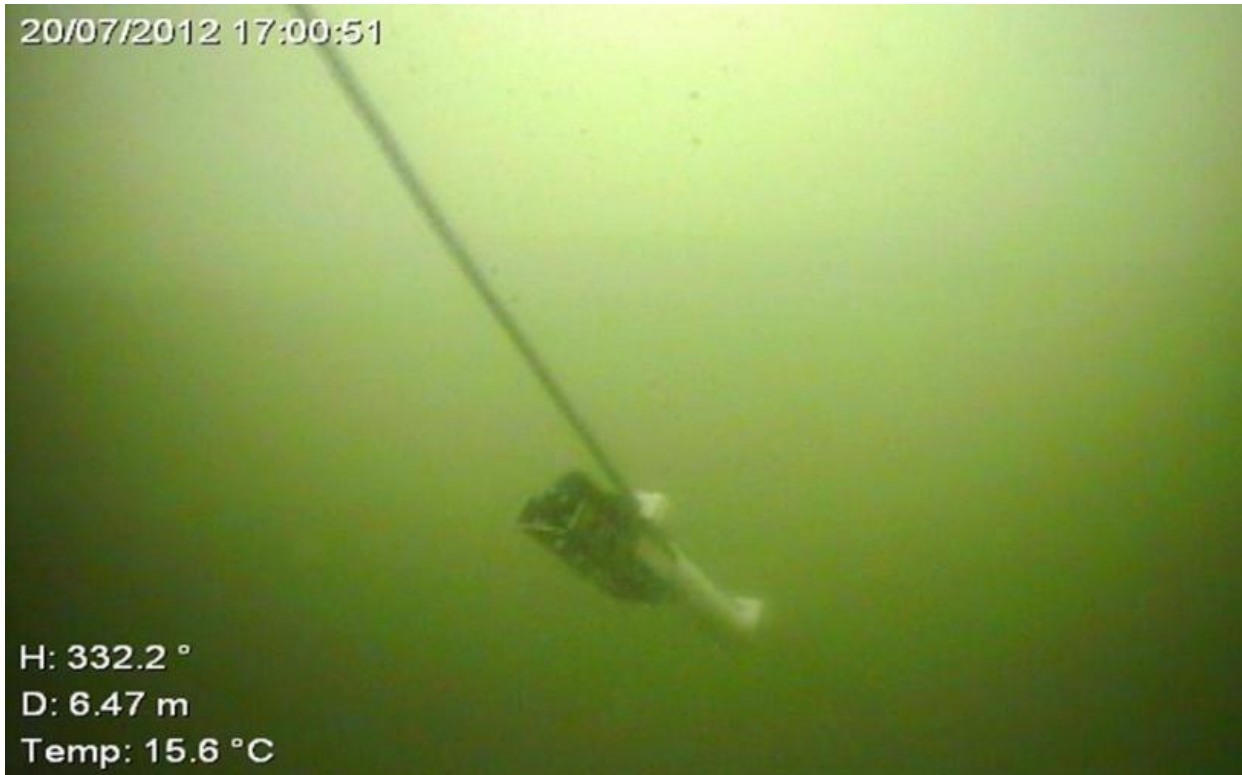
Figure 10. SBE 37 MicroCAT moored on the jacketed combination wire at 7.5m

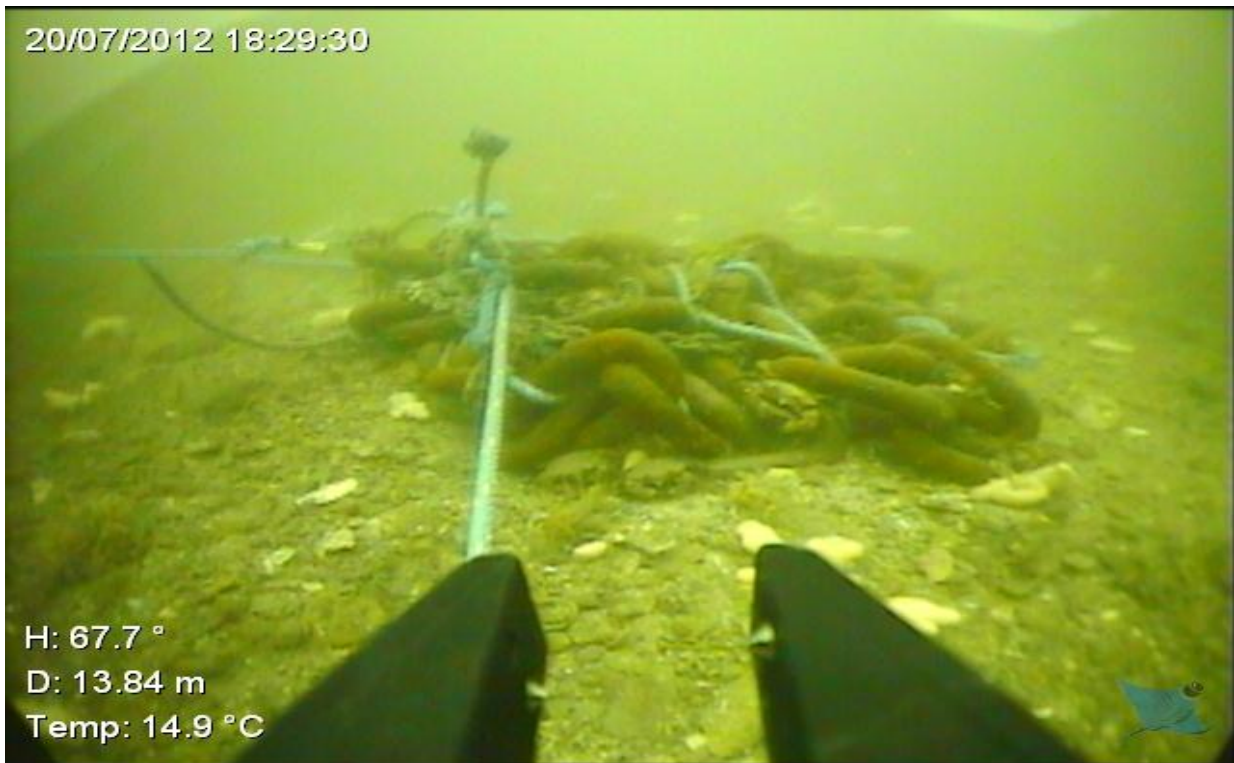
Figure 11. Anchor chain on the seabed at 14m. The two mooring lines coming off the sinker chain lead to the buoy and the AWAC frame.

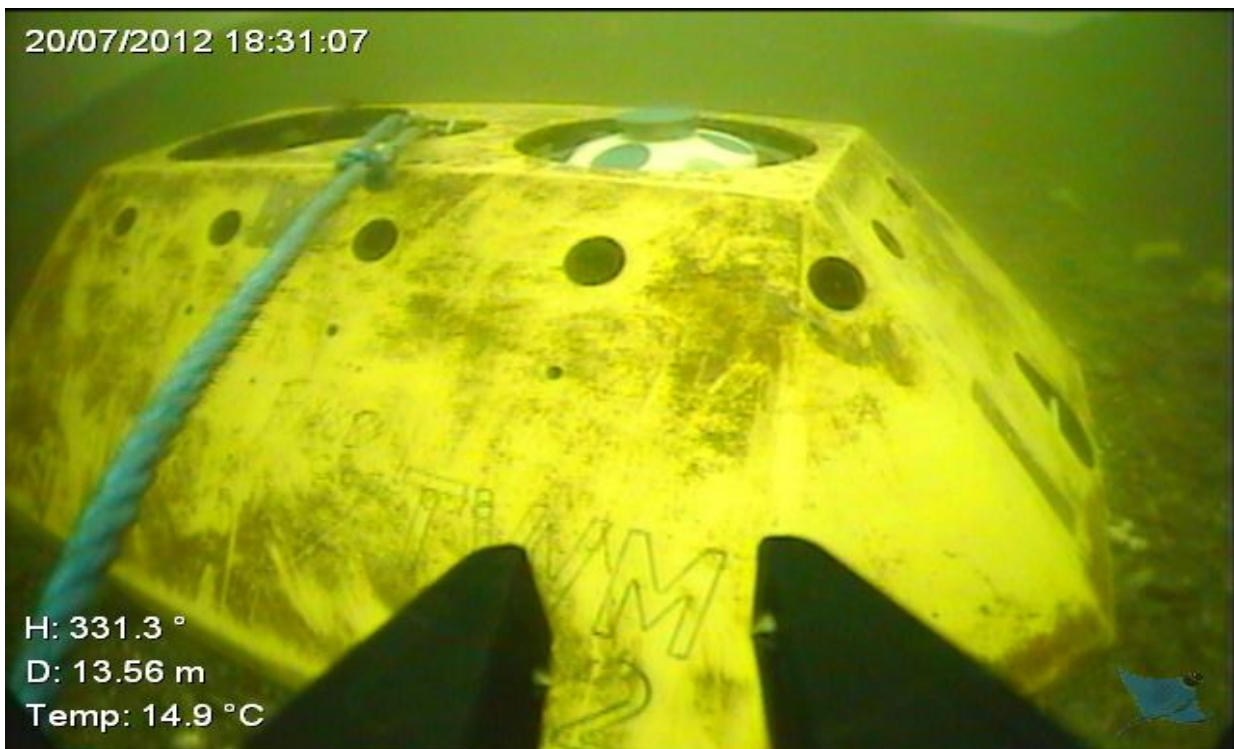
Figure 12. Gimballed mounted AWAC in trawl resistant frame

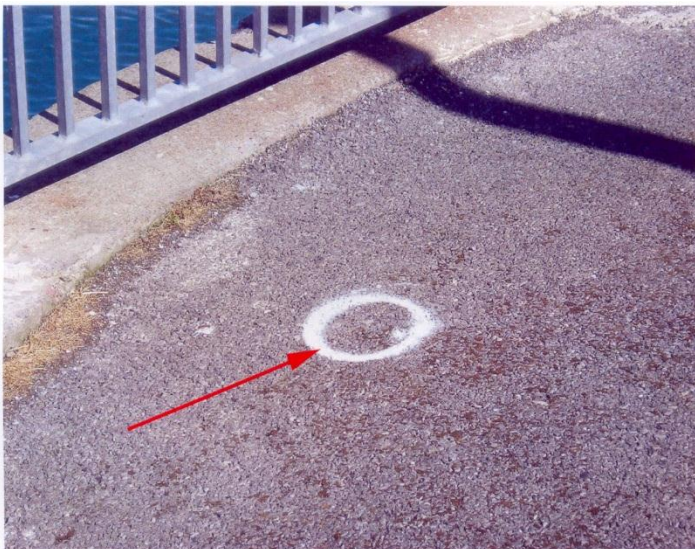
Figure 13. Metal pin in the ground on the pier in Howth Harbour. The RTK surveys carried out by the Marine Institute places this point 3.395m above the Datum at Malin Head.

Distance from tide gauge to metal pin	Offset of pin from Datum at Malin head	Correction
5.99m	3.395cm	2.595m

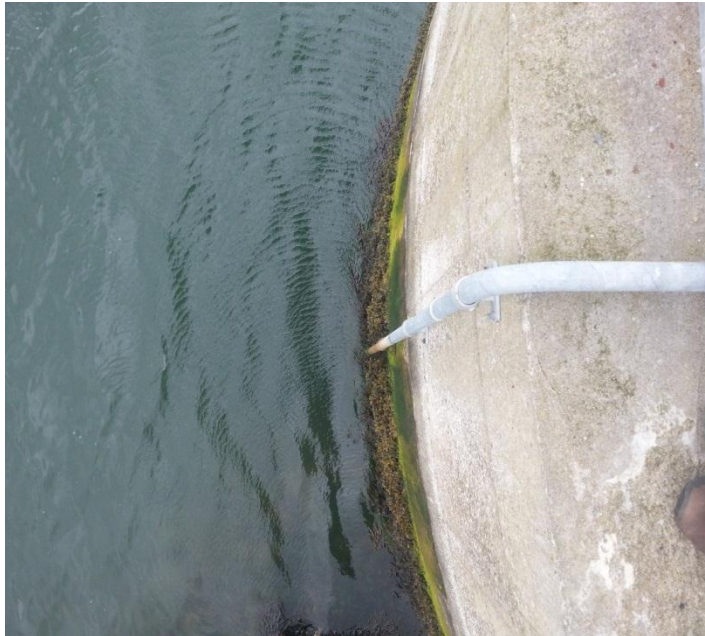
Figure 14. Marine Institute Bubble Tide gauge. TechWorks fastened a pole and Pressure tide gauge to the base of this pipe.

The SBE 39 tide gauges were fastened to the end of a stainless steel pole and lowered approximately 1 metre below the surface at low tide. The distance from the pin on the floor of the pier to the tide gauge was measured.

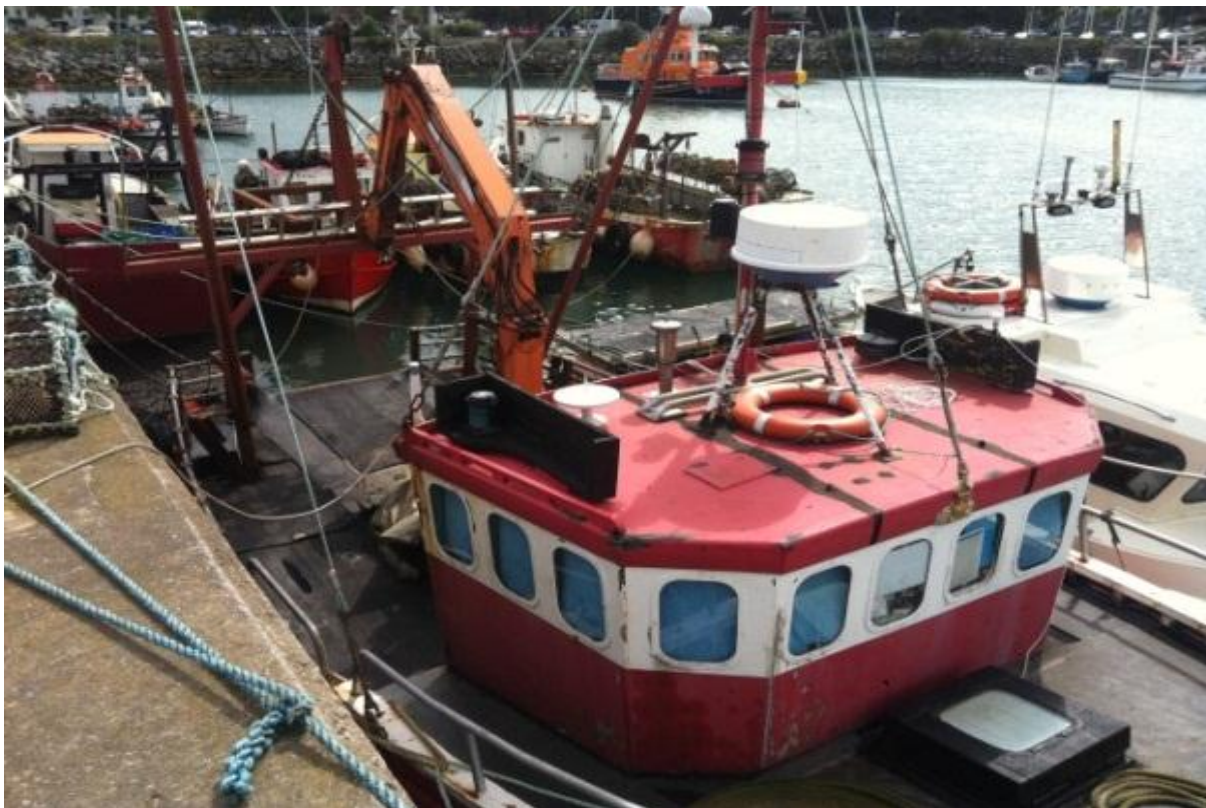
Figure 16. The Cluaran recovery vessel with 1.5 tonne deck crane and 3.5 tonne winch

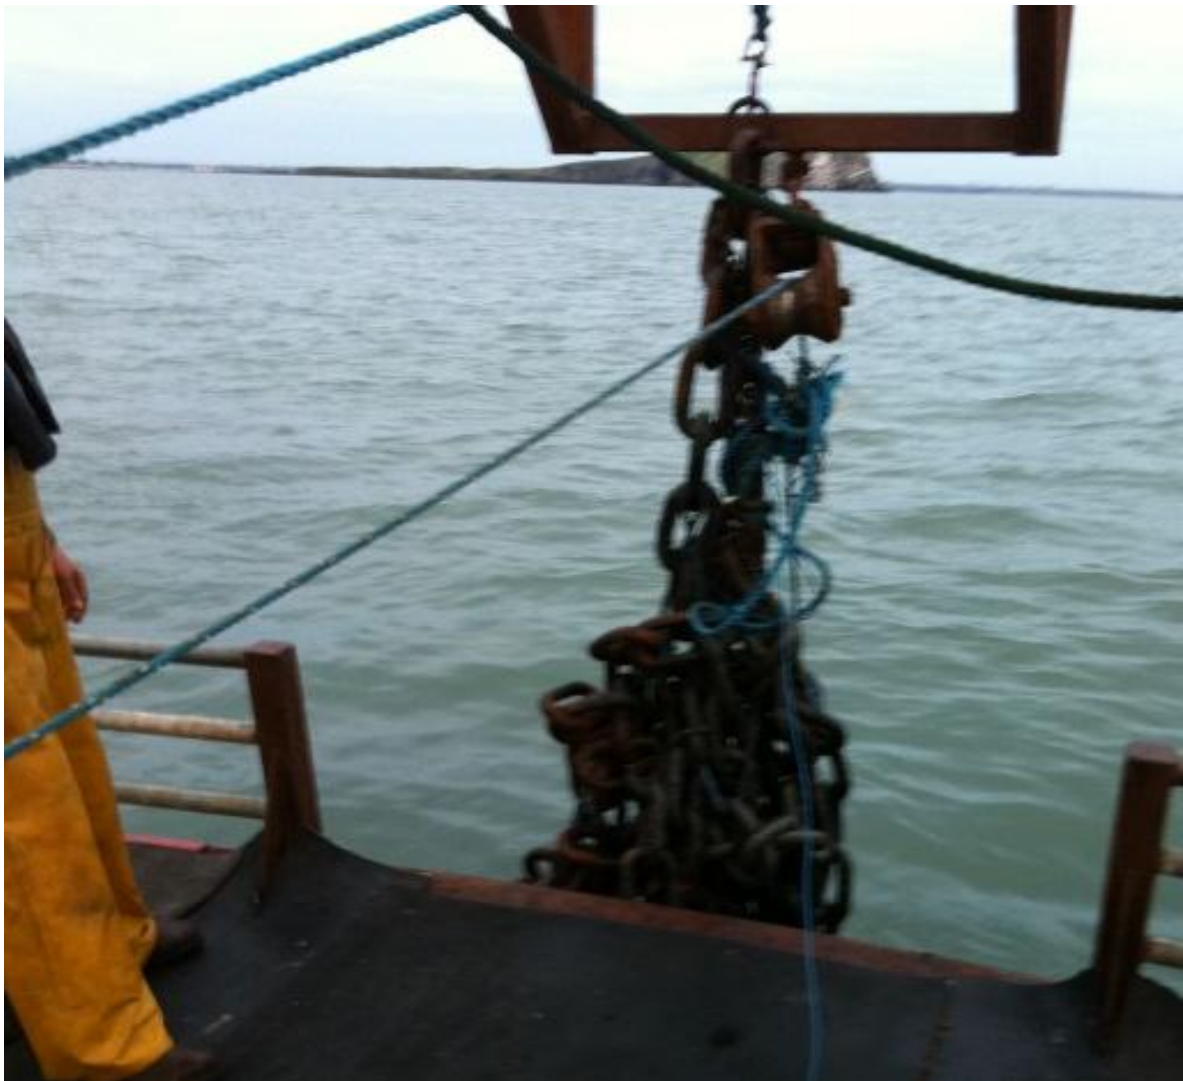
Figure 18. The anchor chain being brought up by the vessel's gantry.

The Anchor chain surfaces and is brought up onto the deck of the boat. The shackle is released from the anchor chain and the polyprop rope is loaded onto the winch.

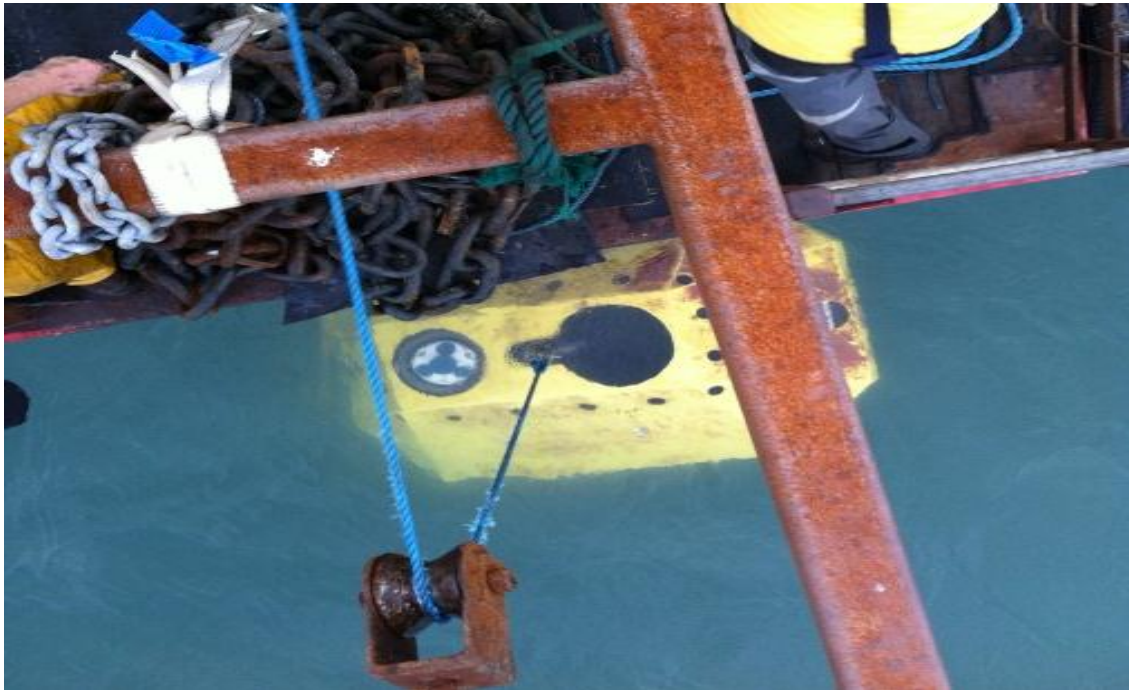
Figure 19. The AWAC frame breaching the surface

The winch is used to haul up the first AWAC frame and the gantry is then tilted to bring the frame onto the deck. Recover ADCP frame. Steam to second site.

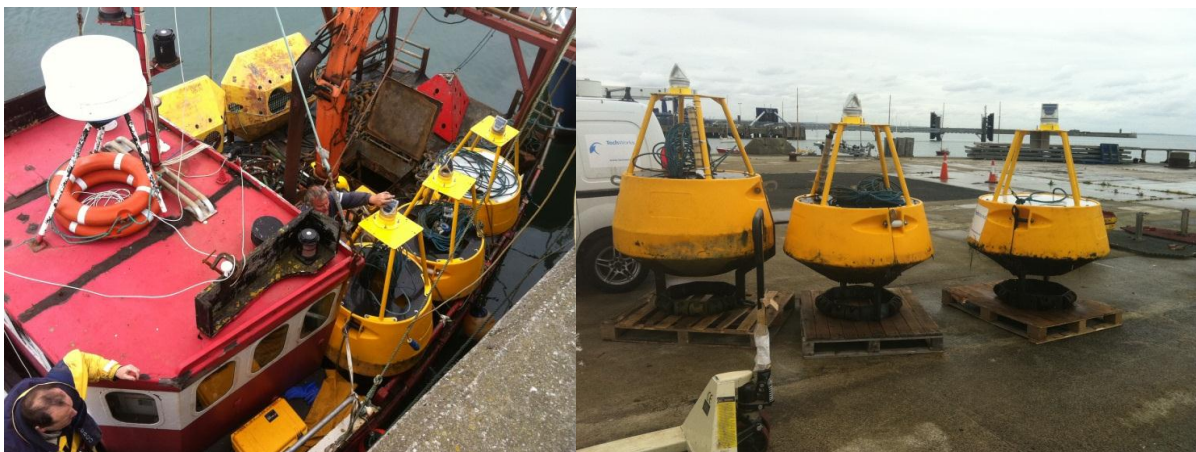
Figure 21 & 22. The recovery vessel moored up on the Carlisle Pier in DunLaoghaire. The vessel's crane was then used to lift all equipment onto the pier before it returned to Howth harbour.

16:00 – Arrived at Carlisle Pier (DunLaoghaire) and offload all equipment and instrumentation using vessel crane. All buoys, anchor chain and frames are stored on pallets on the pier overnight. Harbour police secure gates of Pier.

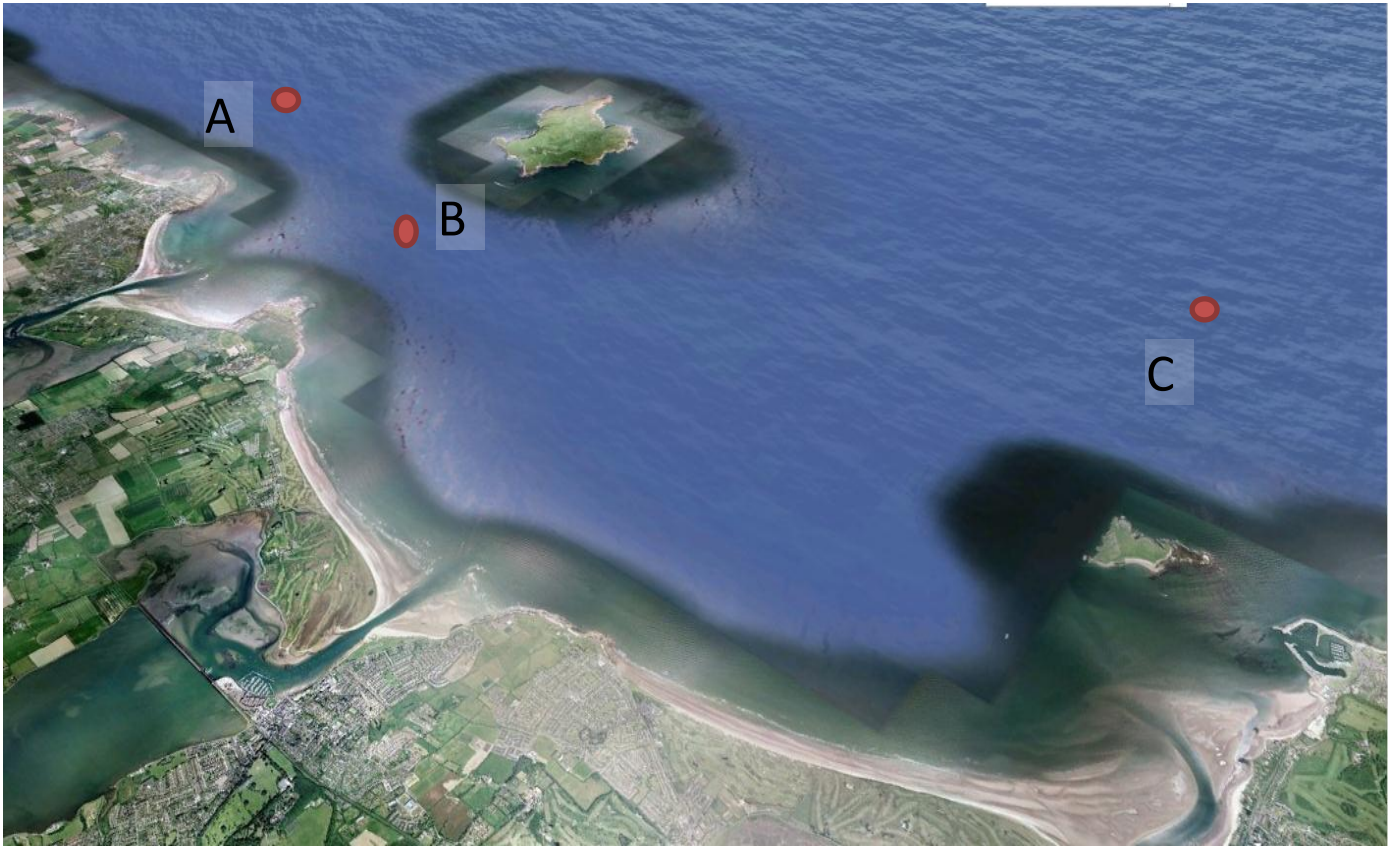
Figure 24. Google earth Image of study area including the positions of the Temperature, Salinity and Current measurements.
