Annual Environmental Report

2018

Derrinturn

D0244-01

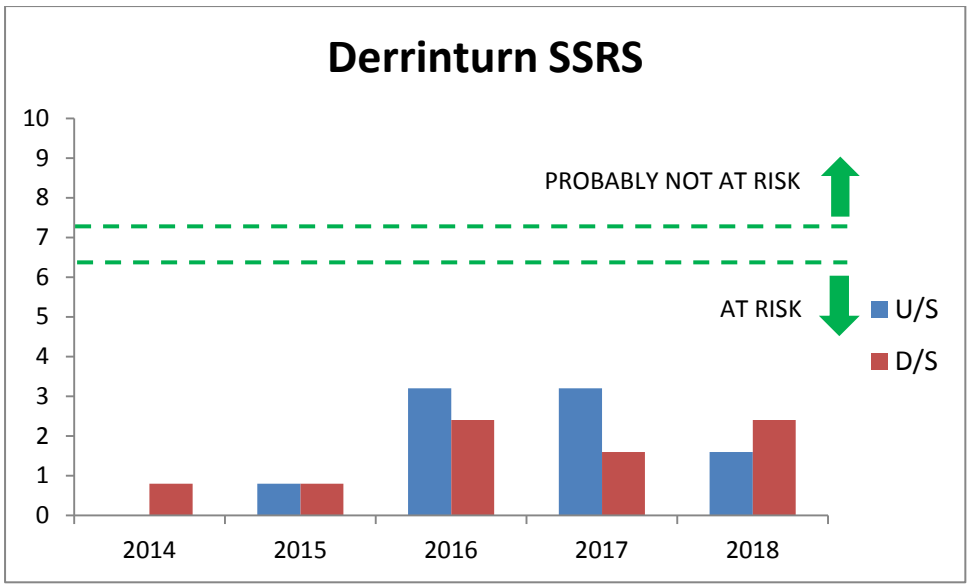
***Figure 1** – SSRS Comparison 2014 -2018 Derrinturn WWTP*

Table 2 compares SSRS results for sampling covering the years 2014 to 2018. **Figure 1** illustrates trends at sites across sampling years, showing that both sites are consistently "At Risk" and of poor water quality. There were no 2014 results for upstream as the sampling site was only selected in 2015. The upstream site was slightly poorer than downstream for the first time to date. There is clearly a water quality problem in this stream, affecting upstream and downstream of the WWTP discharge.
