Annual Environmental Report

2019

Coill Dubh

D0242-01

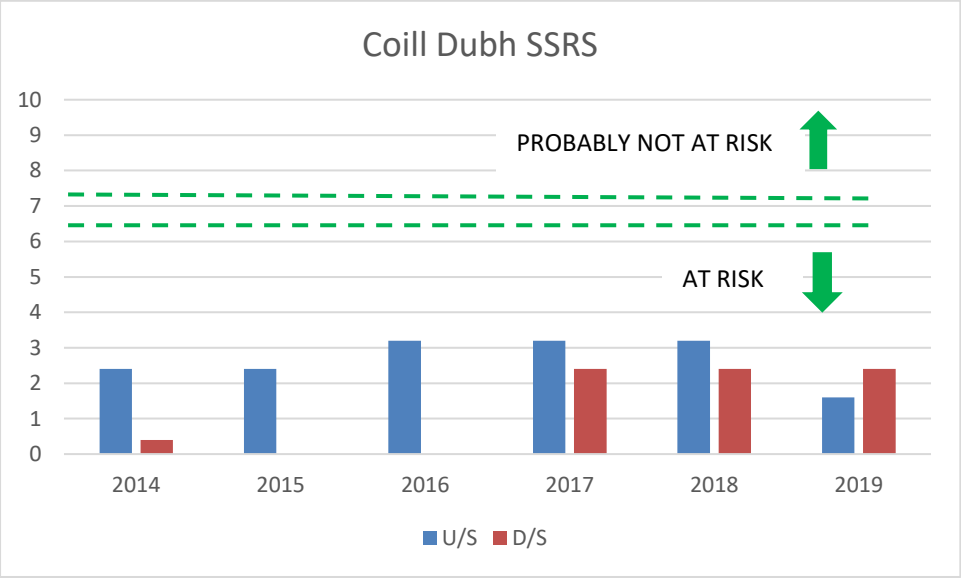
Figure 1 – Coill Dubh WWTP - SSRS Comparison 2014 - 2019

Table 2 compares SSRS results for sampling covering the years 2014 to 2019. **Figure 1** illustrates the trends over time. The upstream site usually displays slightly better quality compared to downstream, but in 2019, this trend was reversed. Overall, however, there has been improvement downstream over the last 3 years, compared to earlier years. There appears to be a correlation between improved SSRS and operation of the new WWTP.
