## Tipper Truck Incident

Document No: IW-HSQE-SA-15

# SAFETY ALERT

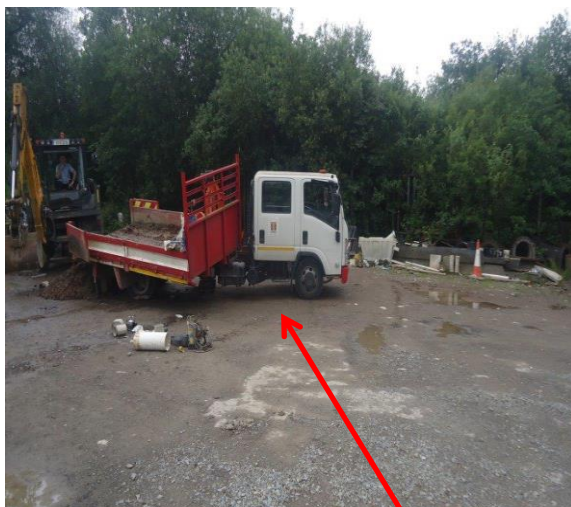
Irish Water were recently notified of a reportable dangerous occurrence involving a small tipper truck. It appears that a pivot bar to the rear of the tipper of the truck, which keeps the tipper in line with the body of the truck while tipping and allows the tipper to lift while the hydraulic ram behind the cab extends, sheared as a load was being tipped causing the tipper to fall to one side of the truck. Luckily a serious accident was avoided as no one was standing close to the tipper truck while the load was being tipped. While it is not clear why the tipper pivot bar sheared it would appear that the bar seized up, possibly due to a lack of greasing or as a result previous damage. The incident highlights the importance of keeping personnel well clear of trucks while they are tipping. The Health and Safety Authority have previously issued an alert after the pivot bar on a small tipper truck failed in a similar fashion in a previous incident.

Tipper truck after incident

- The rear pivot bar and brackets of all small tipper Trucks are to be thoroughly inspected by a competent person immediately.
- Pivot bar and brackets should be replaced before further use if there is any evidence of fatigue/failure.

- Drivers of tipper trucks who notice any defects associated with them should report them to their supervisor immediately.
- It should be ensured that the rear pivot bar and brackets are included in the routine inspection and servicing regime for these vehicles.
- All grease points should be lubricated regularly.
- Ensure that there is a documented risk assessment in place for tipper truck operations.
- Toolbox talk should be provided to all personnel required to work where tipper trucks are in operation reminding them to stand well clear of tipper trucks while they are tipping.
- HSA safety alert regarding previous tipper truck failure to be communicated to relevant personnel-[Safety Alert 2015 Small Tipper Trucks](#)

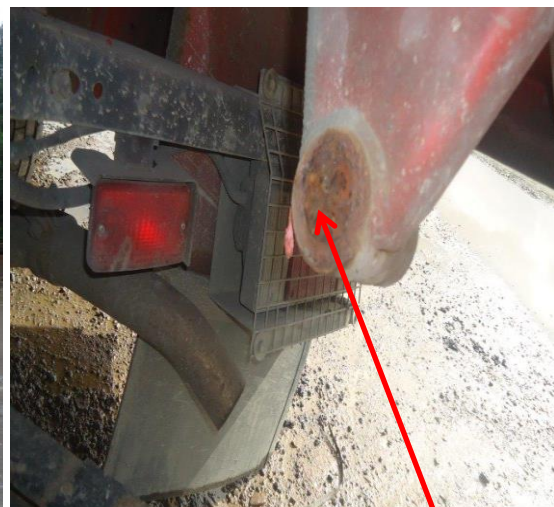
Sheared end of pivot bar seized within bracket
