SAFETY ALERT

Grid Flooring

Document No: IW-HSQE-SA-36
Approved By: Tom Quinlan

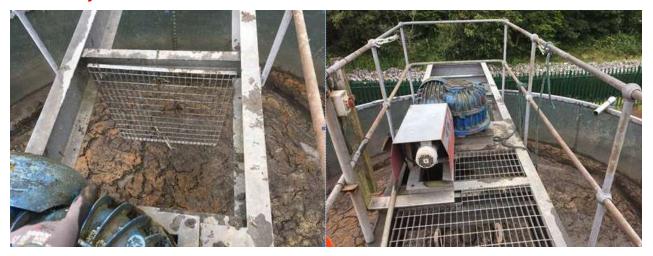
A High Potential near miss occurred, whereby an operative who was walking across a walkway narrowly avoided falling into a tank when the grating moved and gave way beneath him – luckily the operative's quick reactions allowed him to grab the handrail and avoid the fall into the tank. The operative involved in the near miss was undertaking a daily operational routine when the incident occurred.

Photo 1: Incident scene where High Potential Near Miss occurred.

- Ensure <u>inspections</u> are completed on all grating/grid flooring at frequent intervals and prior <u>to the commencement of any works</u> to ensure they are secure and stable. Where defects are identified, notify your line manager and ensure temporary control measures are put in place immediately. Ensure works area is made safe and secure before continuing to use the grating.
- All site visitors including contractors should be made aware of the hazards associated with grating/grid flooring.

- Continue to regularly check the grating/grid flooring in your immediate work area as you progress with your work activity and report any deficiencies immediately.
- If grating/grid flooring needs to be removed as part of any works, please ensure all flooring is reinstated in a secure and stable position once works have been complete.
- Ensure a suitable <u>Method Statement and Risk Assessments</u> are developed and adhered to. This should also include a detailed Emergency Response Procedure.
