## ESB issued a “Stop Work Notice”

Document No: **IW-HSQE-SA-34**

# SAFETY ALERT

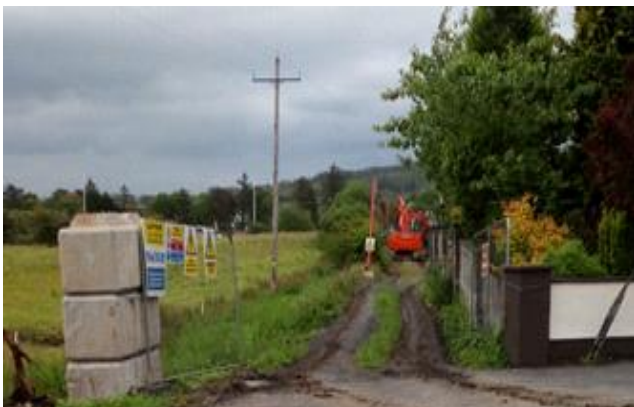
The Contractor was laying a pipe line using 20T & 13 T excavators; in the “Hazard Zone” of Overhead Electricity Lines without adequate controls to prevent all parts of the plant in use entering the exclusion zone (ref to page 46 of the cop)

All works in the area were immediately ceased by the ESB. The Contractor liaised with ESB Networks and agreed upon control measures to be implemented prior to works re-commencing.

- The network owner/operator is consulted before works begin;
- There is a comprehensive, detailed safe system of work in place;
- When it is appropriate to de-energise the network, the work does not begin until after the network owner/operator switches out and earths the line. It is not always possible to switch out or divert lines to permit work that could accidentally breach the exclusion zone.

- Where work is permitted that could accidentally breach the exclusion zone, the following minimum precautions apply:
- Prepare a written risk assessment and work method statement in consultation with the people who will be doing the work. (risk assessment must comply with section 7.3.1 of the COP for avoiding danger from overhead powerlines)

- Establish and use a daily permit-to-work system.
- Use only equipment that has certified operational limiters installed to prevent any part of the equipment breaching the exclusion zone.

- In the risk assessment, specify the limits to which the equipment can operate & n site, ensure only a competent person sets and fixes these limits and that the limits are verified by testing.

- .
- Put in place a competent dedicated observer for plant and equipment. The dedicated observer must be able to communicate with the machine operator at all times and must not do any other work while work in the hazard zone is in progress.
