What Happened?

Whilst undertaking Hydraulic Survey Works on a project, a Fire Hydrant cap was being removed by two engineers in Co Cork. The pressure was not checked or released before the cap was removed and as a result of high pressure within the pipeline, the cap blew off when opened. The cap was contained within the chamber and nobody was injured.

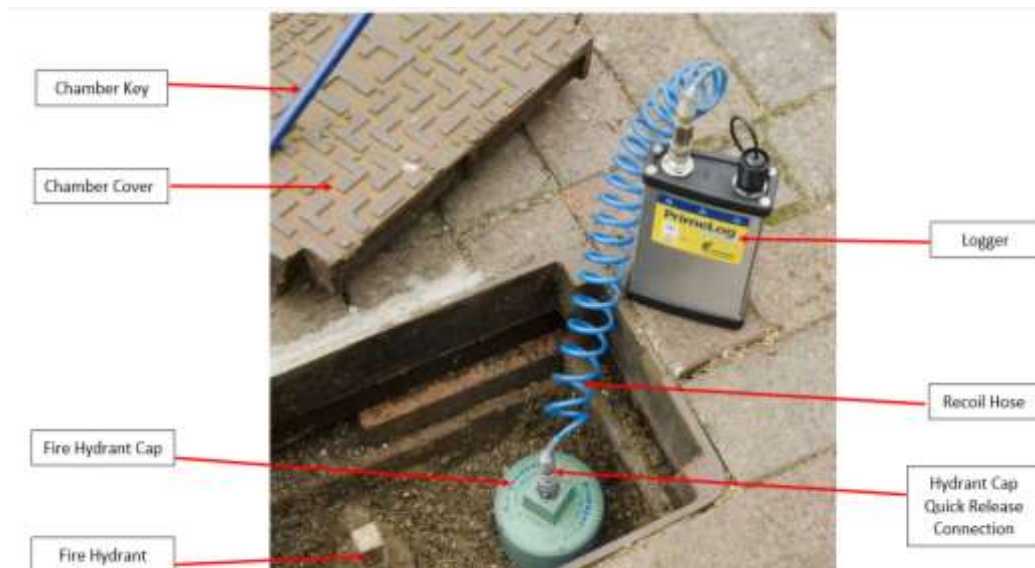
Figure 1

- Carry out a Safe Systems of Work Plan,
- Remove chamber cover using chamber key (Figure 1),
- Turn off hydrant fully using valve key,
- Check for pressure using calibrated pressure gauge to ensure hydrant is not pressurised (Figure 2),
- Remove Logger and recoil hose from cap,
- Open quick release connection on hydrant cap valve to ensure there is no static pressure (double check),
- Remove cap from hydrant,
- Replace chamber cover.
