SAFETY ALERT- 3rd Party

Incident Date: 06/11/2019

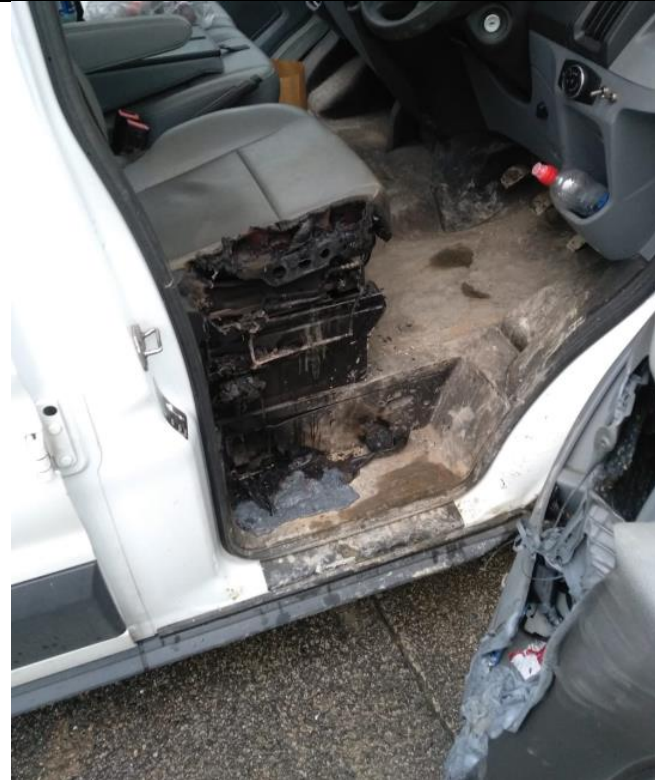
First picture showing damaged to singed/burnt seat.

- Battery under vehicle seat had made contact with object resulting in some combustion.

- Battery not covered as per manufactures specification.
- Works (retro fitting of hazard lights) had been carried out to the vehicle by the Hire Company.

- Retro fitting of axillary devices that require connection to battery to be completed by competent persons.
- Ensure plant machinery arriving to site has thorough inspection report.

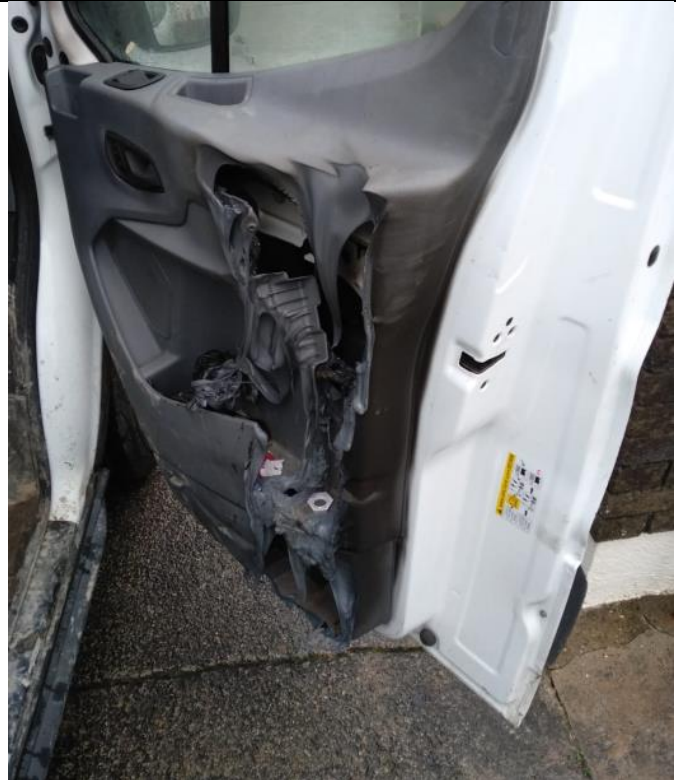
While the second shows the interior of door panel severely melted as a result of heat.
