Tipper Truck Incident

Document No: IW-HSQE-SA-15

1. What Happened?

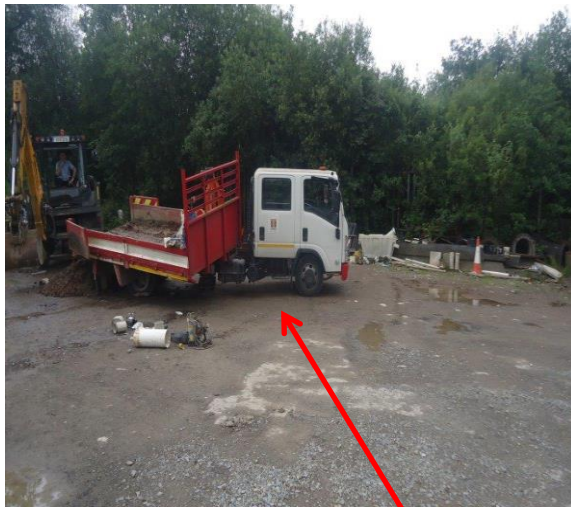
Irish Water were recently notified of a reportable dangerous occurrence involving a small tipper truck. It appears that a pivot bar to the rear of the tipper of the truck, which keeps the tipper in line with the body of the truck while tipping and allows the tipper to lift while the hydraulic ram behind the cab extends, sheared as a load was being tipped causing the tipper to fall to one side of the truck. Luckily a serious accident was avoided as no one was standing close to the tipper truck while the load was being tipped. While it is not clear why the tipper pivot bar sheared it would appear that the bar seized up, possibly due to a lack of greasing or as a result previous damage. The incident highlights the importance of keeping personnel well clear of trucks while they are tipping. The Health and Safety Authority have previously issued an alert after the pivot bar on a small tipper truck failed in a similar fashion in a previous incident.

Tipper truck after incident

- The rear pivot bar and brackets of all small tipper Trucks are to be thoroughly inspected by a competent person immediately.
- Pivot bar and brackets should be replaced before further use if there is any evidence of fatigue/failure.

- Drivers of tipper trucks who notice any defects associated with them should report them to their supervisor immediately.
- It should be ensured that the rear pivot bar and brackets are included in the routine inspection and servicing regime for these vehicles.
- All grease points should be lubricated regularly.
- Ensure that there is a documented risk assessment in place for tipper truck operations.
- Toolbox talk should be provided to all personnel required to work where tipper trucks are in operation reminding them to stand well clear of tipper trucks while they are tipping.
- HSA safety alert regarding previous tipper truck failure to be communicated to relevant personnel-[Safety Alert 2015 Small Tipper Trucks](#)

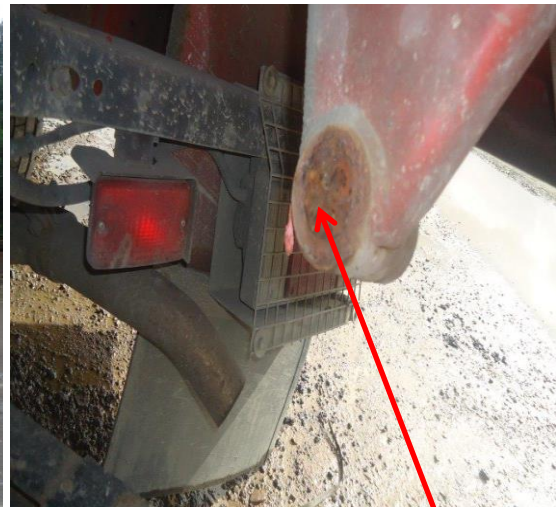
Sheared end of pivot bar seized within bracket
