Grid Flooring

Document No: IW-HSQE-SA-22

SAFETY ALERT

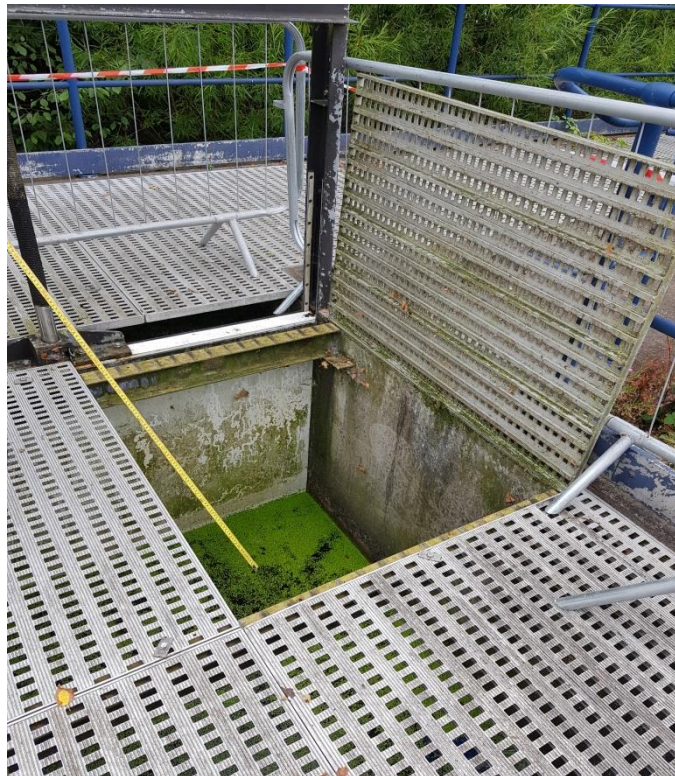
Two Mechanical & Electrical operatives were attending Monaghan WWTP on the 14th August 2018 to supply and install a new grit trap blower at the inlet works. The two operatives proceeded to the works location. As the second operative walked up the concrete steps and proceeded to cross the grid flooring, it appears the grid flooring moved resulting in the operative falling into the sump (approx. 1.7m deep) sustaining a broken arm and a shoulder and a deep laceration to his leg.

Photo 1: Grid flooring over Inlet Works

Works stopped immediately on site and emergency services contacted.

The works area was sealed off with steel safety pedestrian barriers to prevent unauthorised entry. Checks were carried out on all remaining locations containing grid flooring on site to ensure grid flooring was secure.

- Ensure all grating/grid platforms and walkways are checked to ensure they are secure and stable. Where defects are noted the area should be suitably secured using barriers and repairs should be carried out.

- Ensure that regular checks are continued to be carried out on all gratings/grid floorings installed in raised platforms or over fall hazards and report any deficiencies immediately.
