SAFETY ALERT | AMISAFE!?

Grid Flooring

Document No: IW-HSQE-SA-30

1. What Happened?

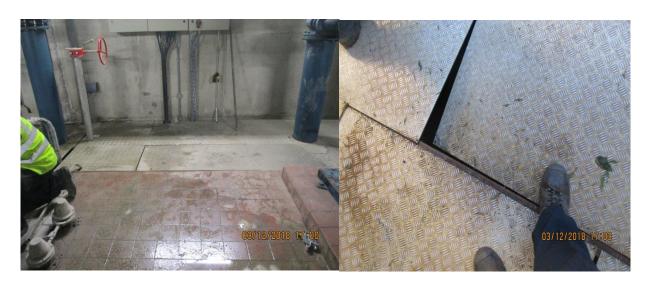
A second incident has occurred in relation to grating/grid flooring. An Electrician foreman was exiting a pump house and traversed across chequer plates covering a channel which fell through an opening as the plate shifted forwards underneath his foot. The operative received extensive bruising and scrapes to his left leg and thigh and also to his right knee.

Photo 1: Checker plates where incident occurred

- Ensure all grating/grid platforms and walkways are checked to ensure they are secure and stable. Where defects are noted the area should be suitably secured using barriers and repairs should be carried out.

- Ensure that <u>regular checks are continued</u> to be carried out on all gratings/grid floorings installed in raised platforms or over fall hazards and report any deficiencies immediately.
